## List of Contributing Structures in the Historic District

# Village of Orland Park, Illinois Historic Buildings Survey

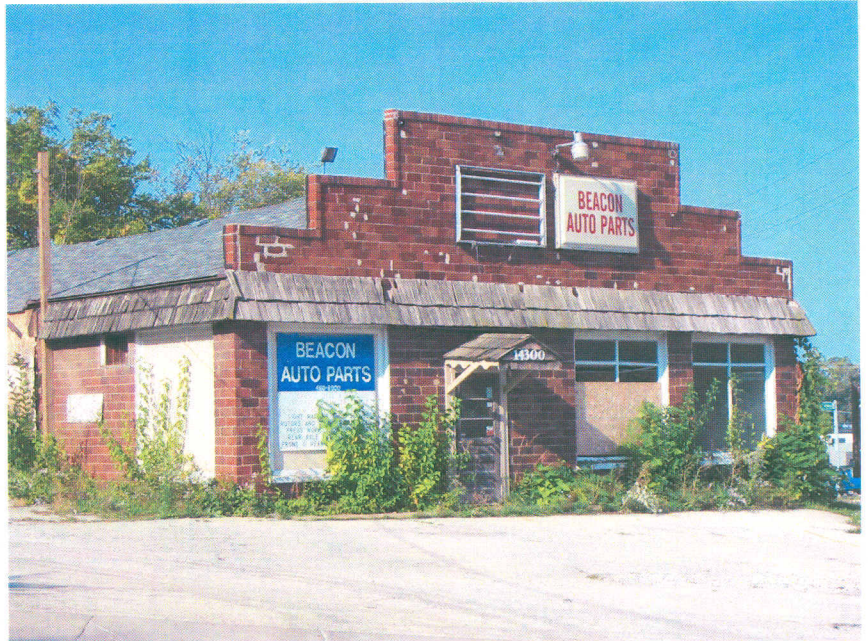
14300 Beacon.jpg

**Condition** Fair

**Window Type & Materials** Wood, fixed divided light with transom; some windows boarded over

**Alterations** A narrow profile false-mansard roof; the portico and door are not original; there is an addition to the side

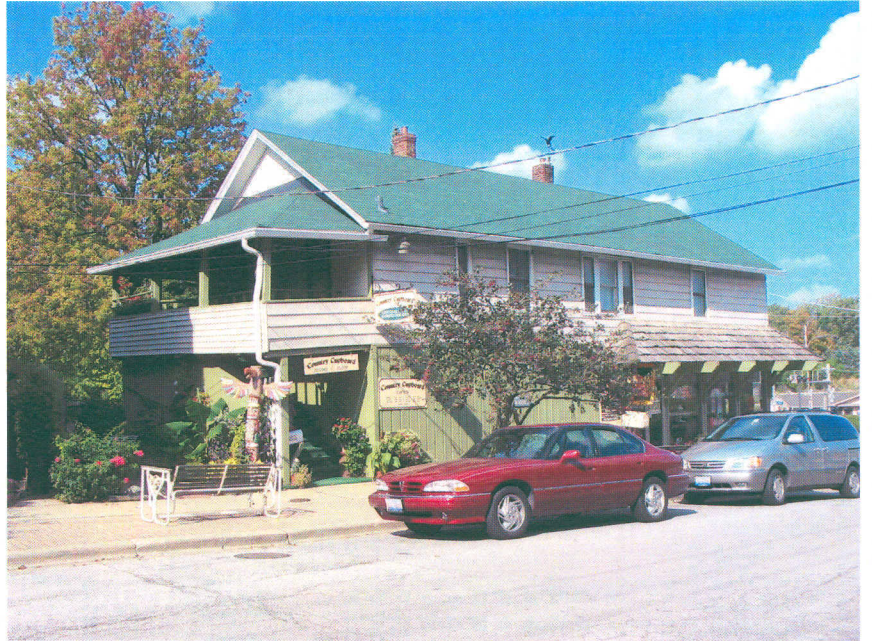
14314 Beacon.jpg

**Condition** Good

**Alterations** Shed roof of wood shingles added over storefront windows; siding altered; gabled side addition; storefronts have been altered

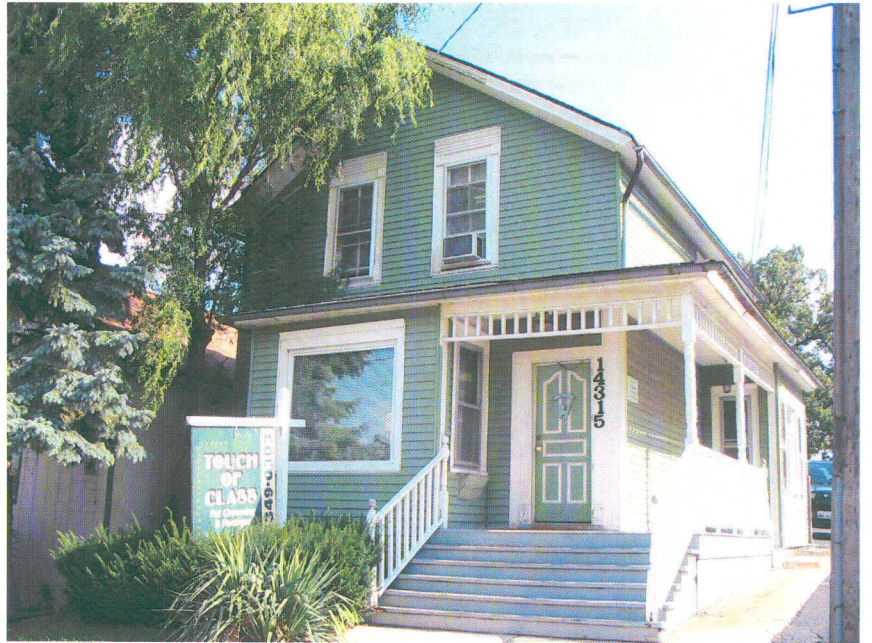
14315 Beacon.jpg

**Condition** Good

**Alterations** Siding altered; some windows replaced

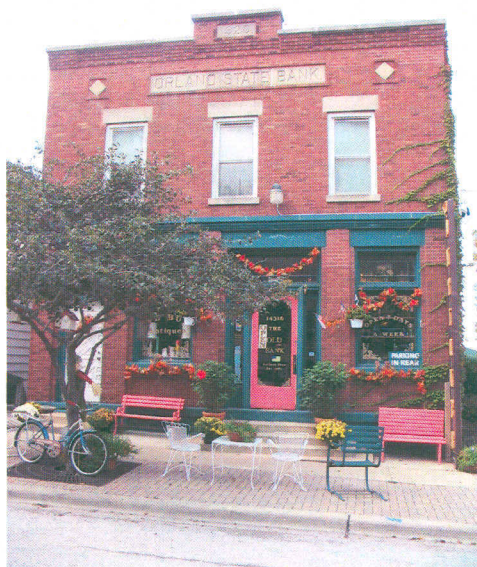
14316 Beacon\_7.jpg

**Condition** Excellent

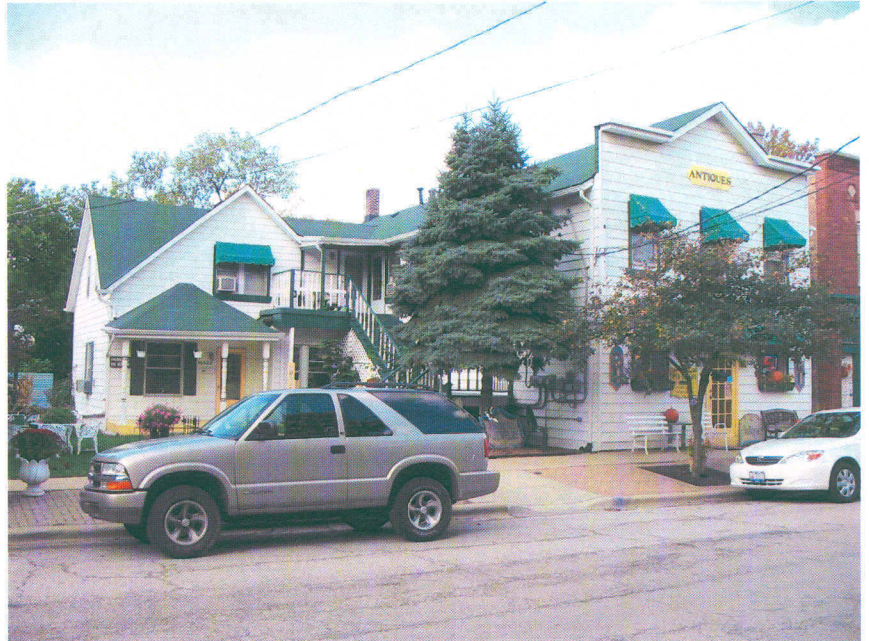
14320-24 Beacon\_5.jpg

**Condition** Good

**Alterations** Synthetic siding; first floor windows altered; residential wing at the side

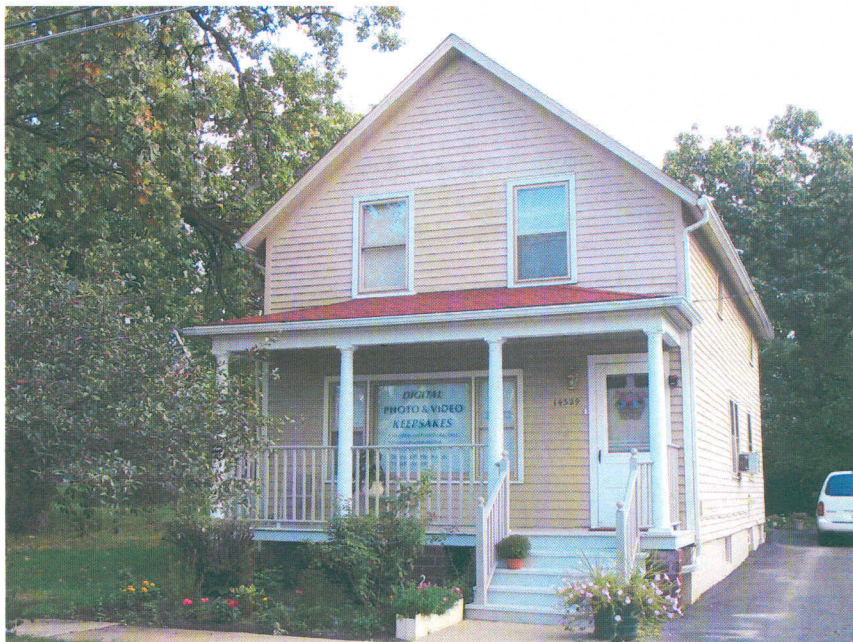
14329 Beacon.jpg

**Condition** Good

**Alterations** First floor window has been altered; interior chimney is new brick

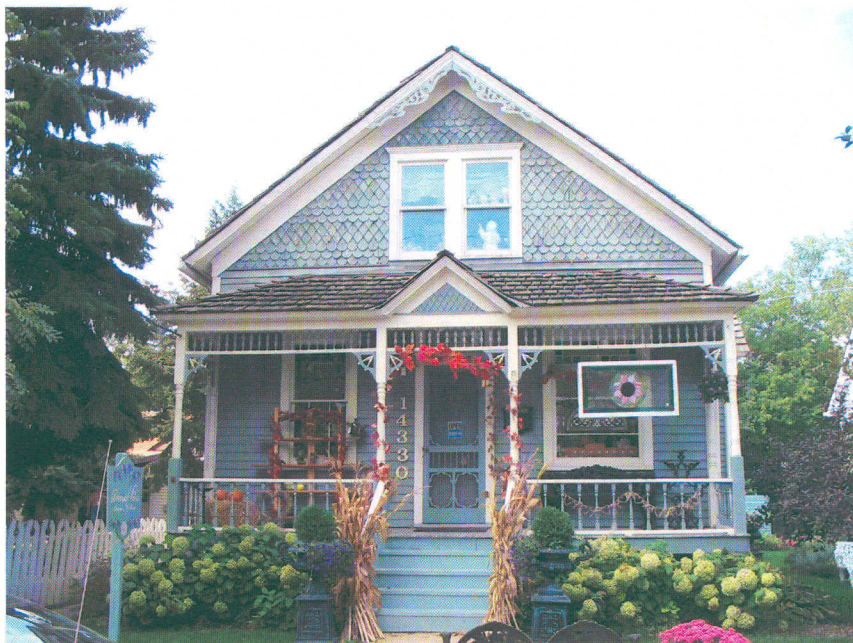
14330 Beacon.jpg

**Condition** Excellent

**Alterations** Parged interior chimney

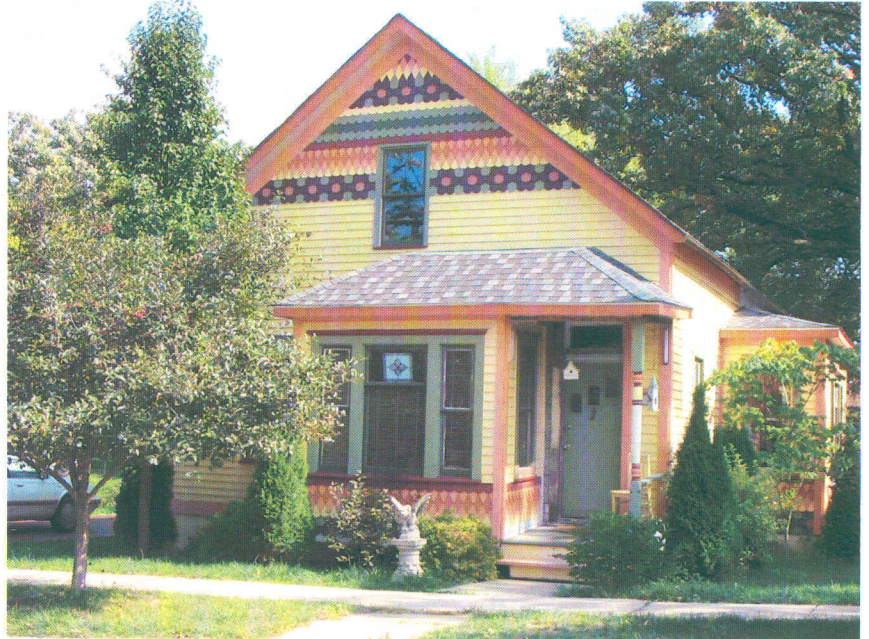
14339 Beacon.jpg

**Condition** Excellent

**Alterations** Decorative shingles under gable installed sometime after 1991, source: 1991 Residential Survey photograph

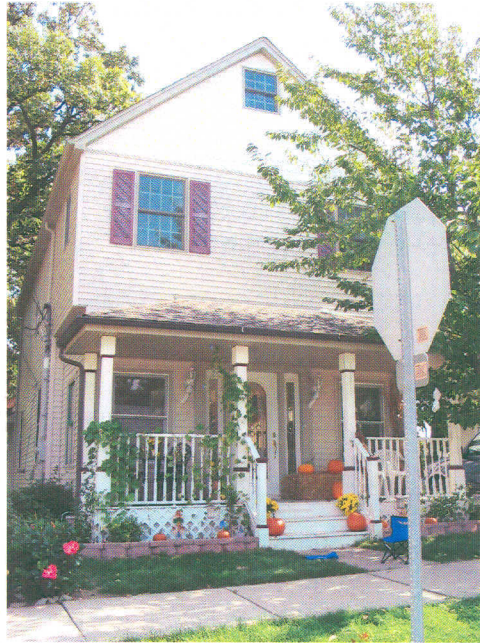
14403 Beacon.jpg

**Condition** Good

**Window Type & Materials** Replacements: 6/6 light, double-hung; 1/1 light double-hung; center fixed window with narrow casements to each side divided by four horizontal muntins

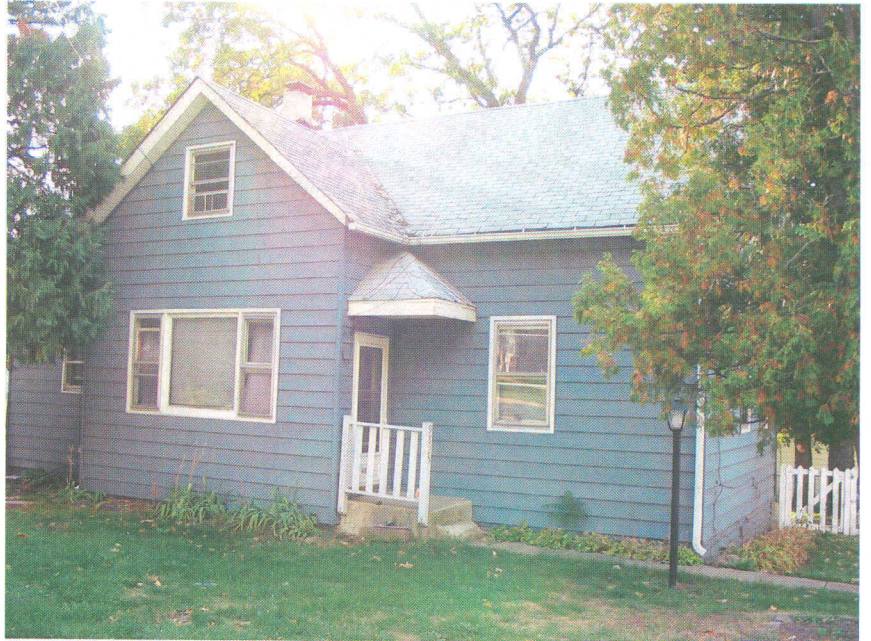
9825 144th St\_2.jpg

**Condition** Good

**Porch** Portico with hipped roof, concrete stair and corner support missing

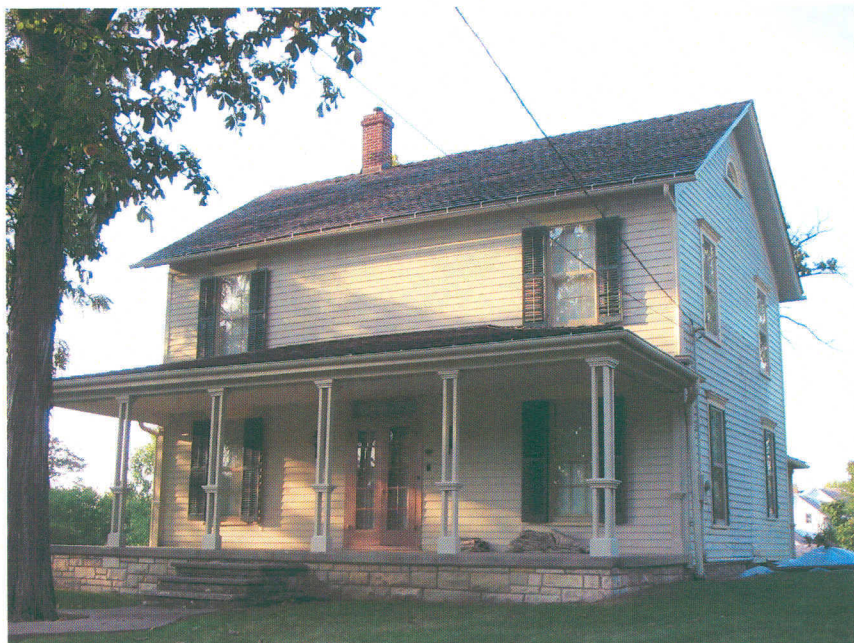
9830 144th Place\_Humphrey House.jpg

**Alterations** Front porch currently undergoing restoration; foundation, concrete deck and steps are replacements
