ORLAND RURAL HISTORY SURVEY

PREPARED FOR
THE VILLAGE OF ORLAND PARK

BY ANNE MCGUIRE & ASSOCIATES

DECEMBER, 1995

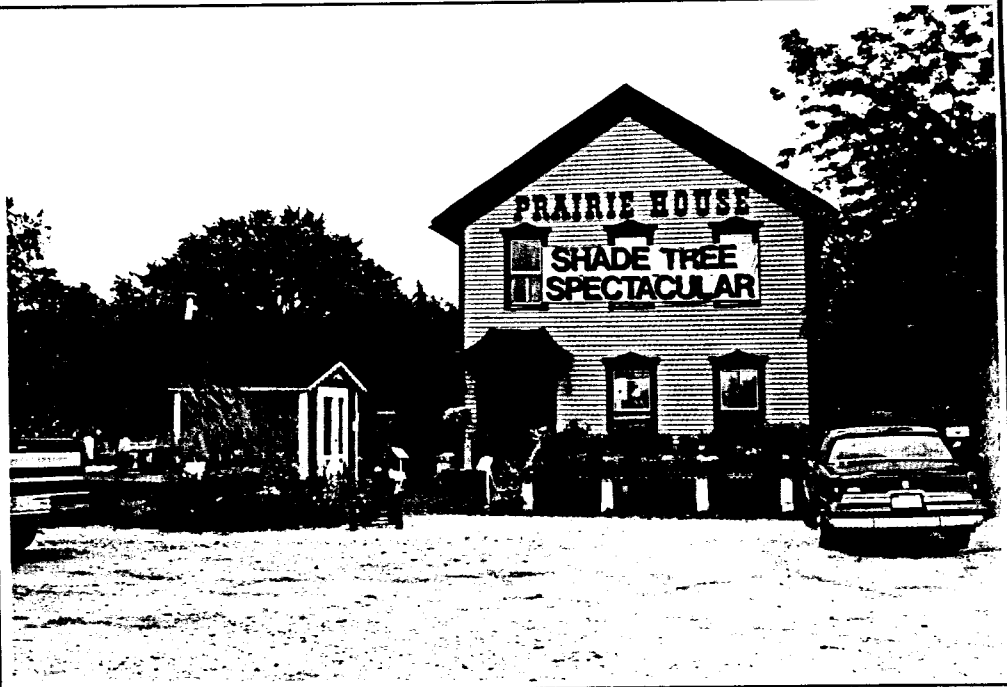
Roll No./Neg. No.: A/12 **Surveyed by:** JM, LS **Date:** 7/20/95

Date/Source: c.1870/Style	Condition: Good	Integrity: Medium
-------------------------------------	---------------------------	-----------------------------

Materials Foundation: Concrete Walls: Aluminum siding Roof: Gable/Asphalt shingles	Architectural Style/Form: Gable Front with Italianate style details Description/Features: Two story Gable Front house has wood panel double door entry, 2/2 wood windows with Italianate style hoods. Entry portico appears to be non-original, perhaps a porch has been removed. Newer addition of brick supports commercial use.
---	--

No. Stories: 2 Major Alterations: recent 1 sty N addition, foundation commercial sign, entry roof	Historic Notes: Plat of 1898 indicates 40.75 acres site subdivided after plat of 1890. House is not indicated on plats through 1902, perhaps house was moved from another site.
---	---

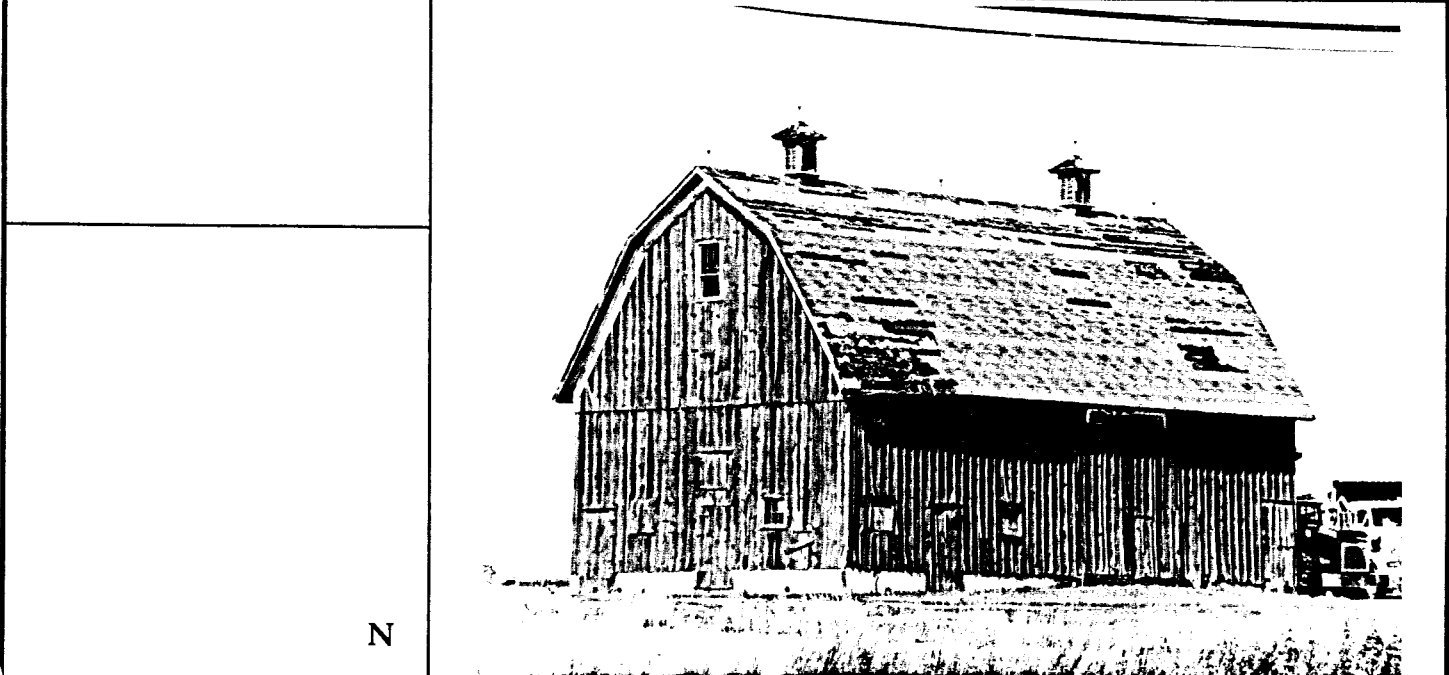
SITE PLAN	Roll No./Neg. No.: B/10	Surveyed by: AM	Date: 7/25/95
------------------	--------------------------------	------------------------	----------------------

Date/Source: c.1880/Noble, Plats	Condition: Fair	Integrity: High
--	---------------------------	---------------------------

Materials Foundation: Concrete Walls: Vertical board & batten Roof: Gambrel/ Asphalt shingle	Architectural Style/Form: Gambrel Bam Description/Features: Bam has gambrel roof with two cupolas, vertical board and batten siding, small six light windows and sliding doors on the side. Two wood cupolas ventilate the roof. The concrete foundation was likely a later improvement.
--	--

No. Stories: 1 + loft Major Alterations: Foundation	Historic Notes: Property is listed as owned by S. Chasfield on 1861 Plat and 1860 Agricultural Census. Site indicated as developed on 1861 Plat.
---	--

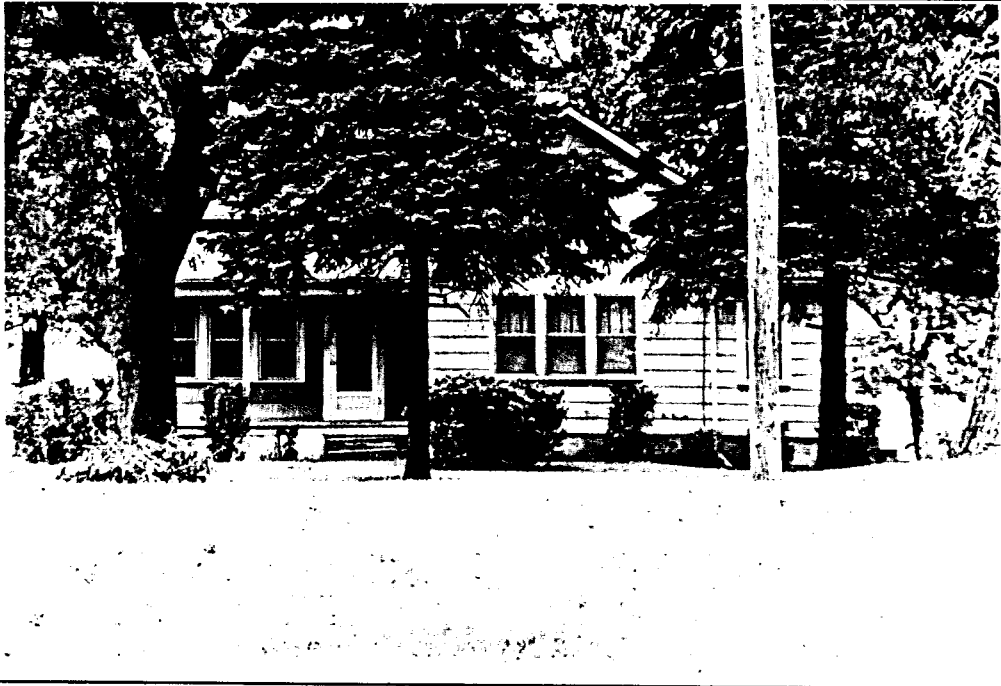
<p align="center">SITE PLAN</p>	Roll No./Neg. No.: 1/9 Surveyed by: JM Date: 7/26/95

Address/Location: 9200 West 143rd Street, Orland Township		Tax Parcel No. 27-03-301-034	Map Key No. 4
Name/Owner Current: Paul Grosskopf Historic: C. Groskopf (sic)/Plat	Structure: House Current Use/Historic Use: House/House Architect/Builder:	Landmark Evaluation Individual: N Farmstead: Y Criteria: 1 National Register: N Local: Y	
Date/Source: c. 1920/Style	Condition: Fair	Integrity: Medium	
Materials Foundation: Concrete Walls: Vinyl siding Roof: Gable with gable/ Asphalt shingle	Architectural Style/Form: L-Cottage Description/Features: L-Cottage is one and one half stories high with gable front and wing to the West. A porch with entrance is at the juncture of the "L". The windows are 3/1 and are in groups of three on the front facade. Porch posts are turned. A one story addition is on the East side.		
No. Stories: 1 + attic Major Alterations: Siding, addition	Historic Notes: While site is indicated as developed as of 1886, and the site has been under Groskopf ownership since 1870, the house appears either to be later based on the 3/1 grouped windows which circa date house to 1920, or has been altered.

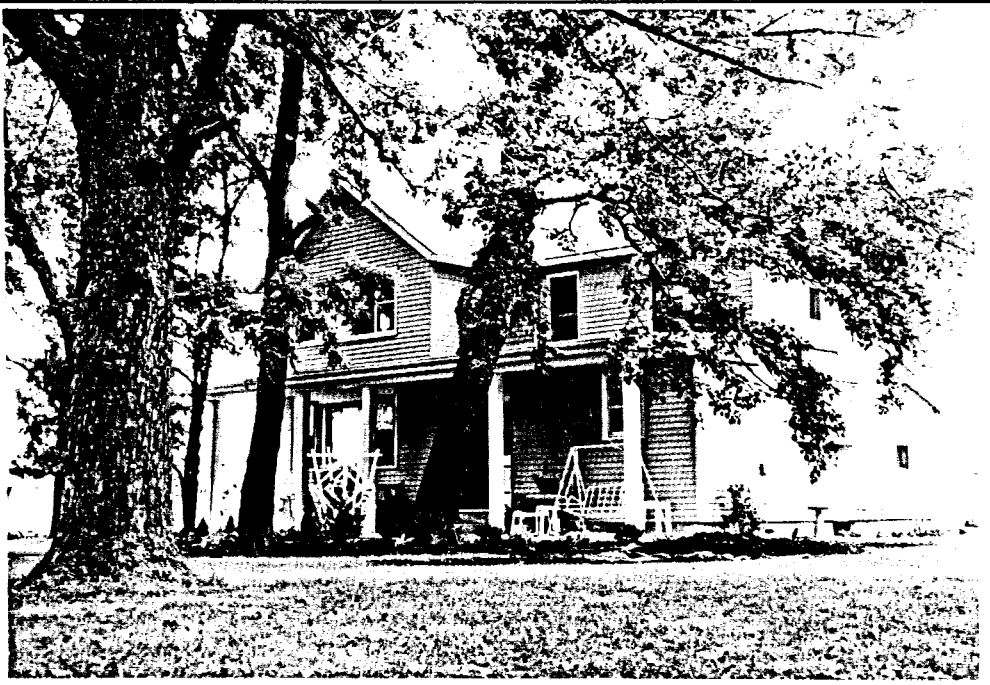
Roll No./Neg. No.: C/24 **Surveyed by:** LS, AM **Date:** 7/26/95

Date/Source: 1851-1861/Plats	Condition: Good	Integrity: Medium
--	---------------------------	-----------------------------

No. Stories: 2 Major Alterations: Original porch enclosed, new porch added, new windows	
Historic Data Sources: Plats, Agricultural Census Data, Owner
