Old Orland Historic District Guidelines

prepared for
The Village of Orland Park
Historic Preservation Review Commission

prepared by
Anne McGuire, Architect
and
Linda F. Grubb and Associates, Architects

December 23, 1991

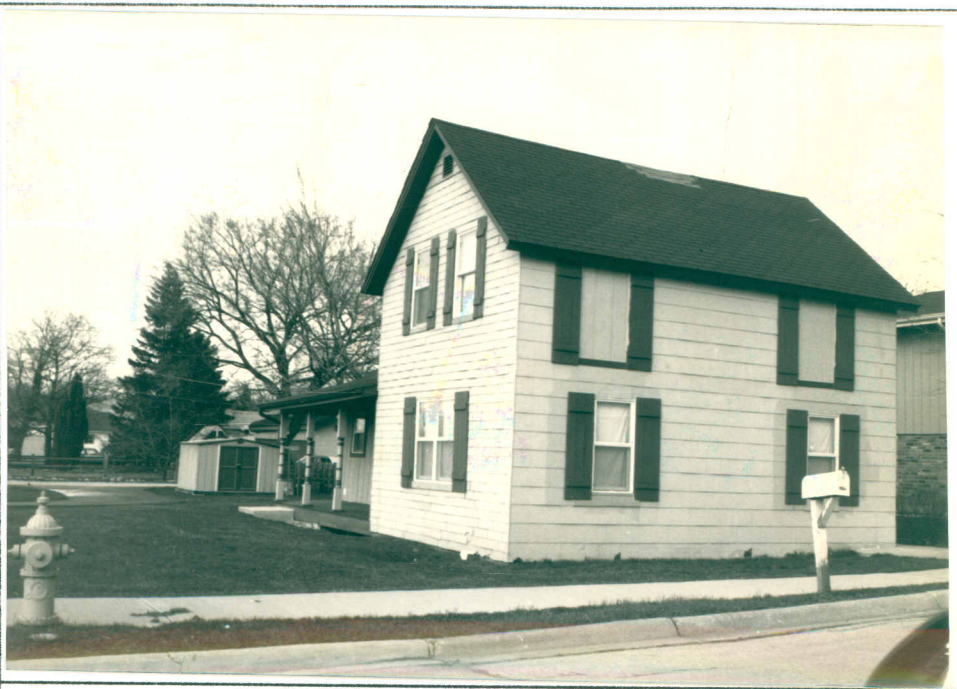
historic function residence

const. date/source c.1890/field obs.

building type
 commercial residential/single
 institutional residential/multi
 religious other: tool shed

overall condition
 altered poor
 unaltered fair
 orig. site good
 moved excellent

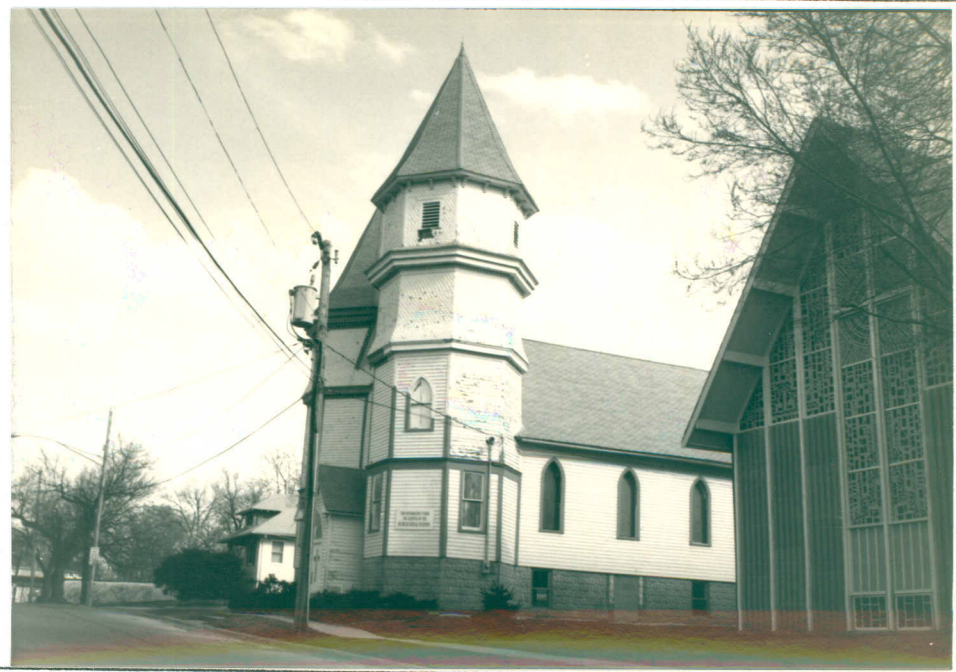
The following should also be considered:
painting of wood
window repair
restore wood roof shingles on towers, if possible
exterior paint analysis for original colors

The raising of the foundation for the basement addition leaves the structure sitting awkwardly above grade. Landscaping with foundation planting could give the church a visual base.

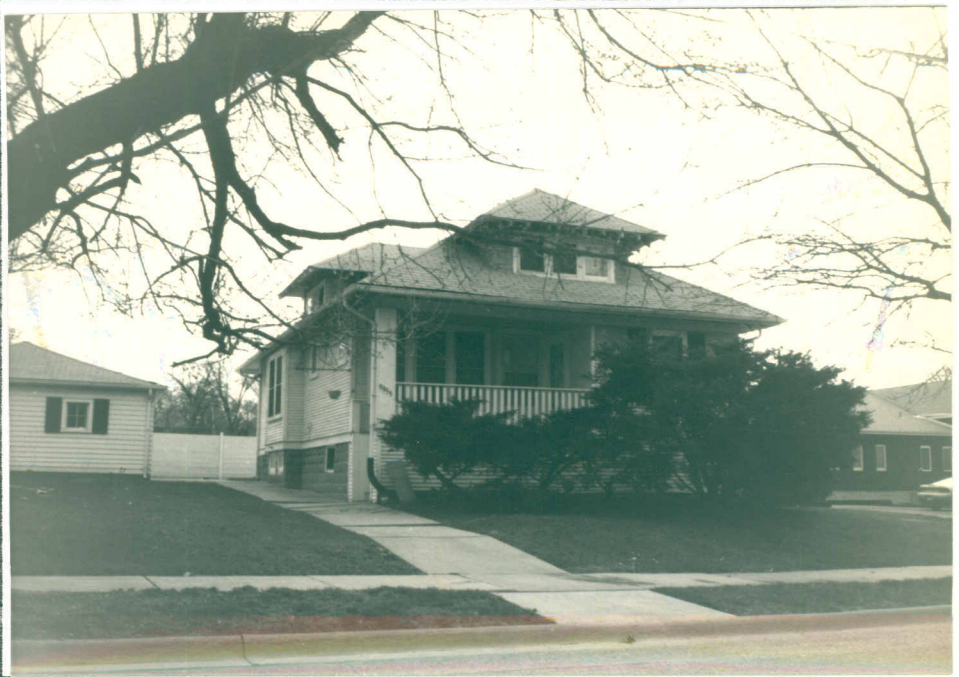
The following should also be considered:
trim back foundation planting
paint
reconstruct Craftsman detail on remaining front porch

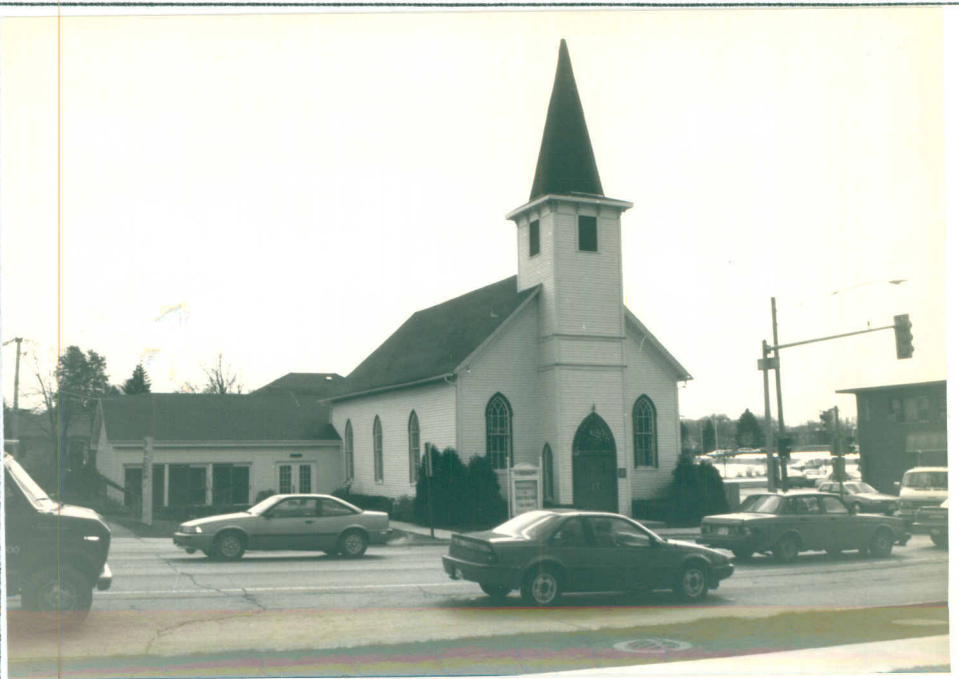
VILLAGE OF ORLAND PARK - HISTORIC BUILDING SURVEY

location SE Cor. 143rd St. & West Ave.
district Old Orland Historic District <input checked="" type="checkbox"/> contributing <input type="checkbox"/> noncontributing
current owner Presbyterian Church of Orland Park
current name Presbyterian Church of Orland Park
current function church
historic name Christ Lutheran Church
historic function church
const. date/source 1898/prev. svy.

building type <input type="checkbox"/> commercial <input type="checkbox"/> residential/single <input type="checkbox"/> institutional <input type="checkbox"/> residential/multi <input checked="" type="checkbox"/> religious <input checked="" type="checkbox"/> other: additions
no. stories 1 plus tower
style/form Gothic Revival
found't'n material
wall material aluminum siding
roof material asphalt shingle
overall condition <input checked="" type="checkbox"/> altered <input type="checkbox"/> poor <input type="checkbox"/> unaltered <input type="checkbox"/> fair <input type="checkbox"/> orig. site <input checked="" type="checkbox"/> good <input type="checkbox"/> moved <input type="checkbox"/> excellent
building character <input type="checkbox"/> unique <input checked="" type="checkbox"/> common

RECOMMENDATIONS

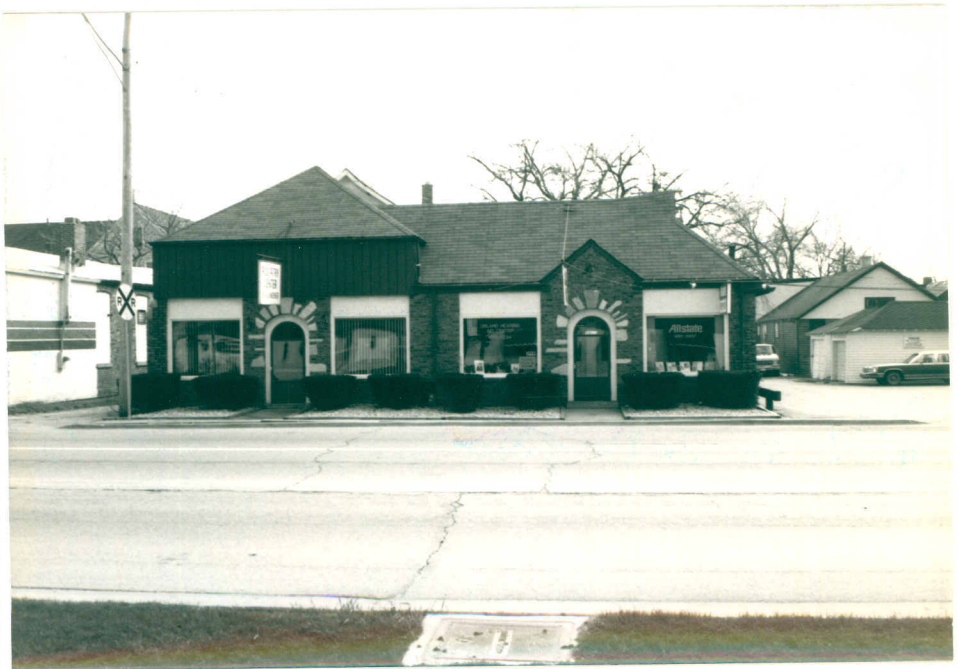
location 9917 143rd St
district Old Orland Historic District <input checked="" type="checkbox"/> contributing <input type="checkbox"/> noncontributing
current owner
current names: Allstate Insurance, Orland Hearing Ctr., Podiatry Ctr.
current function offices
historic name
historic function commercial
const. date/source 1937/prev. svy.
building type <input checked="" type="checkbox"/> commercial <input type="checkbox"/> residential/single <input type="checkbox"/> institutional <input type="checkbox"/> residential/multi <input type="checkbox"/> religious <input checked="" type="checkbox"/> other: addition
no. stories ① 1/2 2 1/2 3 1/2 4
style/form Tudor Revival
found't'n material
wall materials brick, stucco, wood
roof material asphalt shingles
overall condition <input checked="" type="checkbox"/> altered <input type="checkbox"/> poor <input type="checkbox"/> unaltered <input type="checkbox"/> fair <input type="checkbox"/> orig. site <input checked="" type="checkbox"/> good <input type="checkbox"/> moved <input type="checkbox"/> excellent

building character <input type="checkbox"/> unique <input checked="" type="checkbox"/> common
building integrity <input type="checkbox"/> high <input checked="" type="checkbox"/> low

RECOMMENDATIONS

The following items are non-original and are not historically appropriate, restoration to original materials and /or building elements would strengthen the building's integrity:
 facade and roof at wood siding
 doors in arched openings

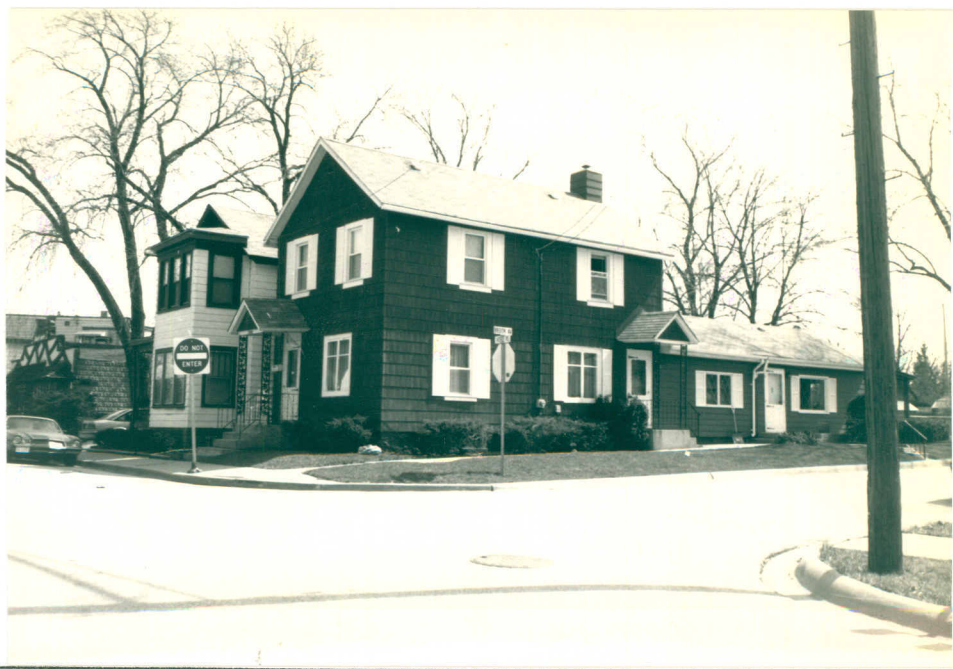
VILLAGE OF ORLAND PARK - HISTORIC BUILDING SURVEY

location 9933 143 rd Pl.
district Old Orland Historic District <input checked="" type="checkbox"/> contributing <input type="checkbox"/> noncontributing
current owner
current name
current function residence
historic name
historic function residence
const. date/source c.1895/field obs.

building type <input type="checkbox"/> commercial <input type="checkbox"/> residential/single <input type="checkbox"/> institutional <input checked="" type="checkbox"/> residential/multi <input type="checkbox"/> religious <input checked="" type="checkbox"/> other: additions
no. stories: ① 1/2 ② 1/2 3 1/2 4
style/form National
found't'n material stone
wall material aluminum siding/compostion bd.
roof material asphalt shingle
overall condition <input checked="" type="checkbox"/> altered <input type="checkbox"/> poor <input type="checkbox"/> unaltered <input type="checkbox"/> fair <input type="checkbox"/> orig. site <input checked="" type="checkbox"/> good <input type="checkbox"/> moved <input type="checkbox"/> excellent
building character <input type="checkbox"/> unique <input checked="" type="checkbox"/> common

RECOMMENDATIONS

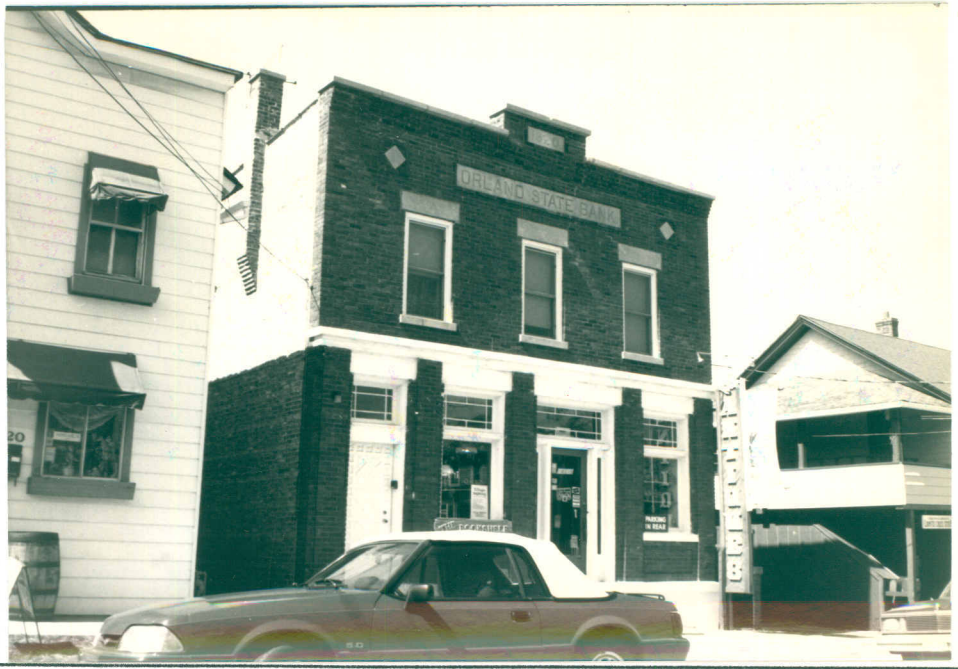
The following should also be considered:
repoint brick at parapet area
repair stone lintels and stone coping where required
install more appropriate signage
paint stone to match natural stone color

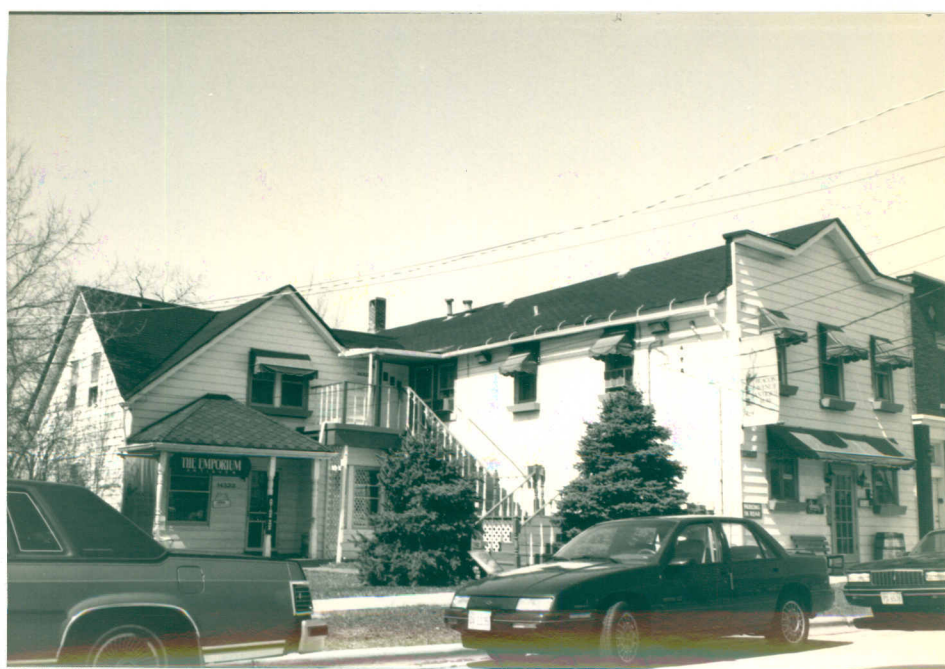
location 14320-24 Beacon Ave.
district Old Orland Historic District <input checked="" type="checkbox"/> contributing <input type="checkbox"/> noncontributing
current owner
current name Emporium/Abigail's
current function antique shops
historic name
historic function commercial/residential
const. date/source c.1880/field obs.
building type <input checked="" type="checkbox"/> commercial <input type="checkbox"/> residential/single <input type="checkbox"/> institutional <input type="checkbox"/> residential/multi <input type="checkbox"/> religious <input checked="" type="checkbox"/> other: ext. stair
no. stories 1 1/2 <input checked="" type="checkbox"/> 1 1/2 3 1/2 4
style/form Commercial Italianate/National
found't'n material
wall material aluminum siding
roof material asphalt shingles
overall condition <input checked="" type="checkbox"/> altered <input type="checkbox"/> poor <input type="checkbox"/> unaltered <input checked="" type="checkbox"/> fair <input type="checkbox"/> orig. site <input type="checkbox"/> good <input type="checkbox"/> moved <input type="checkbox"/> excellent

building character <input type="checkbox"/> unique <input checked="" type="checkbox"/> common
building integrity <input type="checkbox"/> high <input checked="" type="checkbox"/> low

RECOMMENDATIONS

The following items are non-original and are not historically appropriate, restoration to original materials and /or building elements would strengthen the building's integrity:
