## List of Contributing Structures in the Historic District

# Village of Orland Park, Illinois Historic Buildings Survey

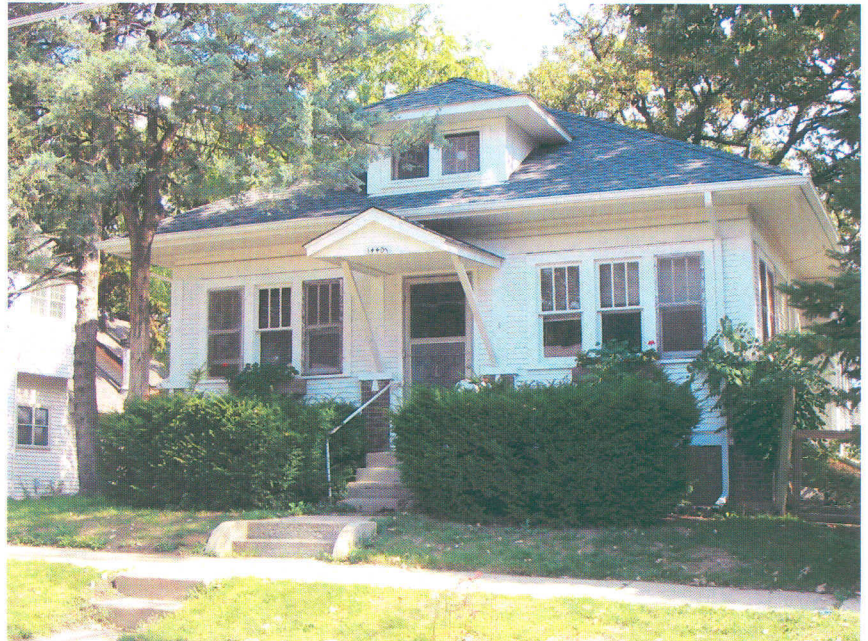
14407 Beacon\_2.jpg

**Foundation** Brick on concrete

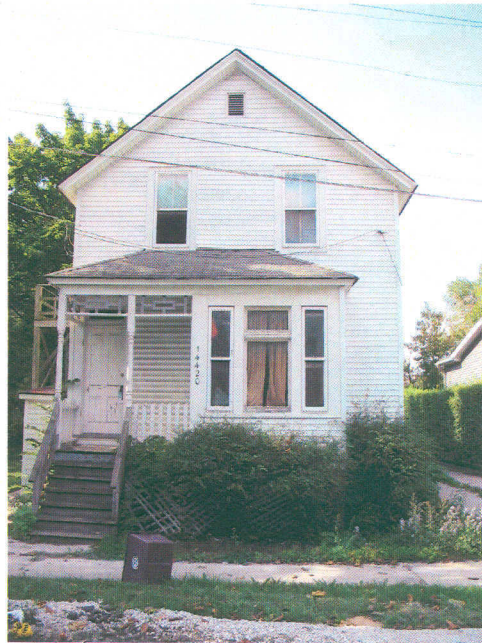
14420 First Ave\_2.jpg

**Condition** Fair

**Foundation** Formed concrete block

**Porch** Wood porch with turned posts, squared spindlework, replaced balusters; porch partially enclosed

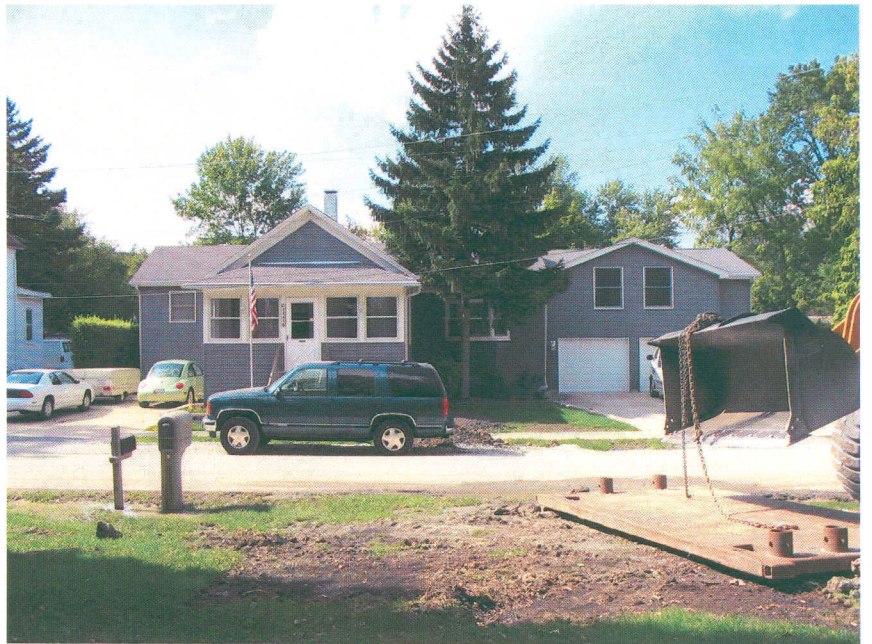
14414 First Ave\_3.jpg

**Alterations** Synthetic siding; replacement windows; multiple additions at each side of the house; interior chimney

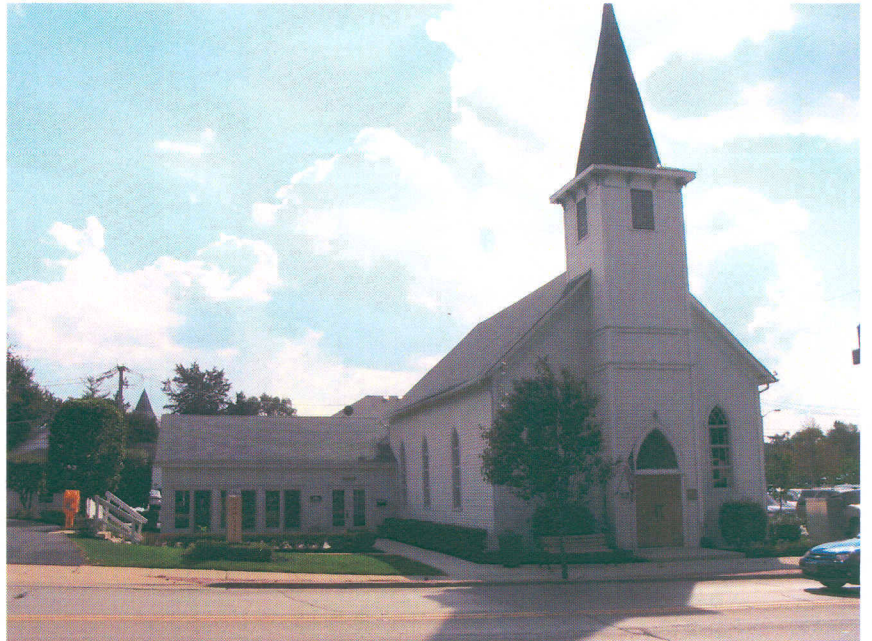
9999 143rd St\_3.jpg

**Window Type & Materials** Original stained glass within the gothic arched window above door; remaining gothic arched windows are replacements with applied muntins

**Alterations** Synthetic siding; windows have been replaced; front door has been altered; there is a large addition at the side toward the rear

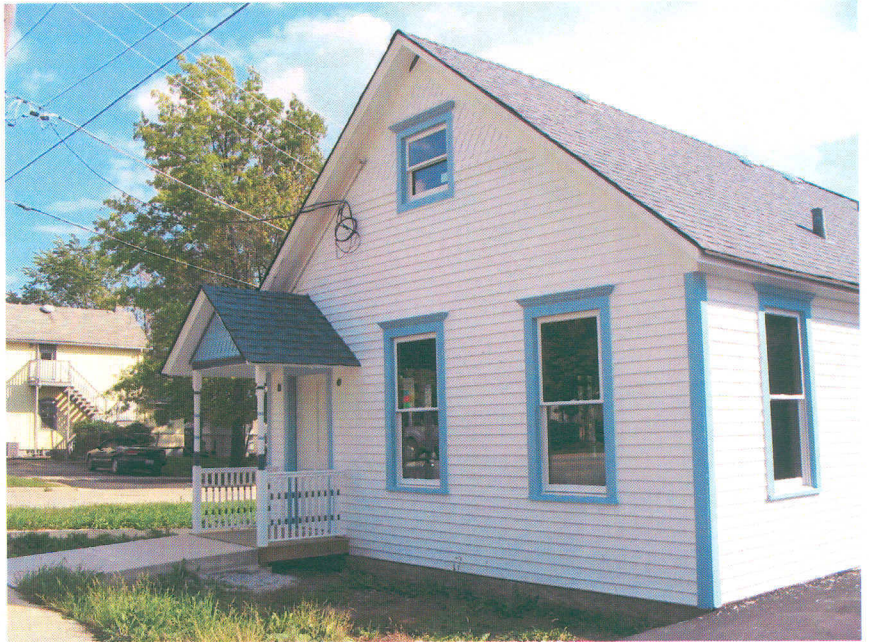
9953 143rd St.jpg

**Alterations** New front door; replacement windows; new concrete ramp from sidewalk to front door

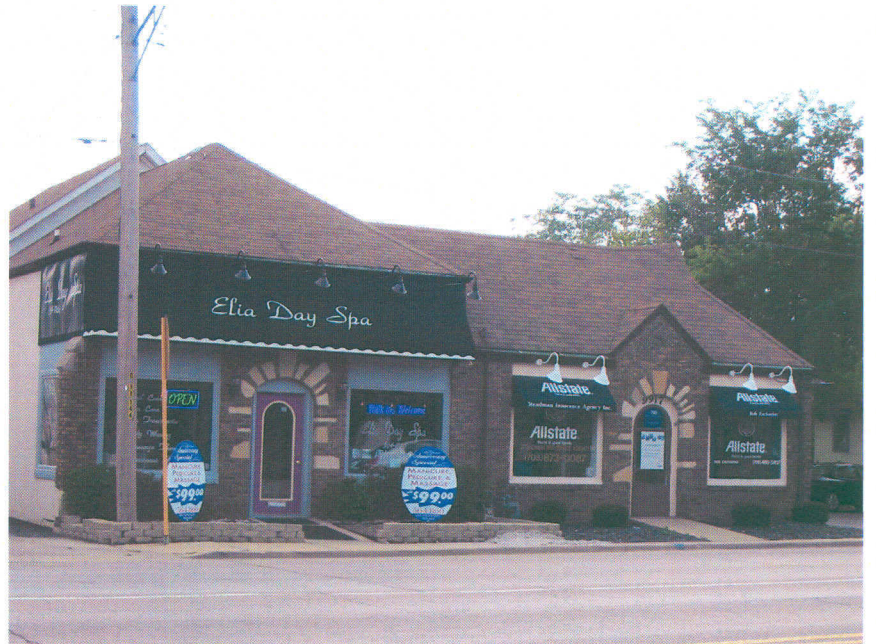
9917 143rd St\_3.jpg

**Alterations** Transoms blocked; new awnings and lighting mounted to the brick facade; doors replaced

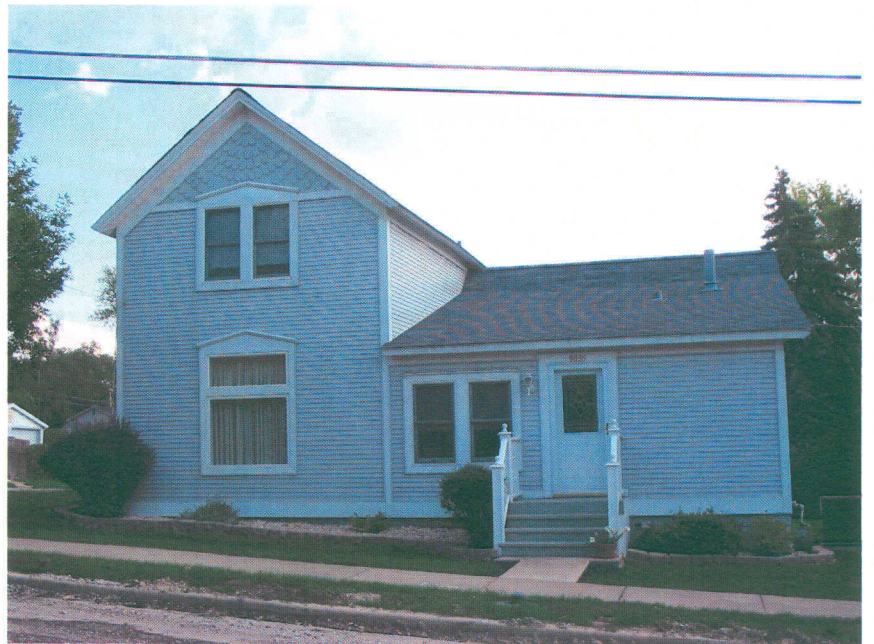
9855 144th St.jpg

**Window Type & Materials** Metal / vinyl replacement 1/1light double-hung; replacement fixed window with transom

**Architectural Details** Pediment detail above windows on front facade; paired windows at second floor; replacement shingles in gable

**Alterations** Synthetic siding; windows have been replaced; synthetic shingle detail; front porch enclosed; front door and entry altered

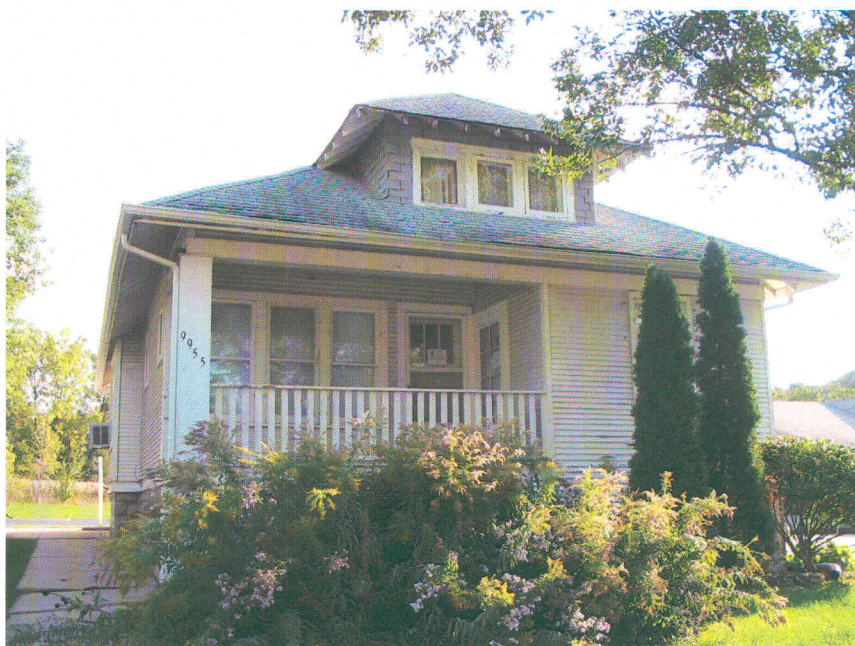
9955 144th St\_parsonage.jpg

**Porch** Open, integral, wood porch with square columns and replacement balustrade

**Alterations** Replacement front porch railing; rafters exposed only on one side; siding on dormer has been altered

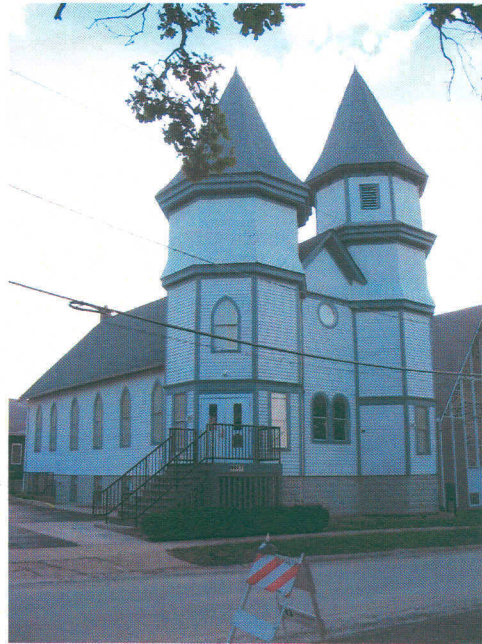
9967 144th St\_2.jpg

**Window Type & Materials** Wood 1/1 light double-hung pointed arch; wood 1/1 light double-hung round arch; opaque glass (opaque glass installed in 1940 which replaced clear glass)

**Alterations** Foundation raised (1918), stone foundation replaced with concrete block raised foundation; center entry constructed in 1942 and removed sometime after 1991; large sanctuary addition to the west (1961); raised east entry added sometime after 1991

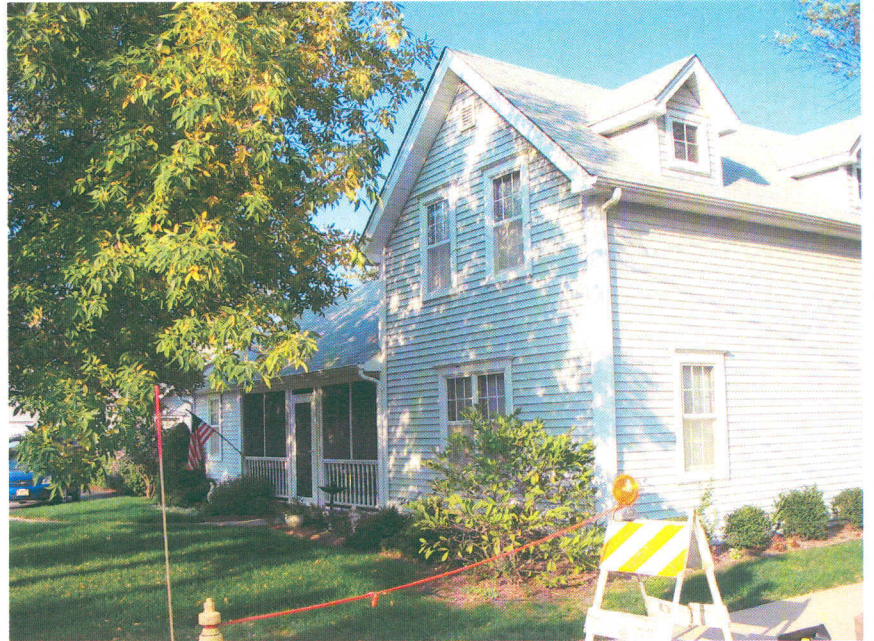
9976 144th St\_3.jpg

**Window Type & Materials** 1/1 replacement windows; 6/6 replacement windows with applied muntins

**Alterations** Synthetic siding; windows have been replaced; gabled roof dormers have been added since 1991; porch enclosed

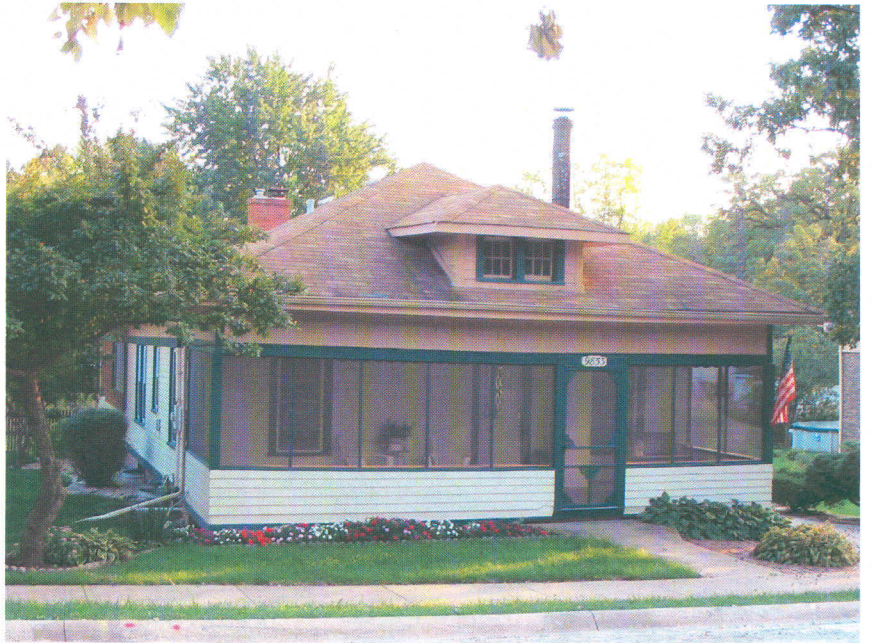
9853 144th Place\_2.jpg

**Alterations** Replacement front door
