ORLAND RURAL HISTORY SURVEY

PREPARED FOR
THE VILLAGE OF ORLAND PARK

BY ANNE MCGUIRE & ASSOCIATES

DECEMBER, 1995

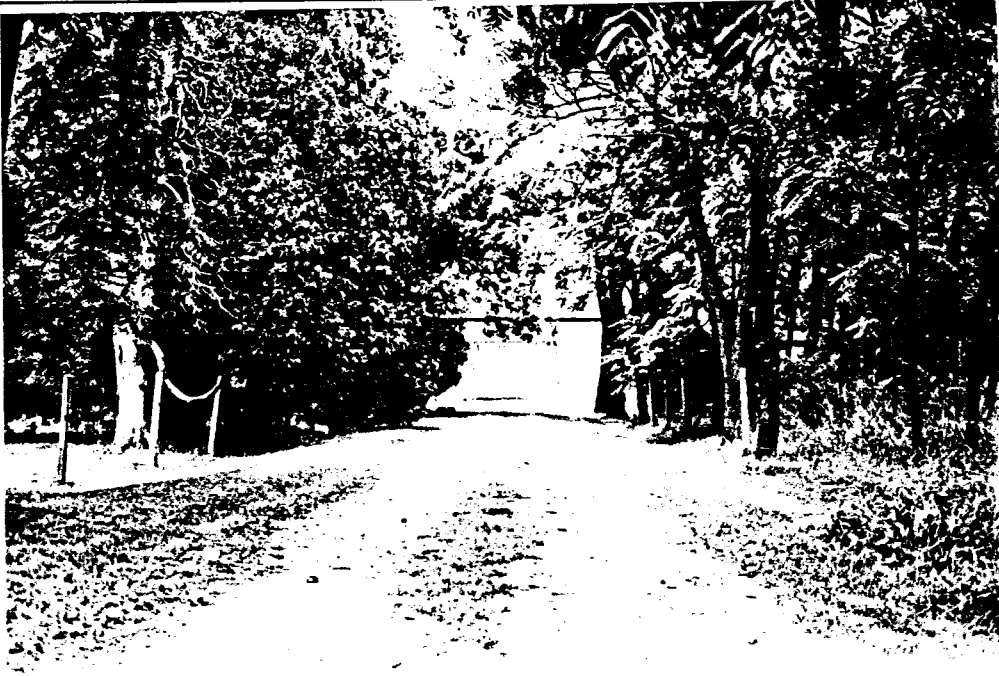
SITE PLAN				
		Roll No./Neg. No.: D/16	Surveyed by: AM/JM	Date: 8/3/95

Address/Location: 8600 W. 143rd Street, Orland Township		Tax Parcel No. 27-02-300-001,002,003	Map Key No. 2	
Name/Owner Current: G. Koehler Historic: G. Kohler (sic)/Plat	Structure: Bam (B1) Current Use/Historic Use: Bam/Bam Architect/Builder:	Landmark Evaluation Individual: N Farmstead: Y Criteria: 1,5 National Register: N Local: Y More info. needed, developed area		
Date/Source: 1880-86/Census,Plats	Condition: N/A	Integrity: N/A		
Materials Foundation: N/A Walls: Vertical board Roof: Gable/ Asphalt shingle	Architectural Style/Form: Gable Barn Description/Features: Gable barn has vertical board siding and sliding doors on the long (S) side. Barn is obscured by trees.			
No. Stories: 1 + loft Major Alterations:	Historic Notes:			
Historic Data Sources: Plats, Agricultural Census data, <u>The Orland Story</u>

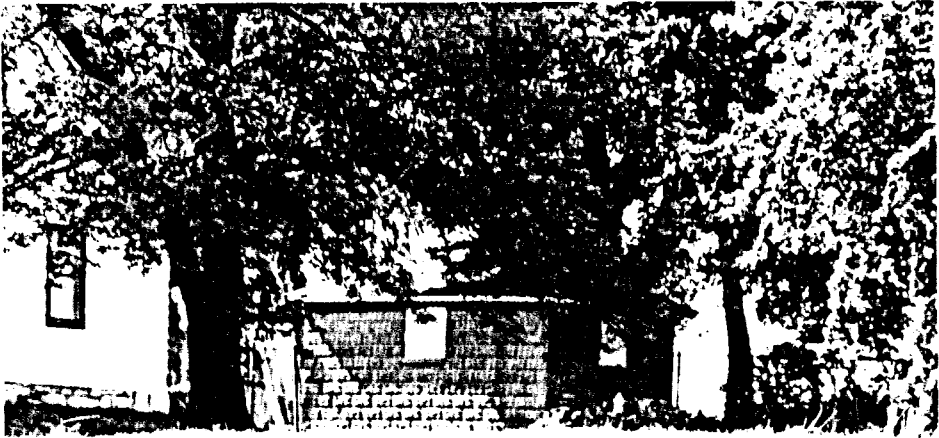
N			
SITE PLAN	Roll No./Neg. No.: B/12 Surveyed by: AM Date: 7/25/95

Address/Location: N. side of 143rd St., E. of LaGrange Rd., Orland Township		Tax Parcel No. 27-03-300-010	Map Key No. 3
Name/Owner Current: C. Grosskopf Amoco Historic: S. Chasfield	Structure: Summer Kitchen Current Use/Historic Use: -/Summer Kitchen Architect/Builder:	Landmark Evaluation Individual: N Farmstead: Y Criteria: 1,5 National Register: N Local: Y Near developing area	
Date/Source: c.1910/Style, materials	Condition: Fair	Integrity: High	
Materials Foundation: Concrete block Walls: Concrete block Roof: Hip/ Asphalt shingle	Architectural Style/Form: Summer Kitchen Description/Features: Hipped roof summer kitchen is built of rusticated concrete blocks. Small windows have been boarded up.		
No. Stories: 1 Major Alterations:	Historic Notes: Property is listed as owned by S. Chasfield on 1861 Plat and 1860 Agricultural Census.		
Historic Data Sources:

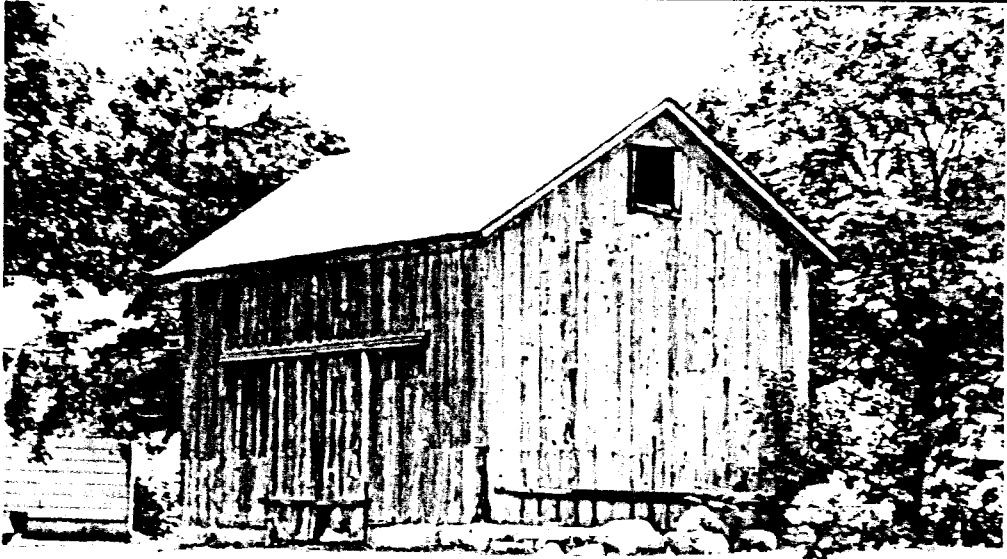
Address/Location: 9200 West 143rd Street, Orland Township		Tax Parcel No. 27-03-301-034	Map Key No. 4
Name/Owner Current: Paul Grosskopf Historic: C. Groskopf (<i>sic</i>)/Plat	Structure: Barn Current Use/Historic Use: Shed/Barn Architect/Builder:	Landmark Evaluation Individual: N Farmstead: Y Criteria: 1,3 National Register: N Local: Y	
Date/Source: c. 1875/Plats	Condition: Fair	Integrity: High	
Materials Foundation: Concrete Walls: Vertical board Roof: Gable/ Asphalt shingle	Architectural Style/Form: Gable Barn, three bay Description/Features: Small gable barn has vertical board siding and sliding doors on the East and West sides. Small windows are located in the gable ends.		
No. Stories: 1 + loft Major Alterations: Roof replaced, foundation	Historic Notes:		
Historic Data Sources: Plats, Agricultural Census data

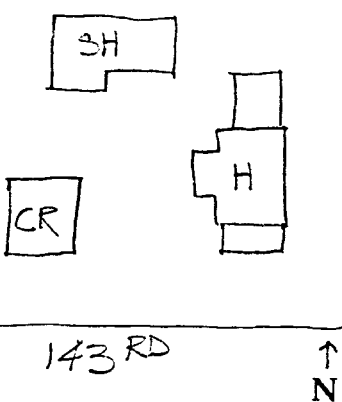
Address/Location: 8800 W. 143rd Street, Orland Township		Tax Parcel No. 27-03-401-055	Map Key No. 5
Name/Owner Current: Alvin Stelter Historic: G. Brandan	Structure: House Current Use/Historic Use: House/House Architect/Builder:	Landmark Evaluation Individual: N Farmstead: Y Criteria: 3,5,6 National Register: N Local: Y Development proposed	
Date/Source: 1870-80/ Plats,Census	Condition: Fair	Integrity: Medium	
Materials Foundation: Stone Walls: Composition siding Roof: Gabled Ell/ Asphalt shingle	Architectural Style/Form: Gabled Ell Description/Features: Two story with attic frame front gable with a one bay wide wing. Wing has bay in first floor. One story hipped roof porch extends across front gable end and has turned posts with decorative brackets. Windows are 1/1 and 2/2 and appear original. An historic, c. 1910, two story wing is located at the rear gable. It is built on concrete block foundation and has a one story enclosed porch element. Historic Notes: Historic photograph of house in <u>The Orland Story</u> shows Italianate style decorative trim at the roof eave and window hoods. These have been removed or covered. Bay dates to historic photograph and may be original. Site listed under G. Brandan in Plat of 1870 and Agricultural Census of 1880; Shown under Henry Kohler in Plat of 1886.

No. Stories: 2 + attic Major Alterations: Siding, porch screens, enclosed side porch			
Historic Data Sources: Plats, Agricultural Census data, <u>The Orland Story</u>

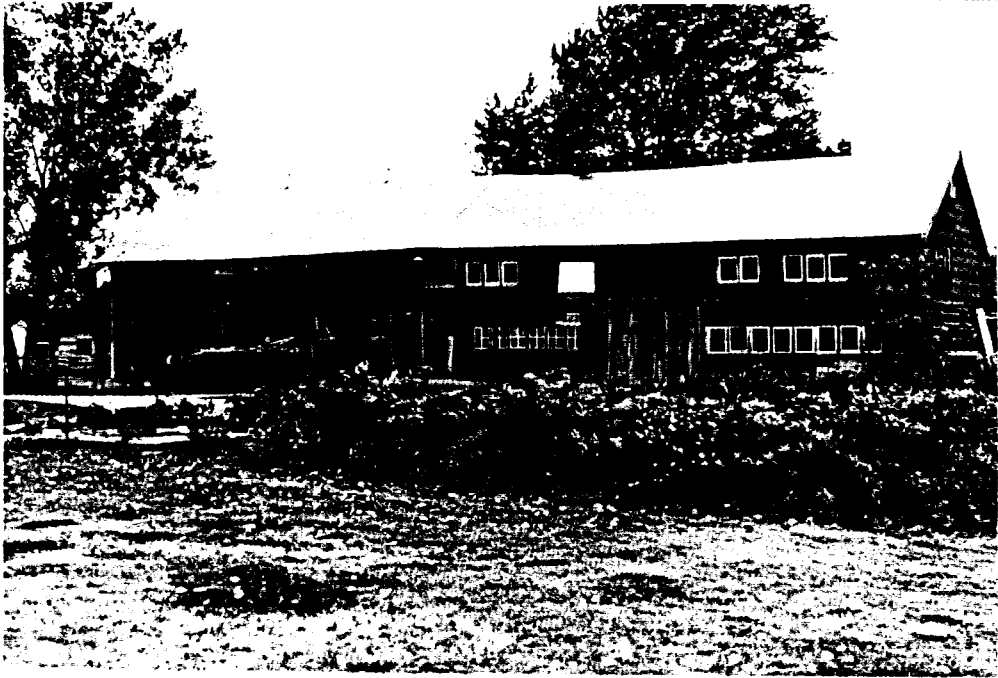
N			
SITE PLAN			
	Roll No./Neg. No.: 1/8	Surveyed by: LS/AM	Date: 7/26/95

Address/Location: NE Corner of Wolf Road and 139th Street, Orland Township		Tax Parcel No. 27-05-102-004	Map Key No. 6
Name/Owner Current: Joseph Brija Historic: J. O. Wilder	Structure: Bam Current Use/Historic Use: Bam/Bam Architect/Builder:	Landmark Evaluation Individual: Y Farmstead: N Criteria: 1,3 National Register: N Local: Y Farmstead setting, impt. bam, altered bldgs.	
Date/Source: 1883/Lintel, c.1890 addition	Condition: Fair	Integrity: High	
Materials Foundation: Concrete Walls: Asphalt siding Roof: Gable/ Asphalt shingles	Architectural Style/Form: Gable Bam, three bay with addition Description/Features: Gable bam and gable bam addition have continuous roof line. West portion is the earlier section with hand hewn heavy timber construction. It is a three bay type bam with entrances on the side. On the West end of the bam is a one story historic shed addition. The bam addition to the East has gable aligned with original (W) bam roof. The addition was altered historically into a 2 story coop with many small windows. Old well and shed foundation are on the North side. Historic Notes: Over the main entrance of the older bam is a board bearing the date "1883." The bam structure of heavy timber hand hewn construction appears earlier. Under the asphalt siding is vertical board siding. The owner indicates some of the timber for the bam was reused from another site;1883 date on the bam likely refers to bam construction on this site. Owner also indicates the addition was used as a cow bam before it was made a coop.

No. Stories: 1 + loft Major Alterations: Has gable bam addition which was made into a coop			
Historic Data Sources: Plats, Agricultural Cencus data, Owner

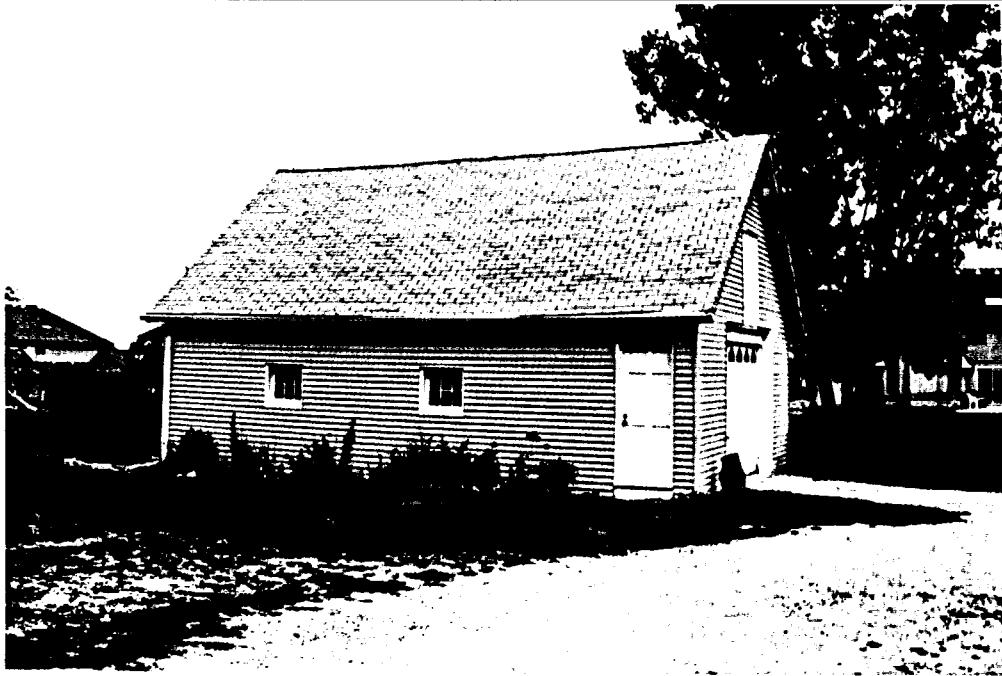
N	SITE PLAN		
Roll No./Neg. No.: D/3		Surveyed by: LS, AM	Date: 7/26/95

Address/Location: NE Corner of Wolf Road and 139th Street, Orland Township		Tax Parcel No. 27-05-102-004	Map Key No. 6
Name/Owner Current: Joseph Brija Historic: J. O. Wilder	Structure: Crib Current Use/Historic Use: Garage/Crib Architect/Builder:	Landmark Evaluation Individual: N Farmstead: N Criteria: National Register: N Local: N Farmstead setting, impt. barn, altered bldgs.	
Date/Source: c. 1880/ Plats, style	Condition: Good	Integrity: Low	
Materials Foundation: Concrete Walls: Aluminum siding Roof: Gable/ Asphalt shingles	Architectural Style/Form: Crib Description/Features: Former crib has gable roof and aluminum siding. On the interior is visible the original pole construction and horizontal spaced board siding.		
No. Stories: 1 Major Alterations: Garage doors, siding	Historic Notes:		
Historic Data Sources: Plats, Agricultural Census data, Owner

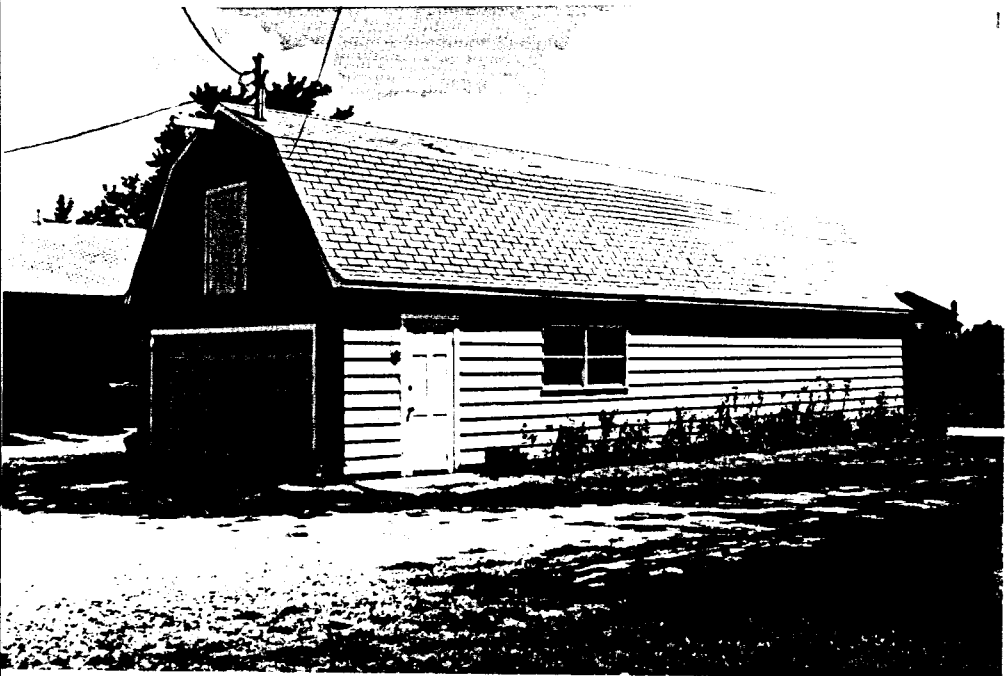
SITE PLAN	N		
Roll No./Neg. No.: D/5		Surveyed by: LS, AM	Date: 7/26/95

Address/Location: NE Corner of Wolf Road and 139th Street, Orland Township		Tax Parcel No. 27-05-102-004	Map Key No. 6
Name/Owner Current: Joseph Brija Historic: J. O. Wilder	Structure: Coop Current Use/Historic Use: Garage/Coop Architect/Builder:	Landmark Evaluation Individual: N Farmstead: N Criteria: National Register: N Local: N Farmstead setting, impt. barn, altered bldgs.	
Date/Source: c. 1920, altered 1970	Condition: Good	Integrity: Low	
Materials Foundation: Concrete Walls: Aluminum siding Roof: Gambrel/ Asphalt shingles	Architectural Style/Form: Coop Description/Features: Large coop with gambrel roof.		
No. Stories: 1 + loft Major Alterations: expanded from an older coop	Historic Notes: Owner indicates that coop structure was used for the processing of poultry.		
Historic Data Sources: Owner

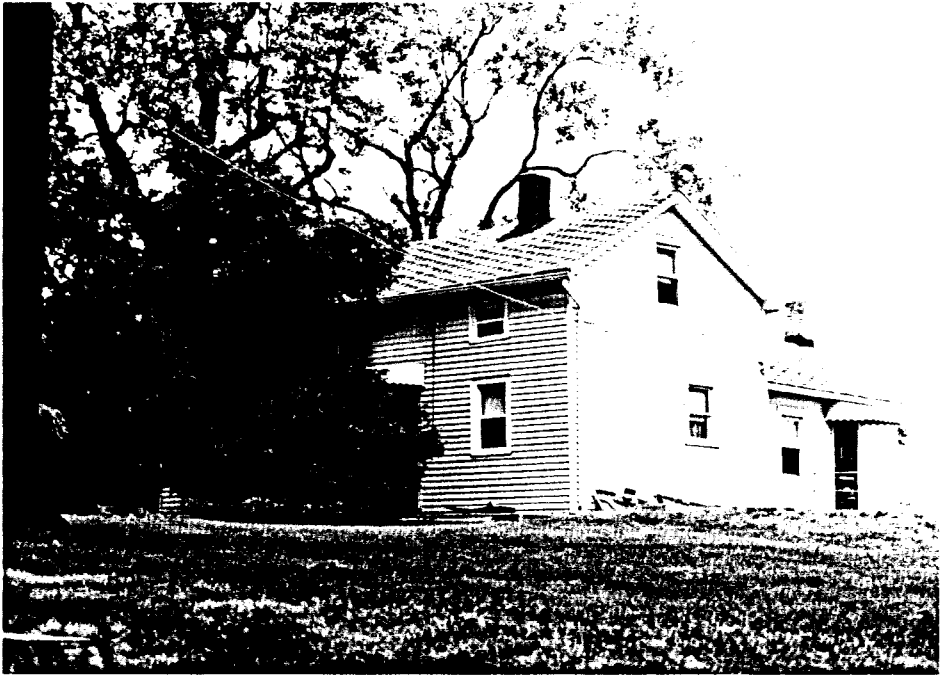
<p align="center">139 FT ↑ N</p> <p align="center">SITE PLAN</p>	<p>Roll No./Neg. No.: C/21 Surveyed by: AM/LS Date: 7/26/95</p>

Address/Location: 13850 S. 110th Street, Orland Township		Tax Parcel No. 27-05-103-004	Map Key No. 7
Name/Owner Current: Dorothea Schumak Historic: John G. Bartlett	Structure: House Current Use/Historic Use: House/House Architect/Builder:	Landmark Evaluation Individual: N Farmstead: Y Criteria: 1 National Register: N Local: Y	
Date/Source: 1851-1860/Plats,Census	Condition: Good	Integrity: Medium	
Materials Foundation: N/A Walls: Aluminum siding Roof: Gable with gable/ Asphalt shingle	Architectural Style/Form: New England 1-1/2 with 1 story wing Description/Features: Frame side gable house is one and one-half stories with one story rear wing. The house is clad in aluminum siding which may obscure additional details. The windows appear to have been replaced. The rear wing appears to be a Summer Kitchen. House along with coop and shed are only remaining buildings.		
No. Stories: 1 + attic Major Alterations: siding, windows	Historic Notes: This site is indicated as developed as early as 1861 Plat and is included under the same name, John G. Bartlett, in the Agricultural Census of 1860 as having 55 improved acres.

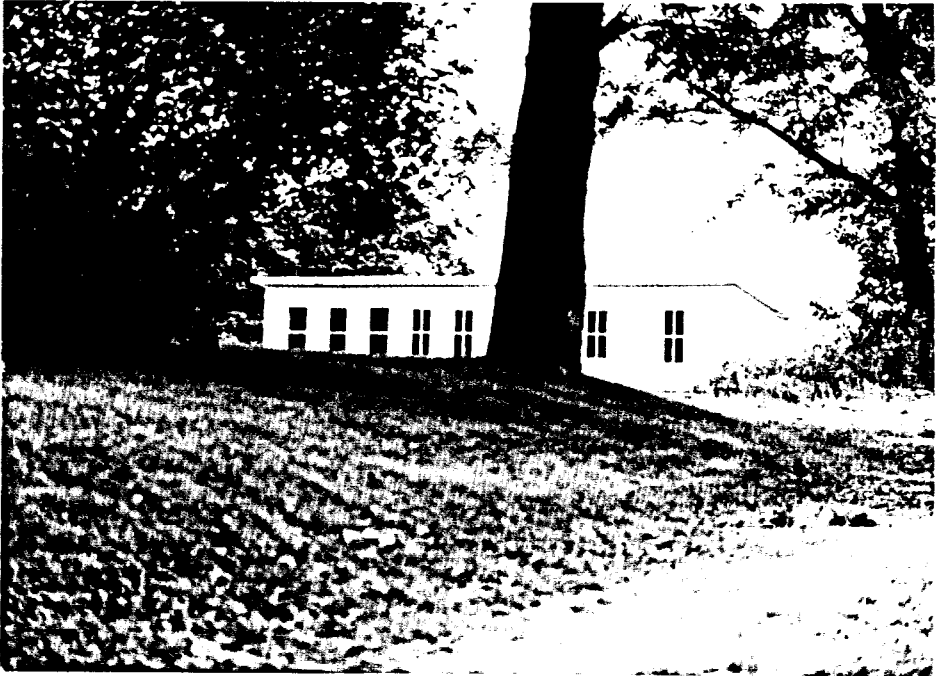
N			
SITE PLAN	Roll No./Neg. No.: C/22 Surveyed by: AM/LS Date: 7/26/95

Address/Location: 13850 S. 110th Street, Orland Township		Tax Parcel No. 27-05-103-004	Map Key No. 7
Name/Owner Current: Dorothea Schumak Historic: John G. Bartlett	Structure: Coop Current Use/Historic Use: -/Coop Architect/Builder:	Landmark Evaluation Individual: N Farmstead: Y Criteria: 1 National Register: N Local: Y	
Date/Source: c. 1870/Plats, Census	Condition: Good	Integrity: High	
Materials Foundation: N/A Walls: Clapboard siding Roof: Shed/ Asphalt shingle	Architectural Style/Form: Coop Description/Features: Long shed coop with windows facing South. Most of the windows are 2/2, however, some windows are 1/1. Perhaps the area of the 1/1 windows to the West is an historic addition.		
No. Stories: 1 Major Alterations: some windows	Historic Notes: This site is indicated as developed as early as 1861 Plat and is included under the same name, John G. Bartlett, in the Agricultural Census of 1860 as having 55 improved acres. Condition of coop indicates may date to later farm period.

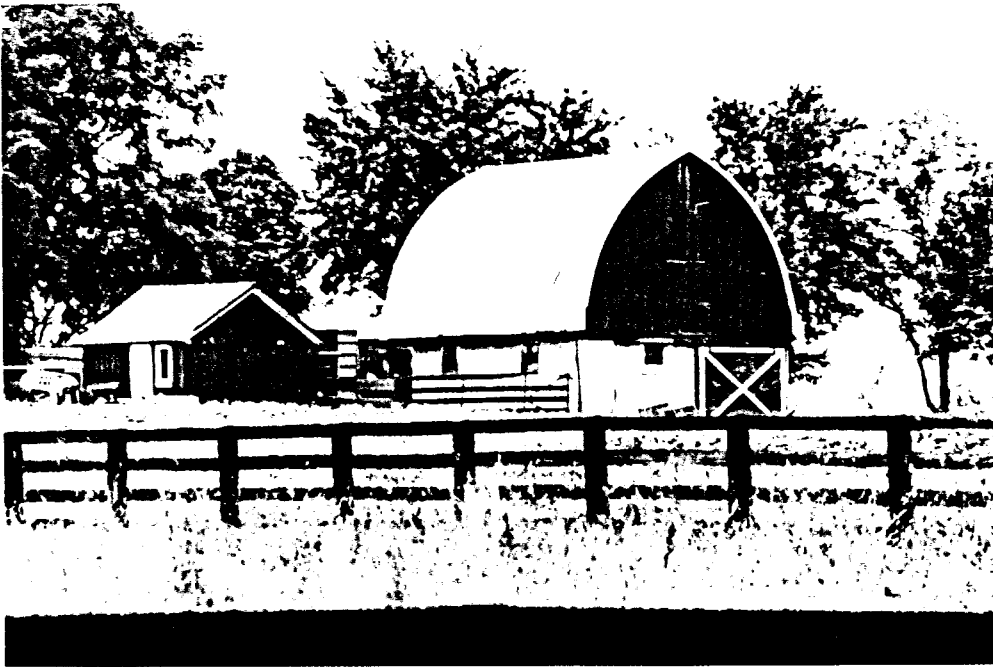
N			
SITE PLAN	Roll No./Neg. No.: D/23 Surveyed by: AM/JM Date: 8/3/95

Address/Location: 13901 S. Wolf Road, Orland Township		Tax Parcel No. 27-05-300-004	Map Key No. 8
Name/Owner Current: Leo V. Delair Historic: J. K. Sisson	Structure: Barn Current Use/Historic Use: Barn/Barn Architect/Builder:	Landmark Evaluation Individual: N Farmstead: N Criteria: National Register: N Local: N	
Date/Source: c.1910/Noble	Condition: Good	Integrity: Medium	
Materials Foundation: Concrete block Walls: Vertical board Roof: Gothic/Corrugated metal	Architectural Style/Form: Gothic Barn Description/Features: Gothic Barn with concrete block foundation and walls extend up to roof line and has vertical board siding at roof ends. Small windows punctuate concrete block walls. A sliding door is at end wall.		
No. Stories: 1 + loft Major Alterations:	Historic Notes: Farm listed on Plats as of 1870, and noted as "Blacksmith" as of 1886 Plat. Barn appears to be later than 1870.		
Historic Data Sources: Plats, Agricultural Census data Noble: <u>Barns of the Midwest</u>

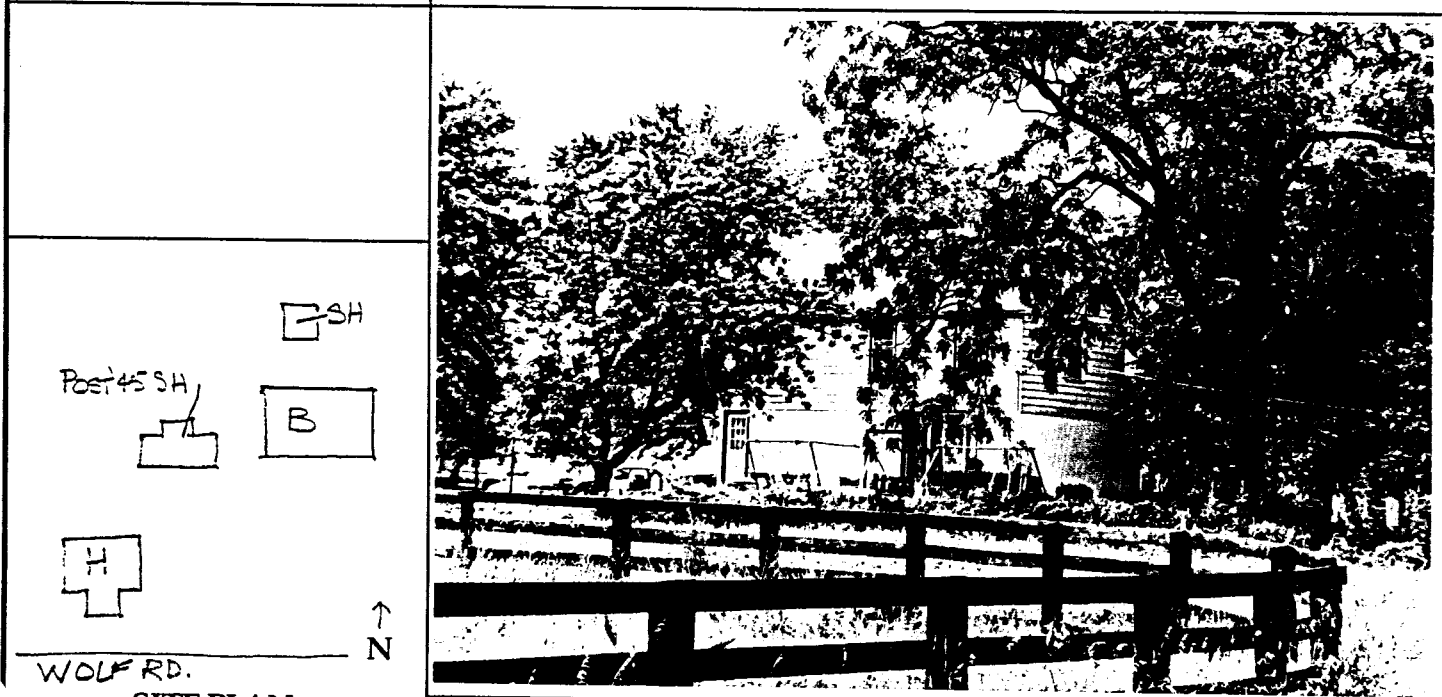
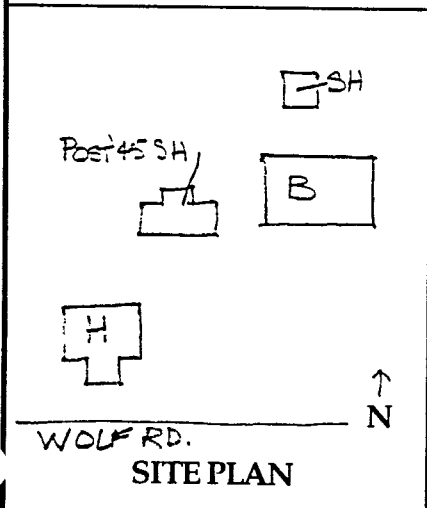
Roll No./Neg. No.: D/24 **Surveyed by:** AM/JM **Date:** 8/3/95

Date/Source: c.1870/Plats, Census	Condition: Fair	Integrity: Low
---	---------------------------	--------------------------

Materials Foundation: N/A Walls: Aluminum siding Roof: Gable with gable/ Asphalt shingle	Architectural Style/Form: Upright-and-Wing Description/Features: Two story frame gable house with one story gable wing has extensive alterations. Lower exterior wall material appears to be stucco or parging. Windows and doors are modern.
No. Stories: 2 Major Alterations: Alterations obscure historic house	Historic Notes: Farm listed on Plats as of 1870, and noted as "Blacksmith" as of 1886 Plat. While house form indicates structure may date from early period of the farmstead, it has been altered.
Historic Data Sources: Plats, Agricultural Census data

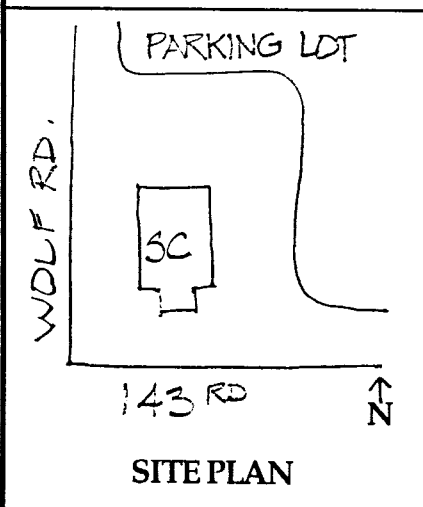
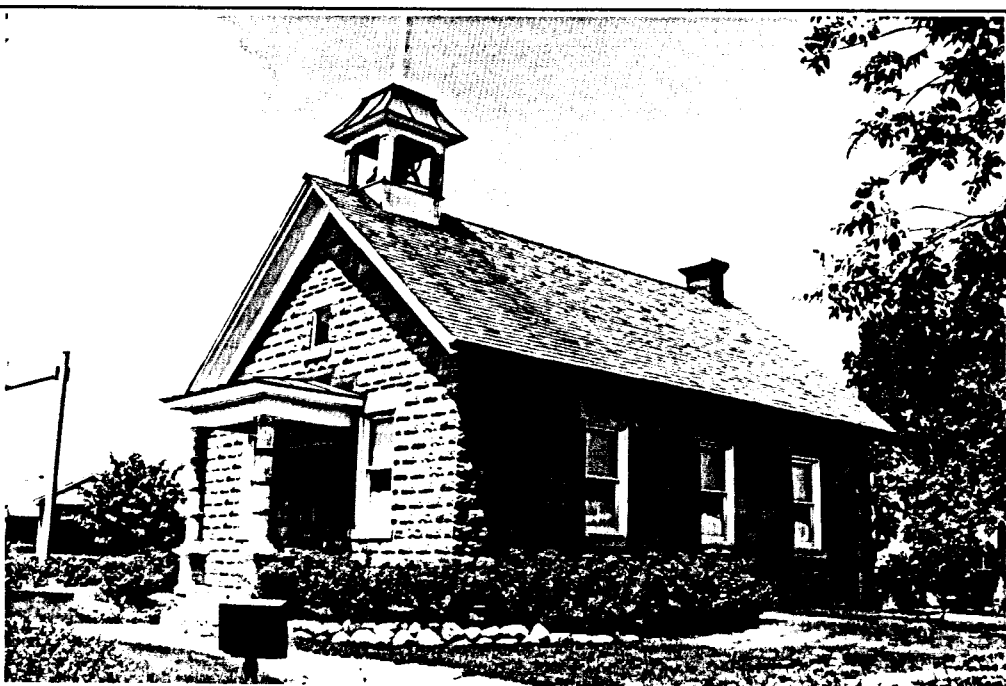
SITE PLAN	Roll No./Neg. No.: A/1 Surveyed by: JM,AM Date: 7/18/95

Address/Location: 14299 S. Wolf Road, Orland Township		Tax Parcel No. 27-05-302-004	Map Key No. 9
Name/Owner Current: Richard Conner Riley Historic: Yunker School/School District 134	Structure: School Current Use/Historic Use: Office/School Architect/Builder: George Hacker	Landmark Evaluation Individual: Y Farmstead: N Criteria: A, 1, 3 National Register: Y Local: Y Oldest of 4 extant 1 room schools	
Date/Source: 1910/School Records	Condition: Excellent	Integrity: Good	
Materials Foundation: Concrete Walls: Concrete Block Roof: Wood Shingle, Gable	Architectural Style/Form: One Room School Description/Features: Gable front one room school with rusticated concrete block walls, concrete window sills and lintels, gabled wood shingle roof, cupola with bell to south/front end, entrance portico with banded stone columns and copper roof (Records indicate original may have been "tin") Front and side wood doors with raised panels. Door lintel bears School District 134; attic window lintel bears "1910". Historic Notes: Built on land bought from William Junker (<i>sic</i>), second school building for School District 134. The previous school, the Jackson School, was located on what is now 139th Street at 108th Avenue. School records include "New School House Expenditures" for 1910 including plans and specifications from George Hacker, land from William Junker, bell from Montgomery Ward, concrete block from R. Heitman.

No. Stories: 1+Attic Major Alterations: Building completely restored. Windows altered			
Historic Data Sources: School District 134 Record Book Plats

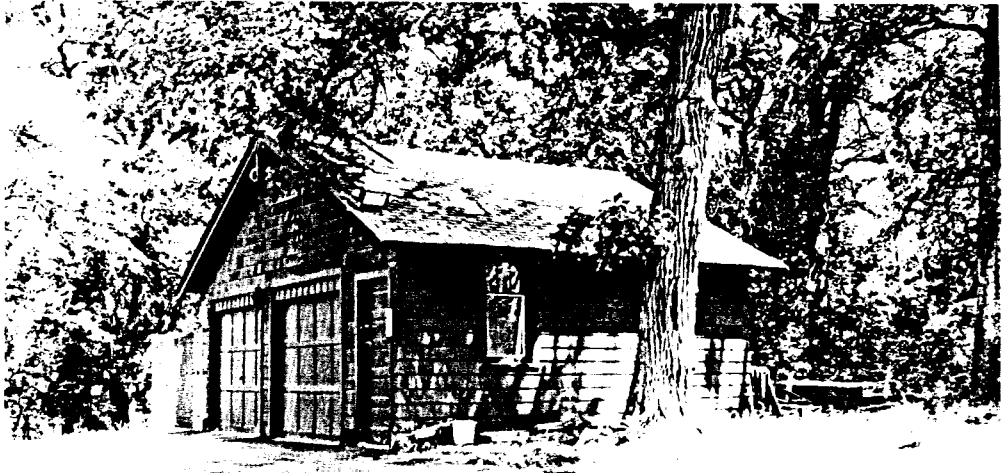
N			
SITE PLAN			
Roll No./Neg. No.: D/7		Surveyed by: JM	Date: 7/27/95

Address/Location: 14249 Wolf Road, Orland Township		Tax Parcel No. 27-05-302-012	Map Key No. 10
Name/Owner Current: De Vono's/Standard B & Tr Co. Historic: W. C. Jancher (1926)	Structure: Garage Current Use/Historic Use: Garage/Garage Architect/Builder:	Landmark Evaluation Individual: N Farmstead: N Criteria: National Register: N Local: N	
Date/Source: c.1920; c.1920-26/Plats	Condition: Good	Integrity: Medium	
Materials Foundation: Walls: Shingle Roof: Gable/ Asphalt shingle	Architectural Style/Form: Garage Description/Features: Gable front two car garage with 2 one-car overhead doors and man door, all paneled construction, at gable front facade. Window to the side (S) is 3/2 with half round attic window on the front (S).		
No. Stories: 1 + attic Major Alterations: Siding, half round attic window	Historic Notes:		
Historic Data Sources:

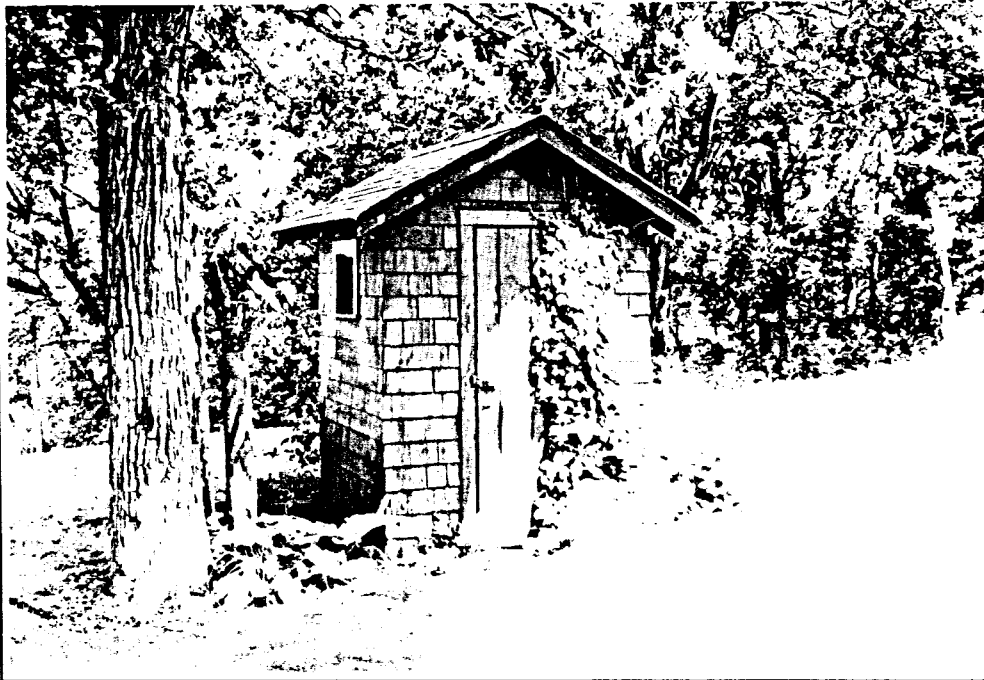
N			
SITE PLAN	Roll No./Neg. No.: D/8 Surveyed by: JM Date: 7/27/95

Address/Location: 14249 Wolf Road, Orland Township		Tax Parcel No. 27-05-302-012	Map Key No. 10
Name/Owner Current: De Vono's/Standard B & Tr Co. Historic: W. C. Jancher	Structure: Privy Current Use/Historic Use: Unused/Privy Architect/Builder:	Landmark Evaluation Individual: N Farmstead: N Criteria: National Register: N Local: N	
Date/Source: c.1920; c.1920-26/Plats	Condition: Good	Integrity: Medium	
Materials Foundation: N/A Walls: Shingle Roof: Gable/ Asphalt shingle	Architectural Style/Form: Privy Description/Features: Privy with gable roof, vertical board door, and shingle siding. One person privy has one small window at the side (W).		
No. Stories: 1 Major Alterations: Newer siding	Historic Notes:		
Historic Data Sources: Plats

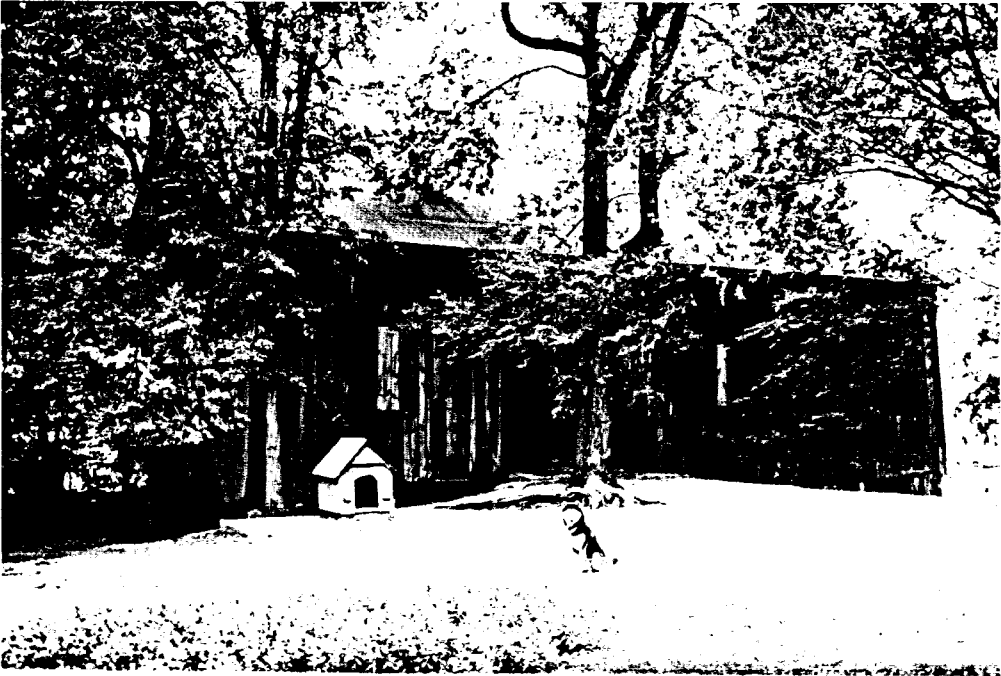
N	SITE PLAN		
Roll No./Neg. No.: C/14		Surveyed by: AM/LS/JM Date: 7/26/95

Address/Location: 11708 W. 139th Street, Orland Township		Tax Parcel No. 27-06-101-005	Map Key No. 11
Name/Owner Current: Frank J. McCabe Historic: R. Bremner	Structure: Barn Current Use/Historic Use: Barn/Barn Architect/Builder:	Landmark Evaluation Individual: N Farmstead: N Criteria: National Register: N Local: N	
Date/Source: c.1898/Plat	Condition: Good	Integrity: High	
Materials Foundation: Concrete Walls: Vertical board Roof: Gable/ Asphalt shingle	Architectural Style/Form: Gable Barn, banked Description/Features: Gable barn has two levels and a loft. The lower level is of concrete with window openings between concrete supports. Sliding doors are located on the barn sides.		
No. Stories: 2 + loft Major Alterations:	Historic Notes: Barn may predate house and 1898 Plat.		
Historic Data Sources: Plats, Agricultural Census data

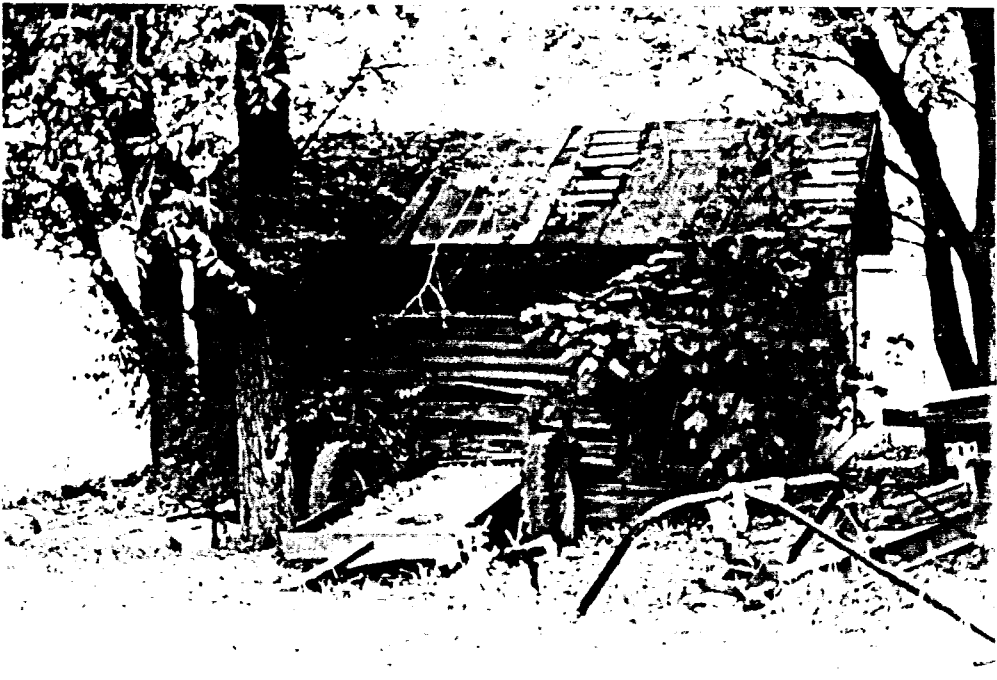
SITE PLAN	N	Roll No./Neg. No.: I/16 Surveyed by: AM/LS/JM Date: 7/26/95

Address/Location: 11708 W. 139th Street, Orland Township		Tax Parcel No. 27-06-101-005	Map Key No. 11
Name/Owner Current: Frank J. McCabe Historic: R. Bremner	Structure: Pump House Current Use/Historic Use: -/Pump House Architect/Builder:	Landmark Evaluation Individual: N Farmstead: N Criteria: National Register: N Local: N	
Date/Source: c.1898/Plat	Condition: Poor	Integrity: Medium	
Materials Foundation: Concrete Walls: Clapboard Roof: Gable/ Asphalt shingle	Architectural Style/Form: Pump House Description/Features: Gabled one story pump house has window openings and door on side (N).		
No. Stories: 1 Major Alterations:	Historic Notes:		
Historic Data Sources: Plats, Agricultural Census data

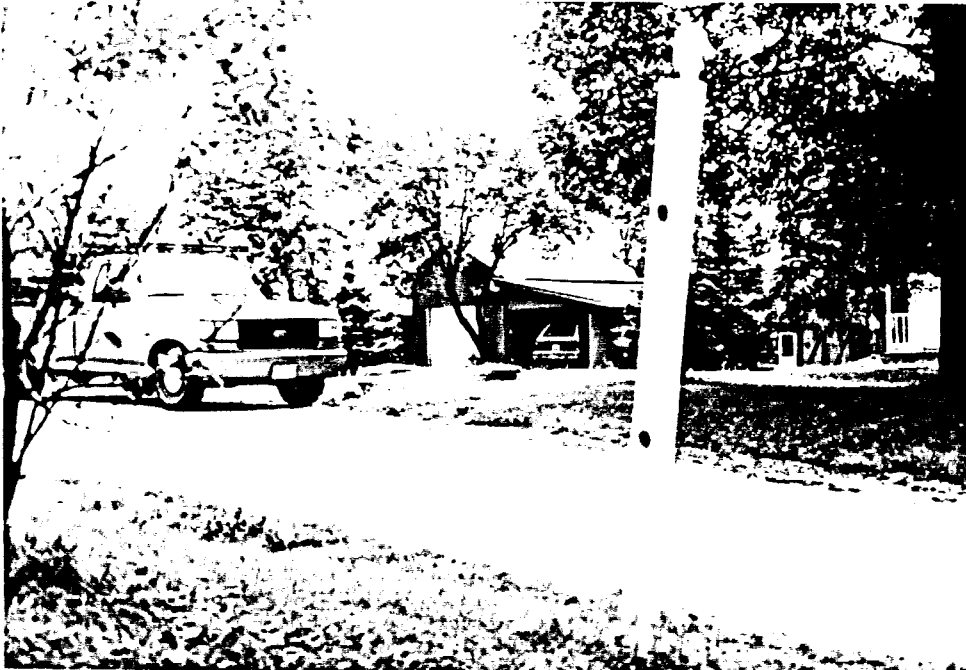
N SITE PLAN	Roll No./Neg. No.: C/17 Surveyed by: AM/LS Date: 7/26/95

Date/Source: 1861-86/Plats	Condition: Good	Integrity: Medium
--------------------------------------	---------------------------	-----------------------------

Materials Foundation: N/A Walls: Vertical board Roof: Gable/ Asphalt shingle	Architectural Style/Form: Gable Barn Description/Features: Gable barn has been modified with an overhead door for garage use and has a post-1945 shed addition also for garage use.
No. Stories: 1 Major Alterations: Shed extension for garage use	Historic Notes:
Historic Data Sources: Plats, Agricultural Census data

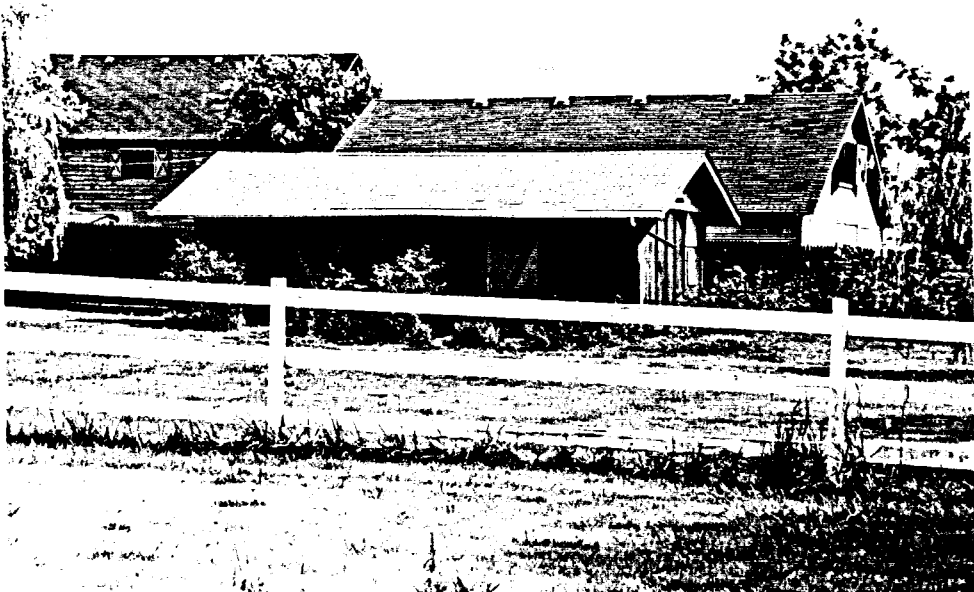
SITE PLAN	N	Roll No./Neg. No.: C/19 Surveyed by: AM/LS Date: 7/26/95

Address/Location: 13500 S. Wolf Road, Orland Township		Tax Parcel No. 27-06-201-005	Map Key No. 12
Name/Owner Current: Ronald J. Szelag Historic: J. Bush	Structure: Barn (B2) Current Use/Historic Use: -/Barn-Stable Architect/Builder:	Landmark Evaluation Individual: N Farmstead: N Criteria: National Register: N Local: N	
Date/Source: c. 1920/Form, materials	Condition: Good	Integrity: Medium	
Materials Foundation: N/A Walls: Vertical board & batten Roof: Gable/ Asphalt shingle	Architectural Style/Form: Gable Barn/Stable Description/Features: Small gable barn has newer board and batten and wood panel sheathing. Doors are on the side. Barn is in the foreground of photograph. Background buildings are not on this site.		
No. Stories: 1 Major Alterations:	Historic Notes:		
Historic Data Sources: Plats, Agricultural Census data

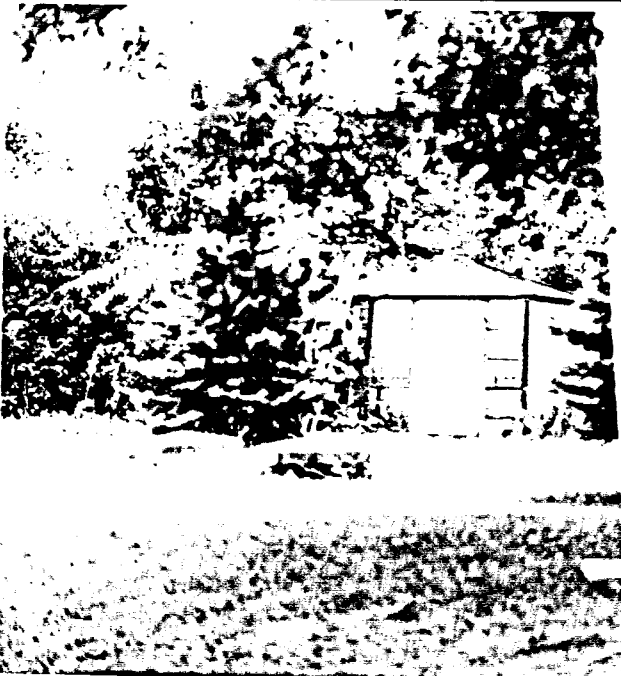
SITE PLAN	N		
		Roll No./Neg. No.: C/18	Surveyed by: AM/LS Date: 7/26/95

Address/Location: 13500 S. Wolf Road, Orland Township		Tax Parcel No. 27-06-201-005	Map Key No. 12
Name/Owner Current: Ronald J. Szelag Historic: J. Bush	Structure: Coop Current Use/Historic Use: -/Coop Architect/Builder:	Landmark Evaluation Individual: N Farmstead: N Criteria: National Register: N Local: N	
Date/Source: c. 1900/Form	Condition: Fair	Integrity: Medium	
Materials Foundation: N/A Walls: Asphalt siding Roof: Polygonal/ Asphalt shingle	Architectural Style/Form: Coop Description/Features: Hexagonal coop has polygonal roof.		
No. Stories: 1 Major Alterations:	Historic Notes: Coop may be an early variety of the prefabricated farm structures available in the 1890's and discussed in the Kane County "Rural Structures Survey", 1987. This source references a prefabricated polygonal chicken brooder coop.		
Historic Data Sources: Plats, Agricultural Census data

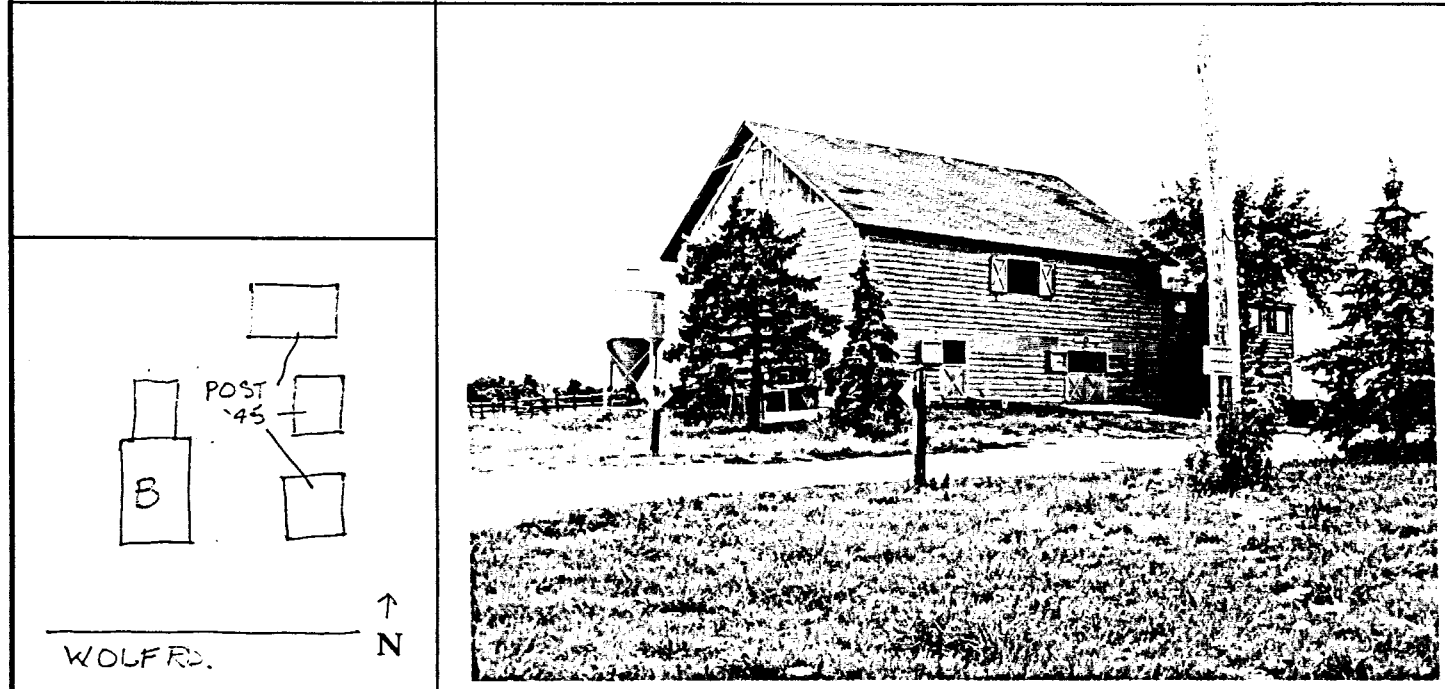
SITE PLAN

Date/Source: c. 1880/Plat, Census, Style	Condition: Good	Integrity: Poor
--	---------------------------	---------------------------

Materials Foundation: Stone & Concrete Walls: Modern wood siding Roof: Gable/ Asphalt shingle	Architectural Style/Form: Gable Barn/Stable Description/Features: Gable Barn with new horizontal wood siding over original vertical board (still visible in gable). Modern 2 story house addition (W). Cross reference with Map Key No.12, barn probably part of that property originally. Three additional, post 1945 structures on the site.
---	--

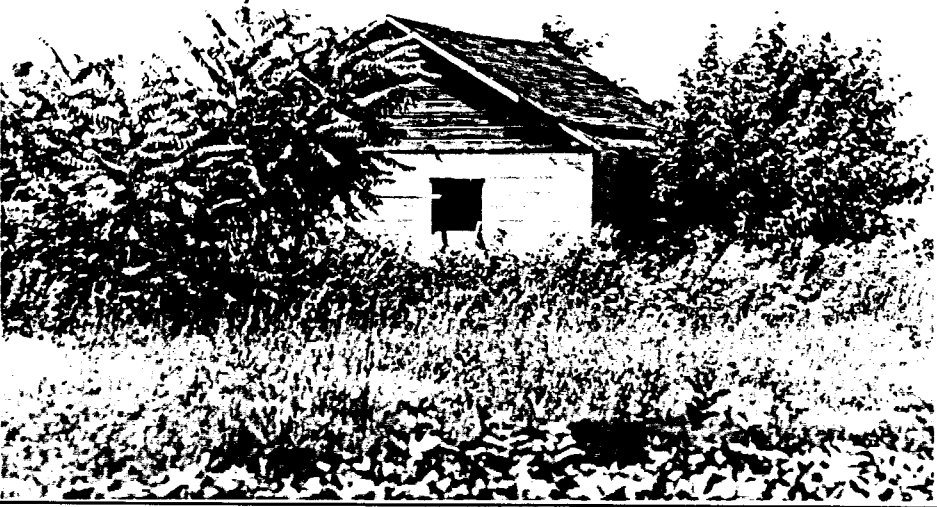
SITE PLAN	N	Roll No./Neg. No.: C/9 Surveyed by: AM/LS Date: 7/27/95

Address/Location: NW Corner of Wolf Road and 139th Street, Orland Township		Tax Parcel No. 27-06-203-001	Map Key No. 14
Name/Owner Current: Gallagher & Henry Historic: Wm. Myrick	Structure: Shed Current Use/Historic Use: Vacant/Shed Architect/Builder:	Landmark Evaluation Individual: N Farmstead: N Criteria: National Register: N Local: N	
Date/Source: c.1910/Form, materials	Condition: Poor	Integrity: High	
Materials Foundation: N/A Walls: Boards & concrete block Roof: Gable/ Asphalt shingle	Architectural Style/Form: Gable Shed Description/Features: Gable shed with concrete block wall up to roof and horizontal boarding in gable ends. Appears to date later than the original farm referenced in Historic Data Sources. Vacant and in severely deteriorated condition.		
No. Stories: 1 Major Alterations:	Historic Notes:		
Historic Data Sources: 1886 Plat, 1880 Agricultural Census

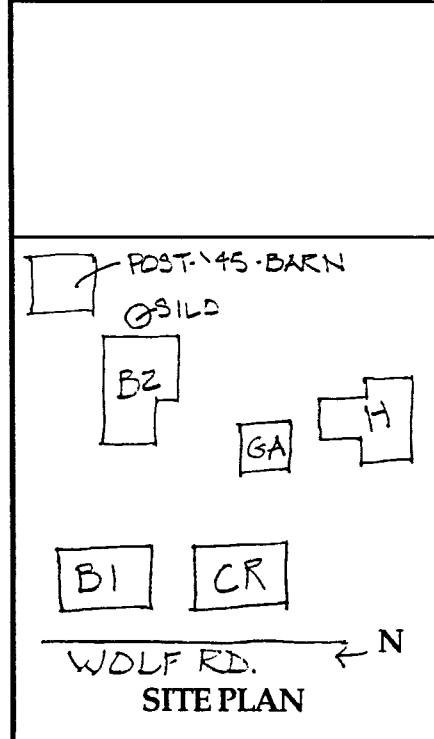
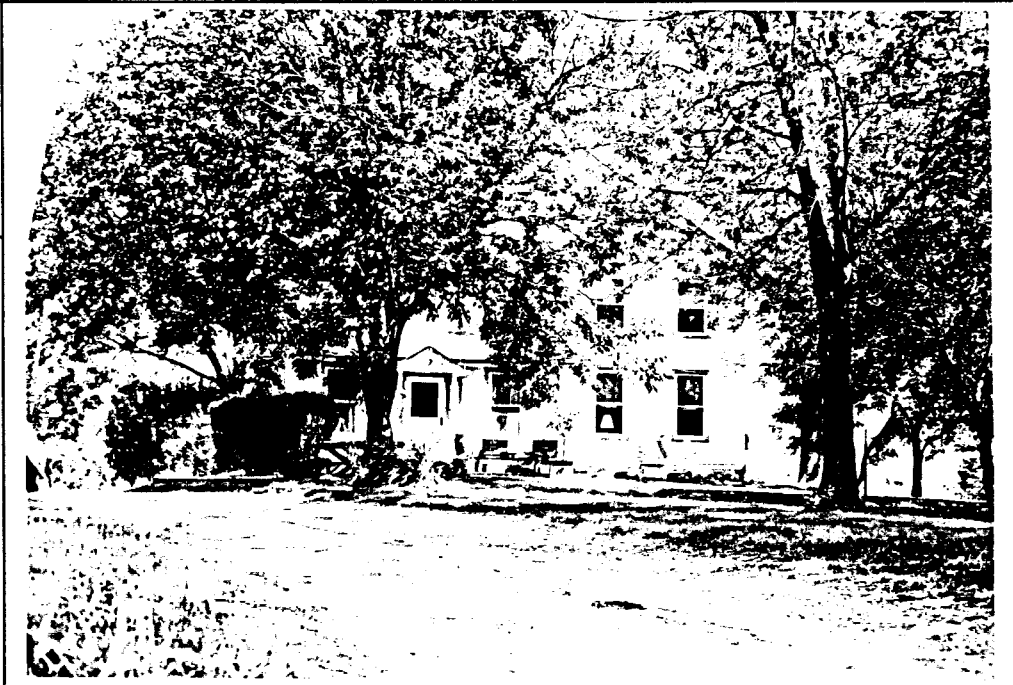
Roll No./Neg. No.: C/3 **Surveyed by:** AM/LS **Date:** 7/26/95

Date/Source: c.1870-80/Plats, Census	Condition: Good	Integrity: High
--	---------------------------	---------------------------

Materials Foundation: N/A Walls: Asphalt siding Roof: Gable with gable/ Asphalt shingle	Architectural Style/Form: Upright-and-Wing Description/Features: Two story frame upright with one story wing has 3/1 windows, c. 1925, and a circular window at the front attic gable. The area in front (W) of the wing appears to have been an earlier one story porch and was enclosed, c. 1925. Also on the site are 3 barns, a garage, and a crib.
No. Stories: 2 Major Alterations: Porch at 1 story wing enclosed, windows	Historic Notes: Site indicated thus developed as of 1886 Plat. Site also listed under J. Junker in Agricultural Census of 1880. Census indicates farm produced sheep, cattle, corn, grains, potatoes, apples, and honey. Yunker (<i>sic</i>) School, School District 143 building, named for a decendant.
Historic Data Sources: Plats, Agricultural Census data

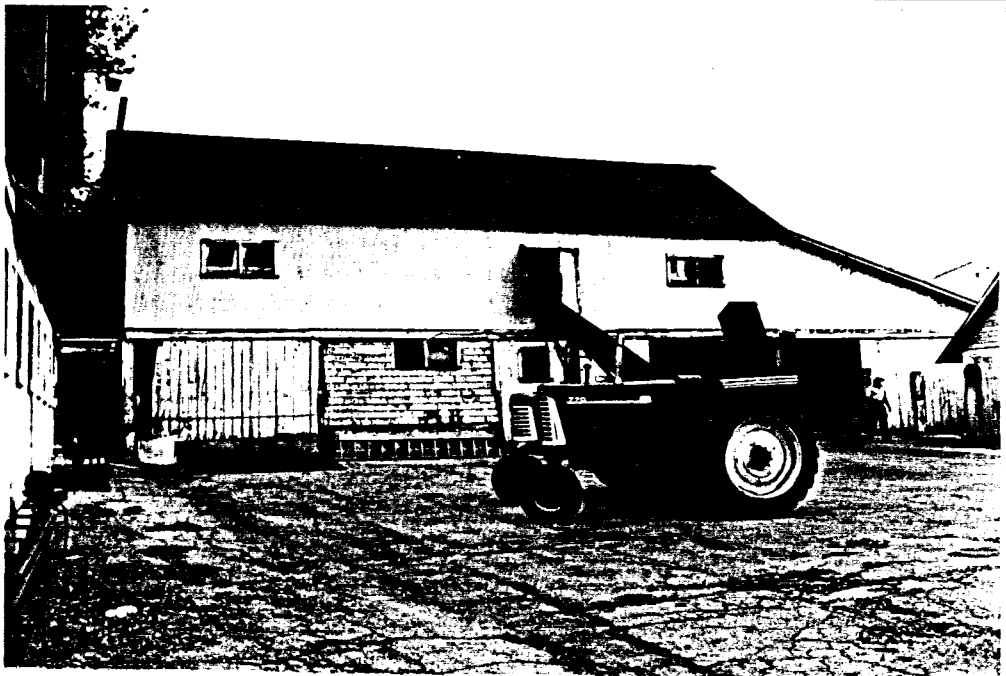
SITE PLAN	N		
Roll No./Neg. No.: /0		Surveyed by: JM	Date: 9/6/95

Address/Location: 15601 S. 108th Street, Orland Township		Tax Parcel No. 27-17-400-003	Map Key No. 25
Name/Owner Current: Mary Pat Del Giomo Historic:	Structure: Bam (B2) Current Use/Historic Use: Bam/Bam Architect/Builder:	Landmark Evaluation Individual: N Farmstead: Y Criteria: 1 National Register: N Local: Y No original farmhouse	
Date/Source: c. 1880/ Noble, materials	Condition: Good	Integrity: High	
Materials Foundation: Concrete Walls: Sheet metal, wood Roof: Gable/ Asphalt roll roofing	Architectural Style/Form: Gable Bam Description/Features: Two story gable bam has a one story extension at the gable end (N). Windows are in pairs and are 6 lights per sash. The material of the first level is of vertical board and wood shingle. The second level gable end is clad in metal.		
No. Stories: 2 + loft Major Alterations: Shed extension at gable end	Historic Notes:		
Historic Data Sources: Noble: <u>Barns of the Midwest</u>
