ORLAND RURAL HISTORY SURVEY

PREPARED FOR
THE VILLAGE OF ORLAND PARK

BY ANNE MCGUIRE & ASSOCIATES

DECEMBER, 1995

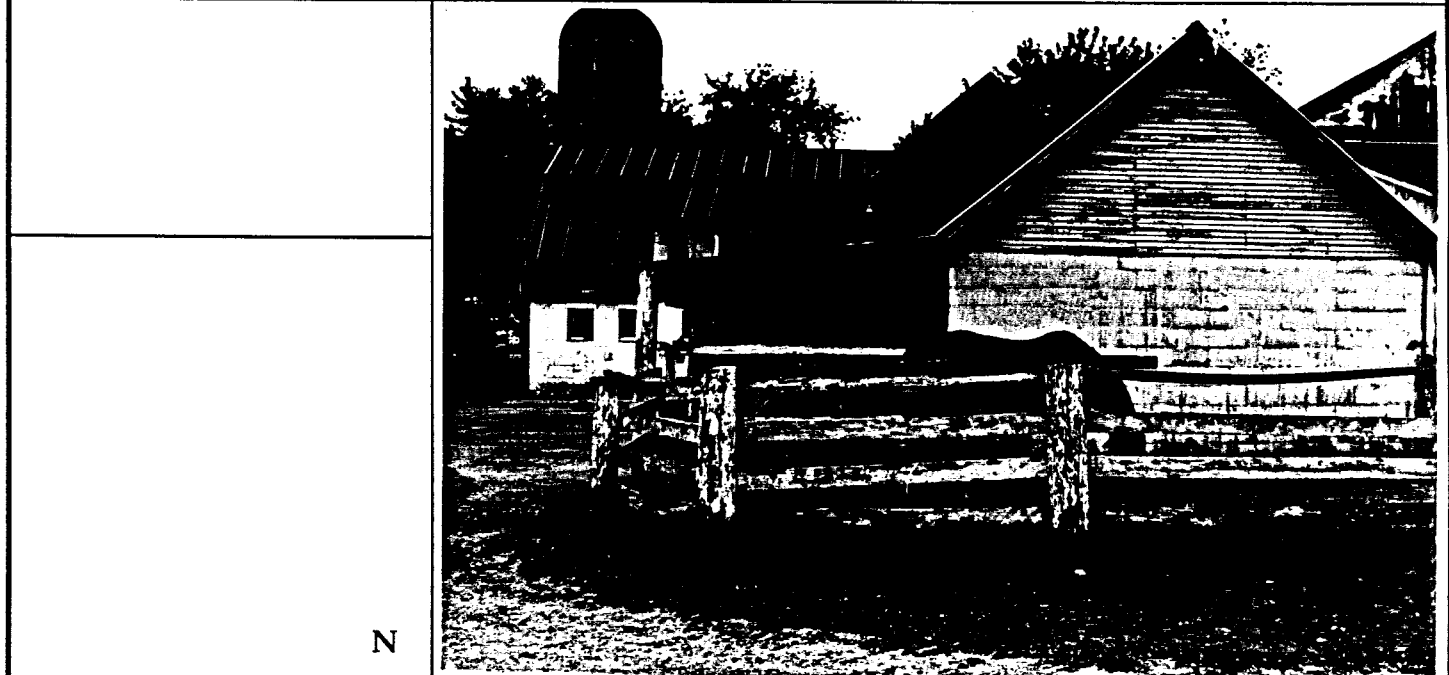
Roll No./Neg. No.: 1/3 **Surveyed by:** JM **Date:** 9/6/95

Date/Source: c.1910/ Noble, materials	Condition: Good	Integrity: High
---	---------------------------	---------------------------

Materials Foundation: Concrete block Walls: Concrete blk & horiz. bds. Roof: Gable with extension/ Asphalt roll roofing	Architectural Style/Form: Gable Bam, Stable Description/Features: Gable bam has an open extension on the side (E), one end of which (S) has been enclosed. The building is used as a stable.
No. Stories: 1 Major Alterations: Extension on one side	Historic Notes:
Historic Data Sources:

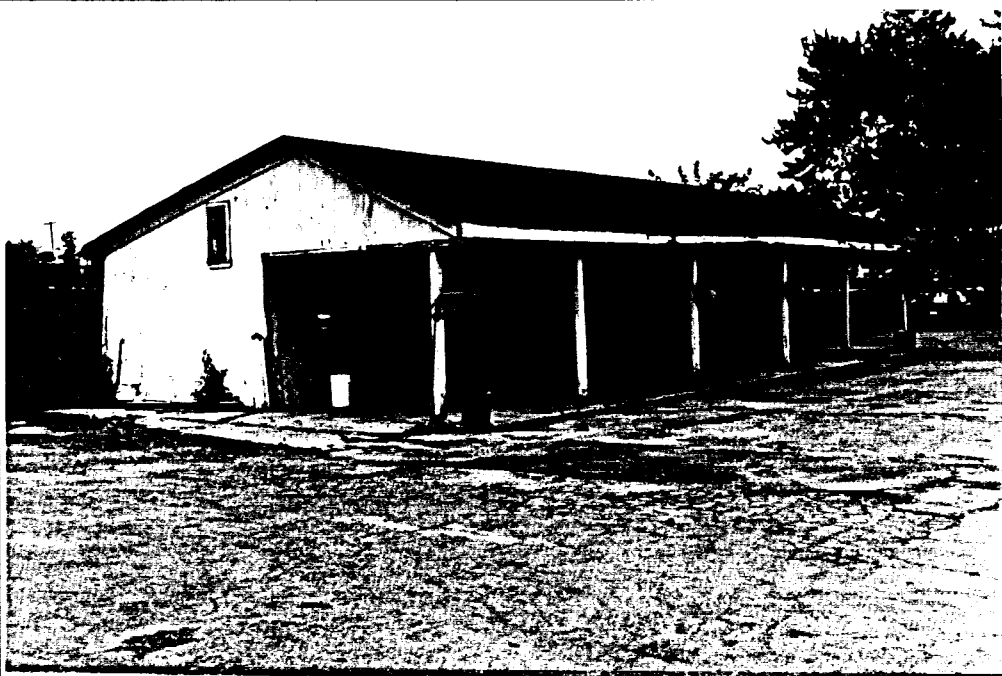
SITE PLAN			
N	Roll No./Neg. No.: 1/4	Surveyed by: JM	Date: 9/6/95

Address/Location: 15601 S. 108th Street, Orland Township		Tax Parcel No. 27-17-400-003	Map Key No. 25
Name/Owner Current: Mary Pat Del Giorno Historic:	Structure: Barn (B4) Current Use/Historic Use: Barn/Barn, Stable Architect/Builder:	Landmark Evaluation Individual: N Farmstead: Y Criteria: 1 National Register: N Local: Y No original farmhouse	
Date/Source: c. 1940	Condition: Good	Integrity: High	
Materials Foundation: N/A Walls: Sheet metal Roof: Gable (uneven)/ Asphalt shingle	Architectural Style/Form: Gable Barn, Stable Description/Features: Gable barn/stable has an open area under the roof line. Used as a horse stable, the barn has a series of 5 stalls or bays each accessing the open area under the roof.		
No. Stories: 1 Major Alterations: Extension on one side	Historic Notes:		
Historic Data Sources:

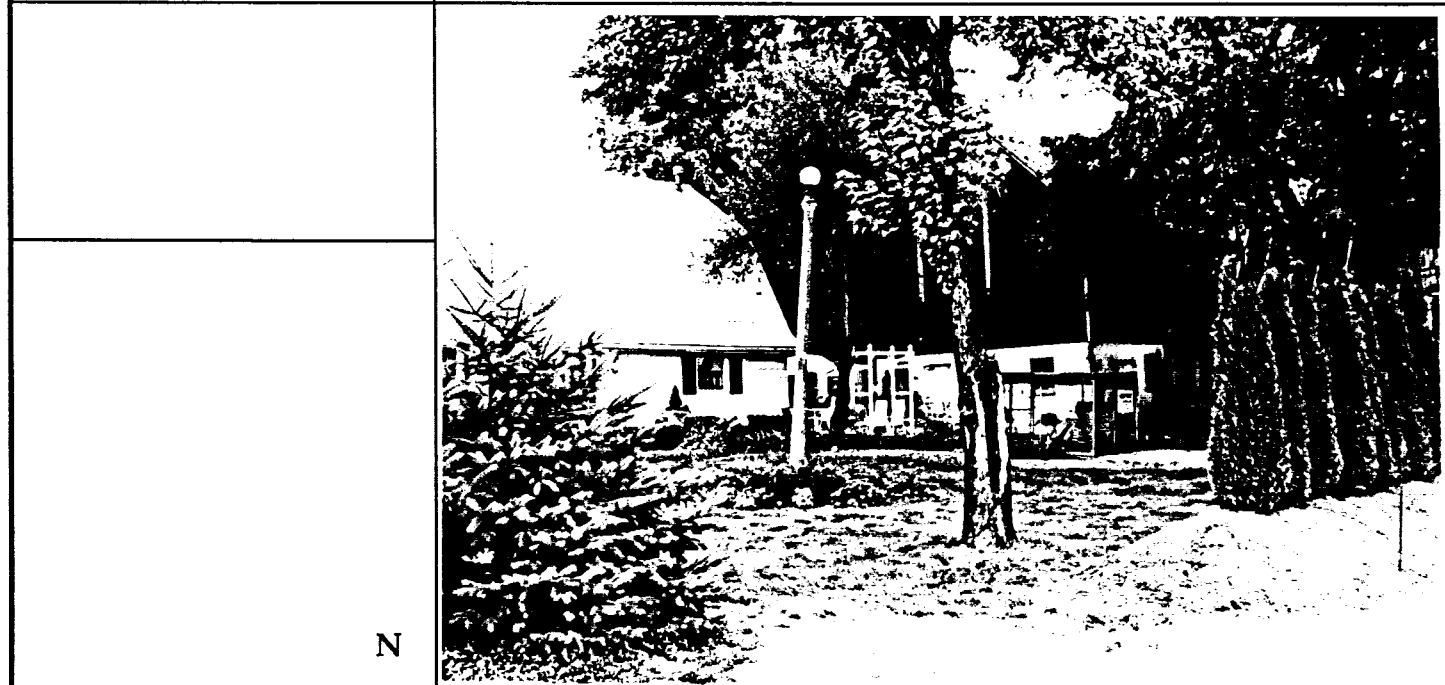
Date/Source: c.1910	Condition: Good	Integrity: Poor
-------------------------------	---------------------------	---------------------------

Materials Foundation: N/A Walls: Aluminum siding Roof: Gambrel/ Asphalt shingle	Architectural Style/Form: Gambrel Bam Description/Features: Gambrel bam has been converted into a house. Siding and windows are not original. Farm buildings include: 7 bams (2 are non-conforming, 1 has been rehabed into house), silo, and garage.
---	--

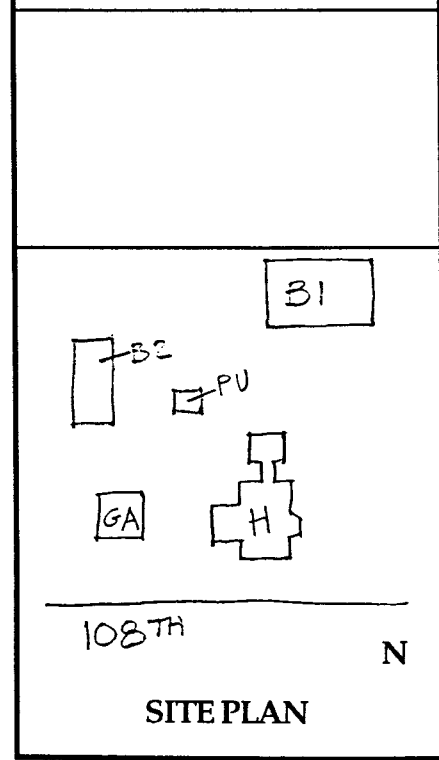
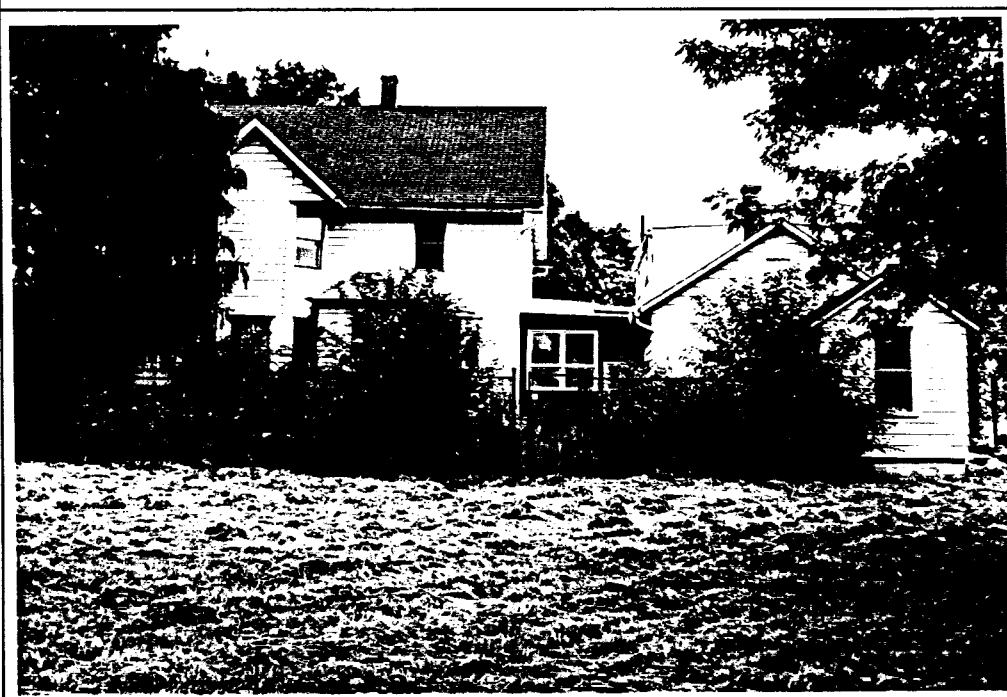
Roll No./Neg. No.: A/24 **Surveyed by:** AM/JM **Date:** 7/25/95

Date/Source: 1886/ Plats, style	Condition: Fair	Integrity: Medium
---	---------------------------	-----------------------------

Materials Foundation: Parged stone Walls: Aluminum siding Roof: Gable/ Asphalt shingle	Architectural Style/Form: Gable Front Description/Features: Two story frame Gable Front house has a two story cut away bay in the Queen Anne style on the South side. The full width front porch has been enclosed, c.1925, with 4/1 windows. A modern, 1 story addition is on the side (N). A modern, rear (E) addition connects the house to the summer kitchen, c. 1910. Frame summer kitchen has gable roof with shed dormers and concrete block foundation. Also on site are 2 barns, a garage and a pump house. Historic Notes: Gee family has owned site since plat of 1861 and is listed in 1860 Agricultural Census data. Buildings on the site appear to be later. First plat to indicate site improved is dated 1886.
No. Stories: 2 + attic Major Alterations: Addition linking summer kitchen, enclosed porch	
Historic Data Sources: Plats, Agricultural Census data

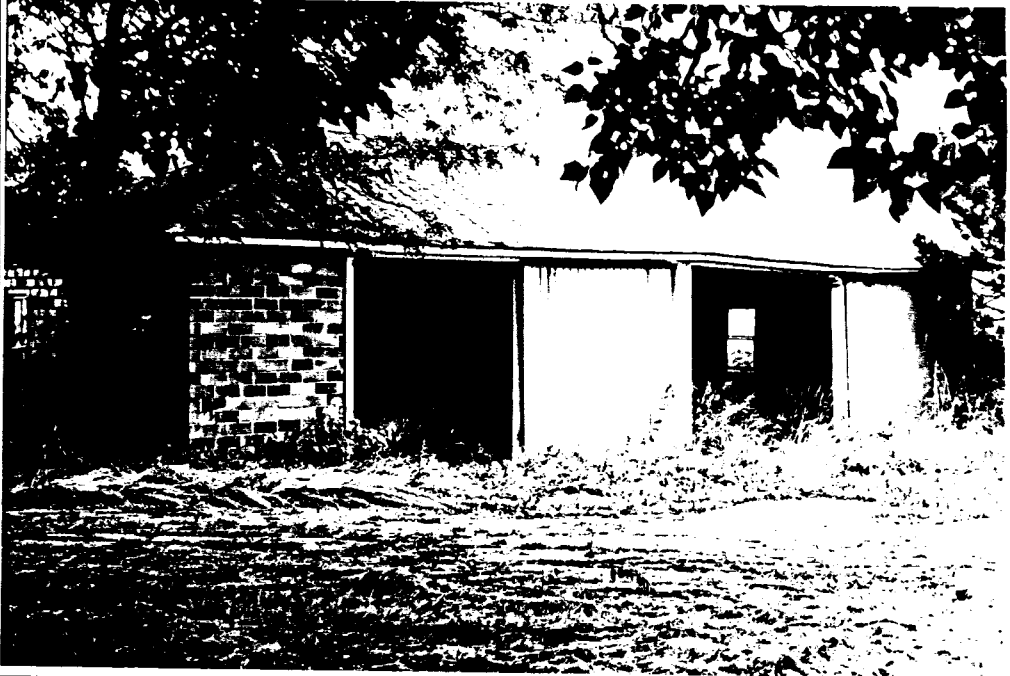
N			
SITE PLAN	Roll No./Neg. No.: A/23 Surveyed by: AM/JM Date: 7/25/95

Address/Location: 15731 S. 108th Avenue, Orland Township		Tax Parcel No. 27-17-402-004	Map Key No. 26
Name/Owner Current: Hughes & Duggan Orland Historic: J. Gee	Structure: Garage Current Use/Historic Use: Vacant/Garage Architect/Builder:	Landmark Evaluation Individual: N Farmstead: Y Criteria: 1,6 National Register: N Local: Y Development proposed	
Date/Source: c. 1925/Noble	Condition: Fair	Integrity: High	
Materials Foundation: Concrete Walls: Hollow tile Roof: Hip/ Asphalt shingle	Architectural Style/Form: Garage Description/Features: Hipped roof two bay garage is constructed of hollow tile, a material promoted during the 1920's for farm structures. The doors of the two bays are sliding and of vertical wood boards. Windows are double hung 2/2.		
No. Stories: 1 Major Alterations:	Historic Notes: The garage has been dated based materials and form.		
Historic Data Sources: Noble: <u>Barns of the Midwest</u>

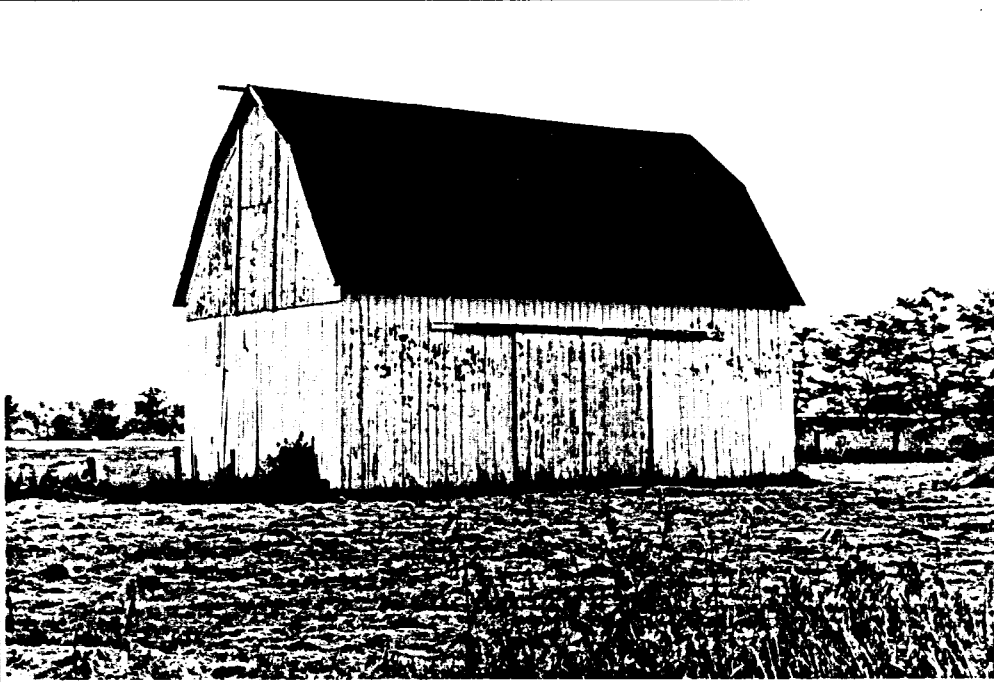
SITE PLAN	N		
Roll No./Neg. No.: A/19		Surveyed by: AM/JM	Date: 7/25/95

Address/Location: 15731 S. 108th Avenue, Orland Township		Tax Parcel No. 27-17-402-004	Map Key No. 26
Name/Owner Current: Hughes & Duggan Orland Historic: J. Gee	Structure: Bam (B1) Current Use/Historic Use: Vacant/Bam Architect/Builder:	Landmark Evaluation Individual: N Farmstead: Y Criteria: 1,6 National Register: N Local: Y Development proposed	
Date/Source: C. 1900/ Plats, style	Condition: Fair	Integrity: High	
Materials Foundation: Concrete block Walls: Vertical board siding Roof: Gambrel/ Asphalt shingle	Architectural Style/Form: Gambrel Bam, three bay Description/Features: Gambrel roof bam has vertical board siding of milled lumber. A pair of sliding doors also of vertical boards is located on the West side.		
No. Stories: 1 + loft Major Alterations:	Historic Notes:		
Historic Data Sources: Plats, Agricultural Census data, Noble: <u>Barns of the Midwest</u>

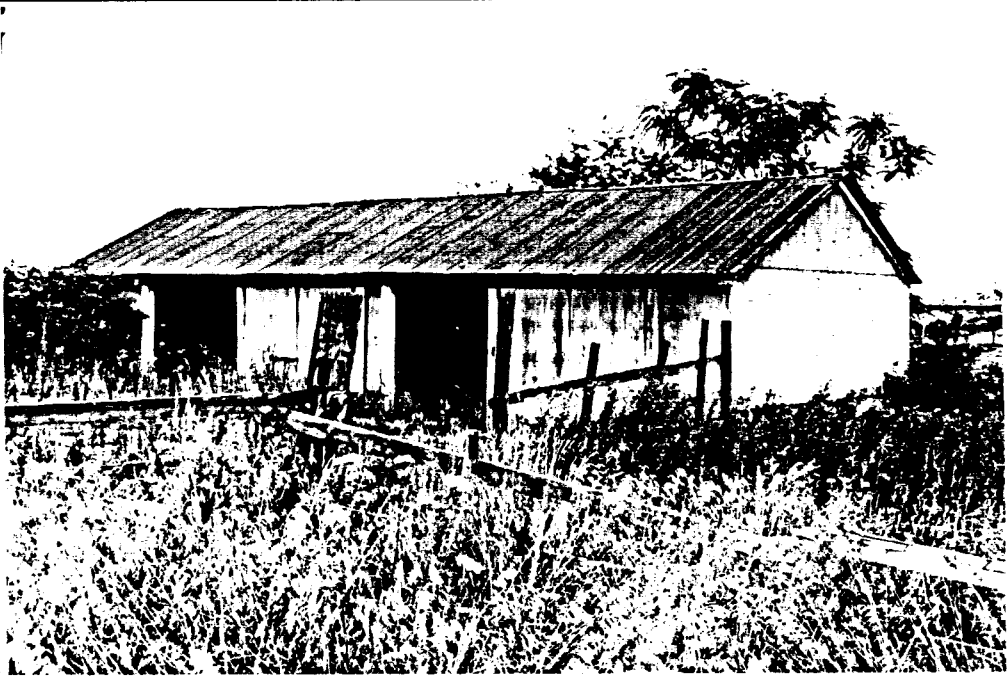
SITE PLAN	Roll No./Neg. No.: A/22 Surveyed by: AM/JM Date: 7/25/95

Address/Location: 15731 S. 108th Avenue, Orland Township		Tax Parcel No. 27-17-402-004	Map Key No. 26
Name/Owner Current: Hughes & Duggan Orland Historic: J. Gee	Structure: Barn (B2) Current Use/Historic Use: Vacant/Barn Architect/Builder:	Landmark Evaluation Individual: N Farmstead: Y Criteria: 1,6 National Register: N Local: Y Development proposed	
Date/Source: c. 1900/ Plats, style	Condition: Fair	Integrity: High	
Materials Foundation: Concrete Walls: Corrugated metal siding Roof: Gable/ Asphalt roll roofing	Architectural Style/Form: Gable Barn Description/Features: Long low gable barn has concrete floor and troughs arranged for cows. Square windows without glazing are on the long (N) side. Two sliding doors also of corrugated metal are located on the side (S).		
No. Stories: 1 Major Alterations:	Historic Notes: Earliest owner of site is J. Gee based on information from 1861 Plat and 1860 Agricultural census data. While portions of the site's 5 structures may date to the earliest period of the farm, the barn has been dated based materials and form.

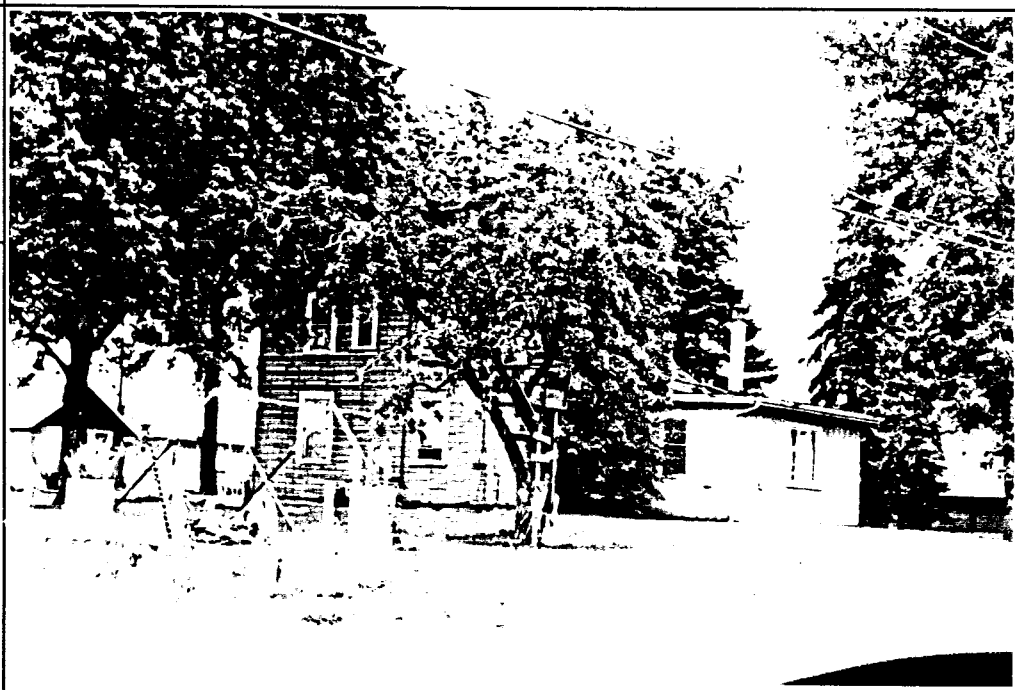
Roll No./Neg. No.: E/6 **Surveyed by:** AM/JM **Date:** 8/3/95

Date/Source: 1870-86/Plats	Condition: Fair	Integrity: Low
--------------------------------------	---------------------------	--------------------------

Materials Foundation: N/A Walls: Asphalt siding Roof: Gable with gable/ Asphalt shingle	Architectural Style/Form: Upright-and-Wing Description/Features: Two story frame upright with attic and one and one half story wing has a post-1945, one story, flat roof addition on front (W) at juncture of Upright-and-Wing. House is clad in asphalt siding and foundation is obscured.
No. Stories: 2 + attic Major Alterations: One story addition on front, siding	Historic Notes: Agricultural Census of 1880 indicates Martin Weiler farmed 40 acres. Property is also indicated on 1870 Plat under T. Weiley (<i>sic</i>). Structures on the site also include: 4 coops, crib, summer kitchen, and modern prefabricated shed.
Historic Data Sources: Plats, Agricultural Census data

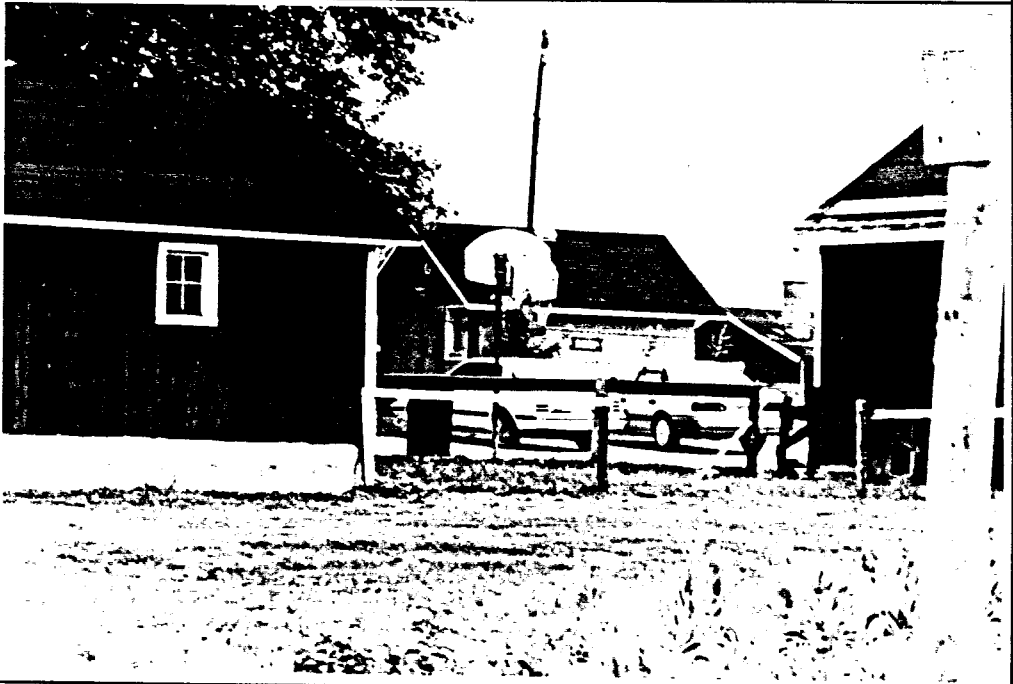
SITE PLAN	N	Roll No./Neg. No.: E/10 Surveyed by: AM/JM Date: 8/3/95

Address/Location: 15401 S. Will-Cook Road, Orland Township		Tax Parcel No. 27-18-102-005	Map Key No. 27
Name/Owner Current: Edward Lucas Historic: M. & T. Weiler	Structure: Summer Kitchen Current Use/Historic Use: -/Summer Kitchen Architect/Builder:	Landmark Evaluation Individual: N Farmstead: N Criteria: National Register: N Local: N	
Date/Source: c.1910/Style	Condition: Good	Integrity: High	
Materials Foundation: Concrete block Walls: Concrete block Roof: Gable/ Asphalt roll roofing	Architectural Style/Form: Summer Kitchen Description/Features: Inaccessible summer kitchen is made of concrete block with a gable roof.		
No. Stories: 1 Major Alterations:	Historic Notes:		
Historic Data Sources: Plats, Agricultural Census data

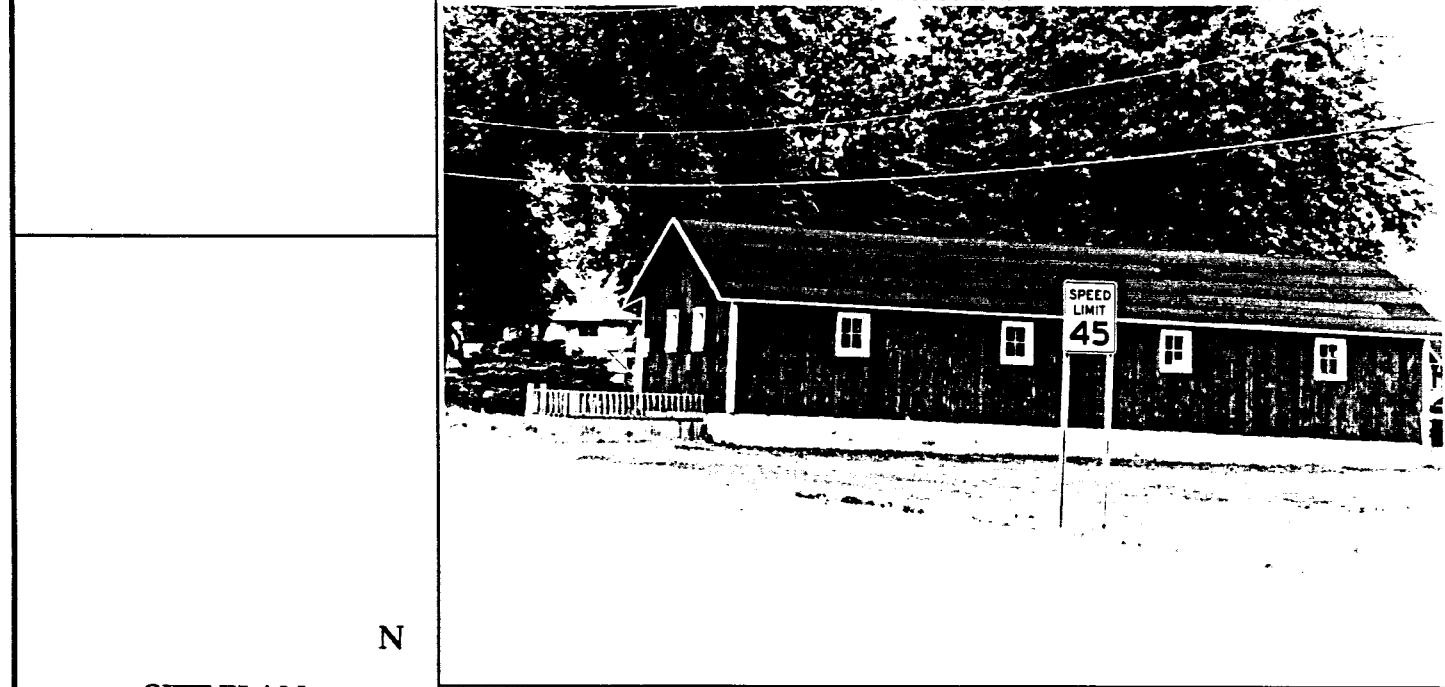
Date/Source: c.1910/Style	Condition: Good	Integrity: High
-------------------------------------	---------------------------	---------------------------

Materials Foundation: Concrete Walls: Vertical board Roof: Gable/ Asphalt roll roofing	Architectural Style/Form: Gable Barn, Stable Description/Features: Gable roofed barn/stable has poured concrete foundation and vertical board siding. Several small 4 light windows are on both the long side (S) and gable end (W). The long (N) side has sliding wood board doors.
--	--

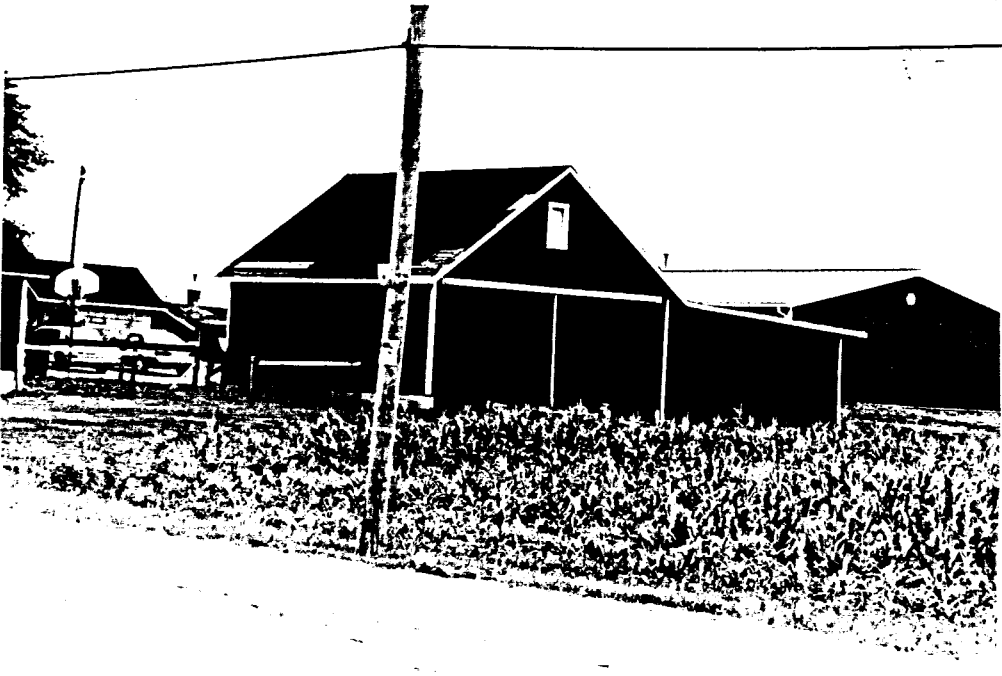
Address/Location: 15401 S. Will-Cook Road, Orland Township		Tax Parcel No. 27-18-102-005	Map Key No. 27
Name/Owner Current: Edward Lucas Historic: M. & T. Weiler	Structure: Crib Current Use/Historic Use: -/Crib Architect/Builder:	Landmark Evaluation Individual: N Farmstead: N Criteria: National Register: N Local: N	
Date/Source: c.1880/Plats, materials	Condition: Good	Integrity: High	
Materials Foundation: Concrete Walls: Vert. & horiz. board Roof: Gable/ Asphalt roll roofing	Architectural Style/Form: Crib with extension Description/Features: Gable roofed crib has shed extension to the East. Crib has spaced horizontal board siding for com storage on the East side and vertical board siding elsewhere. Sliding doors are located at the gable end (S).		
No. Stories: 1 Major Alterations: Shed extension	Historic Notes:		
Historic Data Sources: Plats, Agricultural Census data

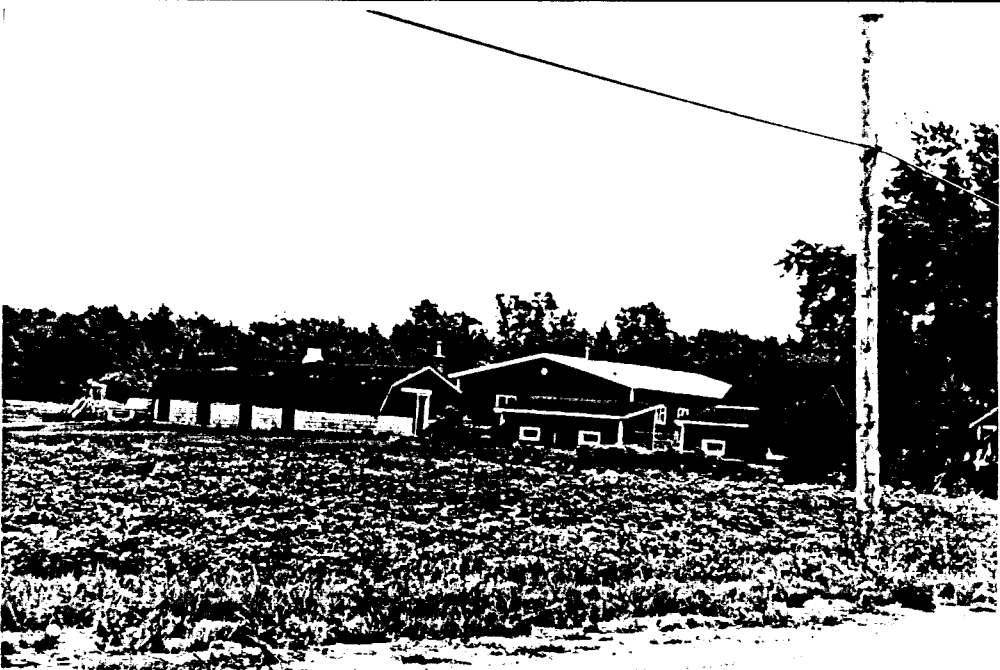
N			
SITE PLAN	Roll No./Neg. No.: E/5 Surveyed by: AM/JM Date: 8/3/95

Address/Location: 15401 S. Will-Cook Road, Orland Township		Tax Parcel No. 27-18-102-005	Map Key No. 27
Name/Owner Current: Edward Lucas Historic: M. & T. Weiler	Structure: Coop (CO1) Current Use/Historic Use: Coop/Coop Architect/Builder:	Landmark Evaluation Individual: N Farmstead: N Criteria: National Register: N Local: N	
Date/Source: c.1910/Style	Condition: Good	Integrity: High	
Materials Foundation: Concrete block Walls: Concrete block Roof: Gambrel/ Asphalt roll roofing	Architectural Style/Form: Coop Description/Features: Gambrel roofed coop has roof sitting directly on concrete block foundation and low walls. Several small windows openings are along the long side (N). The coop also has a concrete block chimney. Just West of this coop are two shed coops, CO2 and CO3, each with two 3 light windows on the rear (W) side.		
No. Stories: 1 Major Alterations:	Historic Notes:		
Historic Data Sources: Plats, Agricultural Census data

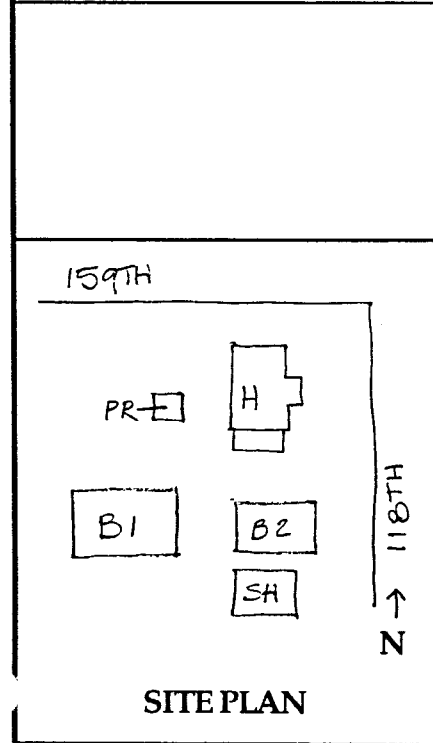
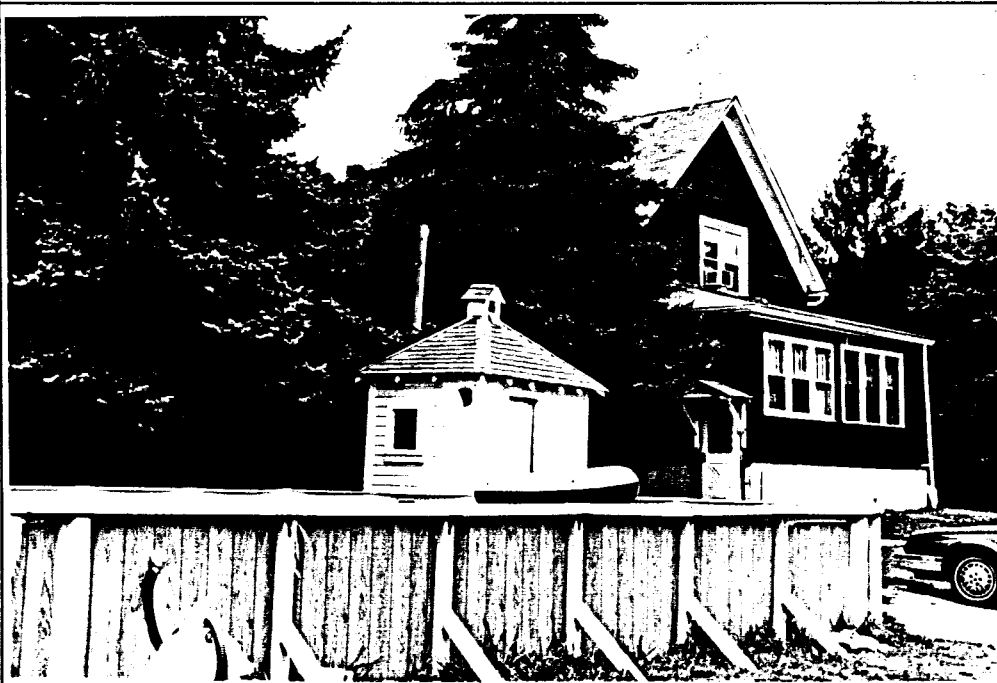
Roll No./Neg. No.: E/13 **Surveyed by:** AM/JM **Date:** 8/3/95

Date/Source: c.1910/Plats, style	Condition: Good	Integrity: Medium
--	---------------------------	-----------------------------

Materials Foundation: Concrete block Walls: Asphalt siding Roof: Gable/ Asphalt shingle	Architectural Style/Form: Gable Front Description/Features: One and one-half story gable front frame house has 1/1 windows. A rear (S) porch has been enclosed, c.1925, using 3/1 windows.
---	---

No. Stories: 1 + attic Major Alterations: rear porch enclosed, siding	Historic Notes: While 19th century plats, 1886 and 1898, do not show property of Mrs. Dodge as developed, the barn appears to predate the house. Agricultural census data of 19th century does not include Mrs. Dodge.
--	---

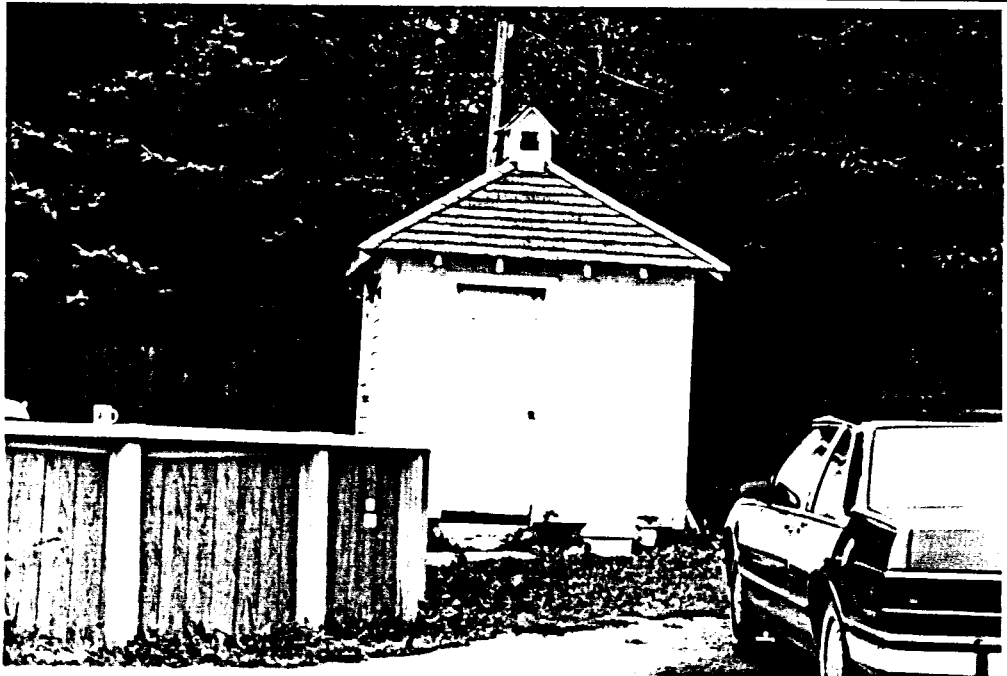
SITE PLAN			
N	Roll No./Neg. No.: E/14 Surveyed by: AM/JM Date: 8/3/95

Address/Location: 11801 W. 159th Street, Orland Township		Tax Parcel No. 27-19-100-007	Map Key No. 28
Name/Owner Current: Richard Goniak Historic: Mrs. Dodge/Plats 1886, 1898	Structure: Privy Current Use/Historic Use: -/Privy Architect/Builder:	Landmark Evaluation Individual: N Farmstead: N Criteria: National Register: N Local: N	
Date/Source: c. 1910/style	Condition: Good	Integrity: High	
Materials Foundation: N/A Walls: Clapboard Roof: Hip/ Asphalt shingle	Architectural Style/Form: Privy Description/Features: Privy has exposed rafter tails. The door is of vertical boards and there is a small square window opening on the side (W).		
No. Stories: 1 Major Alterations:	Historic Notes:		
Historic Data Sources:

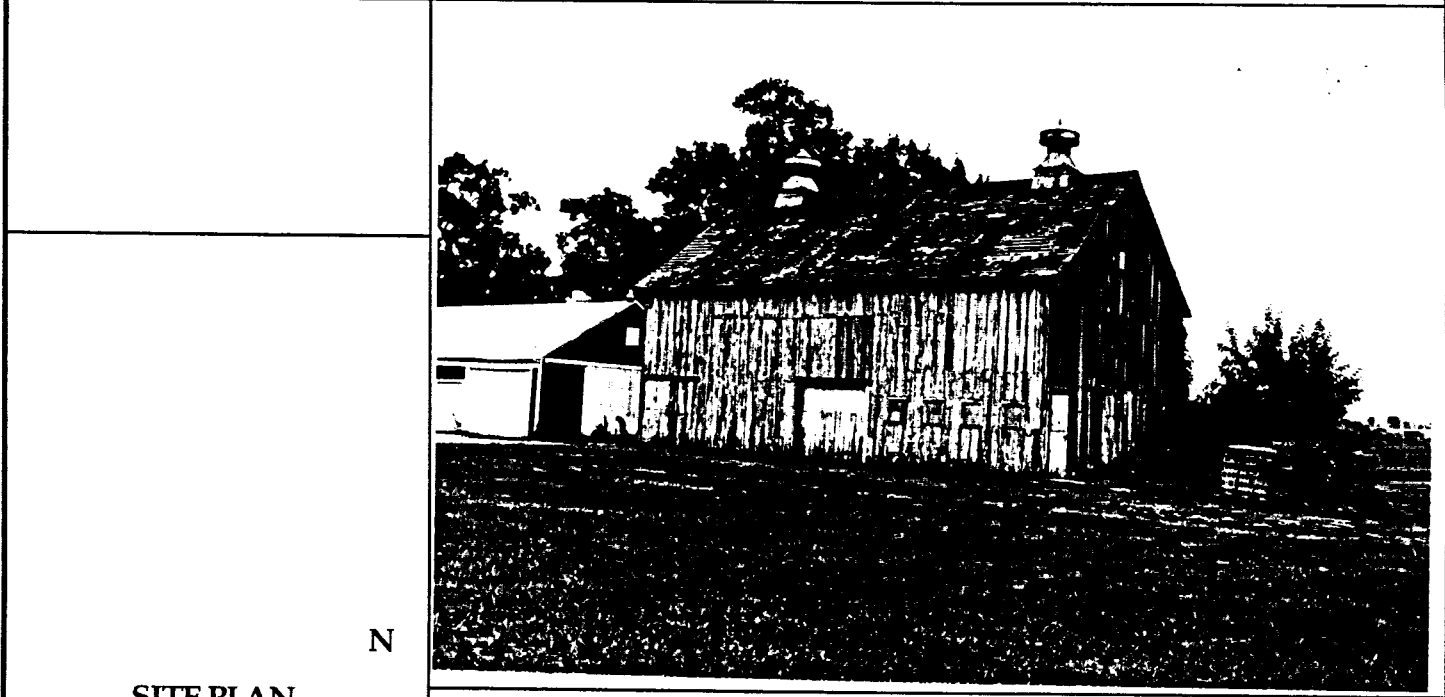
Roll No./Neg. No.: E/11 **Surveyed by:** AM/JM **Date:** 8/3/95

Date/Source: c.1880/Style, materials	Condition: Poor	Integrity: High
--	---------------------------	---------------------------

Materials Foundation: N/A Walls: Vertical board & batten Roof: Gable/ Asphalt shingle	Architectural Style/Form: Gable Bam Description/Features: Gable bam with doors on both the side (N) and end (W). The roof has two metal ventilators. Several small windows on the lower level side (N), West end, have been boarded up.
No. Stories: 1 + loft Major Alterations:	Historic Notes: While 19th century plat do not show property of Mrs. Dodge as developed, the bam appears to predate the c.1910 house.
Historic Data Sources:

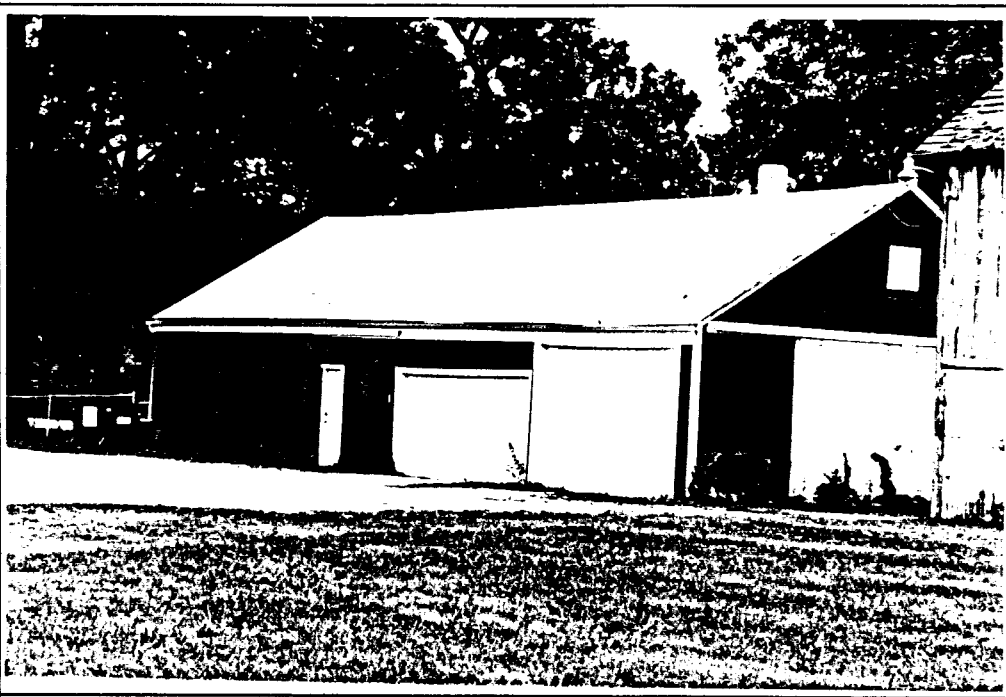
Roll No./Neg. No.: E/12 **Surveyed by:** AM/JM **Date:** 8/3/95

Date/Source: c. 1900/Style, materials	Condition: Fair	Integrity: Medium
---	---------------------------	-----------------------------

Materials Foundation: N/A Walls: Asphalt, vertical boards Roof: Gable/ Asphalt shingle	Architectural Style/Form: Gable bam Description/Features: Gable roof garage structure has multiple doors on the long (N) side. Original sliding doors are on the gable end (E). The building has a concrete block chimney.
No. Stories: 1 Major Alterations:	Historic Notes:
Historic Data Sources:

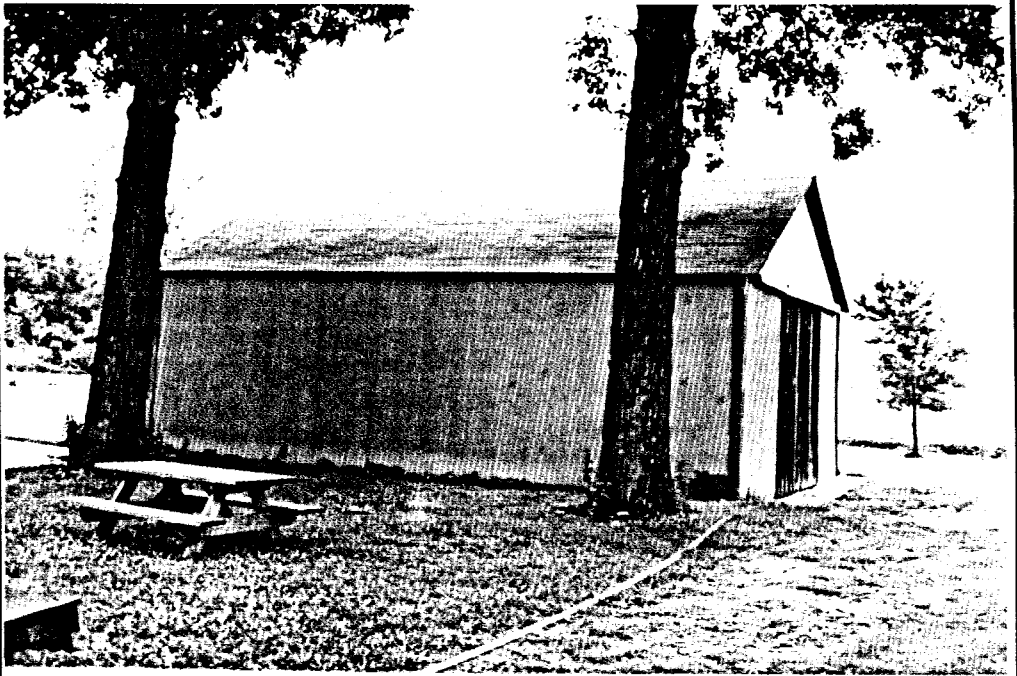
Address/Location: 11801 W. 159th Street, Orland Township		Tax Parcel No. 27-19-100-007	Map Key No. 28
Name/Owner Current: Richard Goniak Historic: Mrs. Dodge/Plats 1886, 1898	Structure: Shed Current Use/Historic Use: -/Shed Architect/Builder:	Landmark Evaluation Individual: N Farmstead: N Criteria: National Register: N Local: N	
Date/Source: c. 1900/Style, materials	Condition: Good	Integrity: Low	
Materials Foundation: N/A Walls: Corrugated metal Roof: Gable/ Asphalt shingle	Architectural Style/Form: Shed Description/Features: Gable shed has been clad in corrugated sheet metal. The wood, vertical board, sliding doors at the gable end remain exposed.		
No. Stories: 1 Major Alterations: Metal siding	Historic Notes:		
Historic Data Sources:			
SITE PLAN

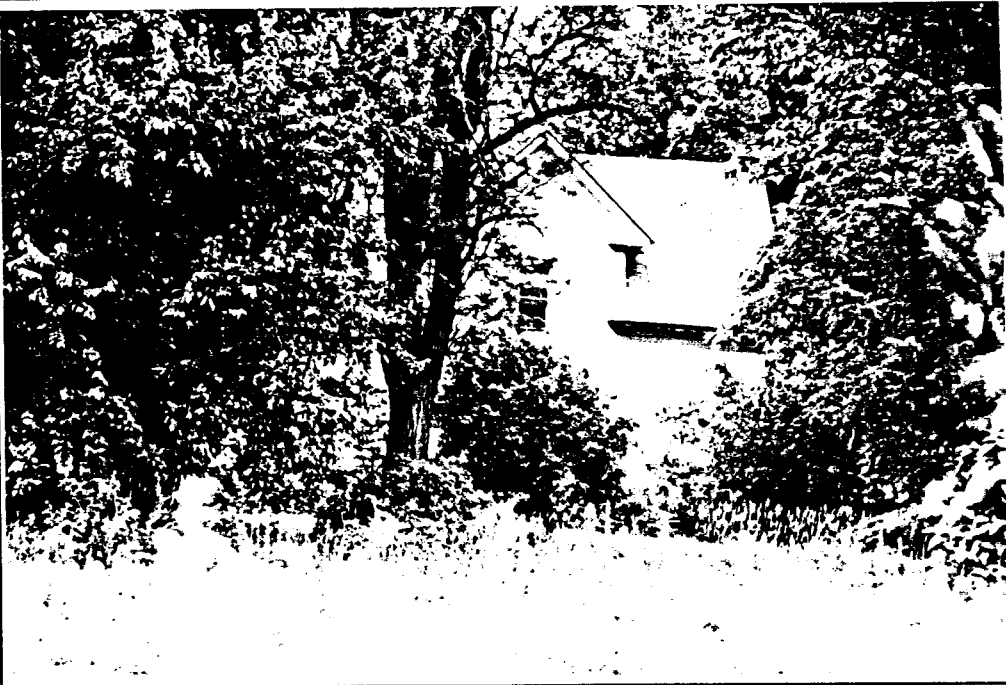
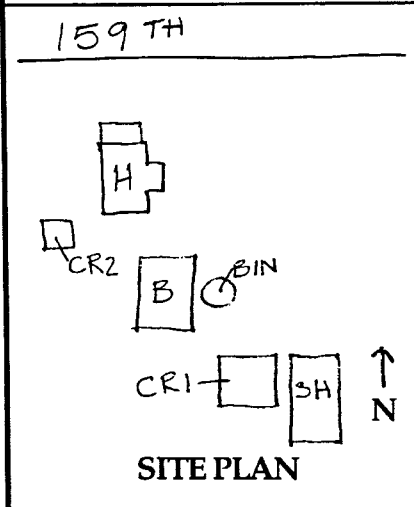
Roll No./Neg. No.: E/18 **Surveyed by:** AM/JM **Date:** 8/3/95

Date/Source: 1880-86/Census.Platt	Condition: Fair	Integrity: High
---	---------------------------	---------------------------

Materials Foundation: N/A Walls: Composition siding Roof: Gable/ Asphalt shingle	Architectural Style/Form: Gable Front Description/Features: Obscured one and one-half story frame house has projecting side gable. The house is clad in composition siding and has a hipped roof front porch. The visible windows are 1/1.
No. Stories: 1 + attic Major Alterations: Siding	Historic Notes: Agricultural census of 1880 lists Daniels and indicates mixed farming including two acres of apple orchard.
Historic Data Sources: Plats, Agricultural Census data

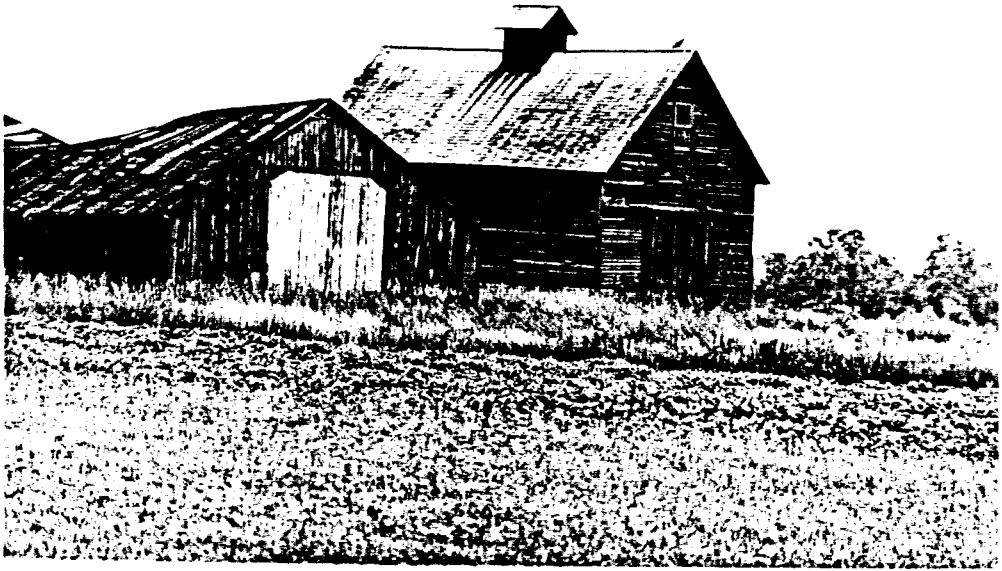
Roll No./Neg. No.: E/17		Surveyed by: AM/JM	Date: 8/3/95

Address/Location: 11430 W. 159th Street, Orland Township		Tax Parcel No. 27-19-200-003	Map Key No. 29
Name/Owner Current: Harold Sayers Historic: J. Daniels	Structure: Crib (C1) Current Use/Historic Use: -/Crib Architect/Builder:	Landmark Evaluation Individual: N Farmstead: Y Criteria: 1,6 National Register: N Local: Y Development concept approved	
Date/Source: 1880-86/Census, Plat	Condition: Fair	Integrity: High	
Materials Foundation: N/A Walls: Horizontal board Roof: Gable/ Asphalt shingle	Architectural Style/Form: Crib Description/Features: Gable corn crib has spaced horizontal boards on East side for corn; the rest of the crib has tight horizontal board siding. A small 6/6 window is located in the loft at the gable end. A ventilator or elevator tops roof.		
No. Stories: 1 + loft Major Alterations:	Historic Notes:		
Historic Data Sources: Plats, Agricultural Census data

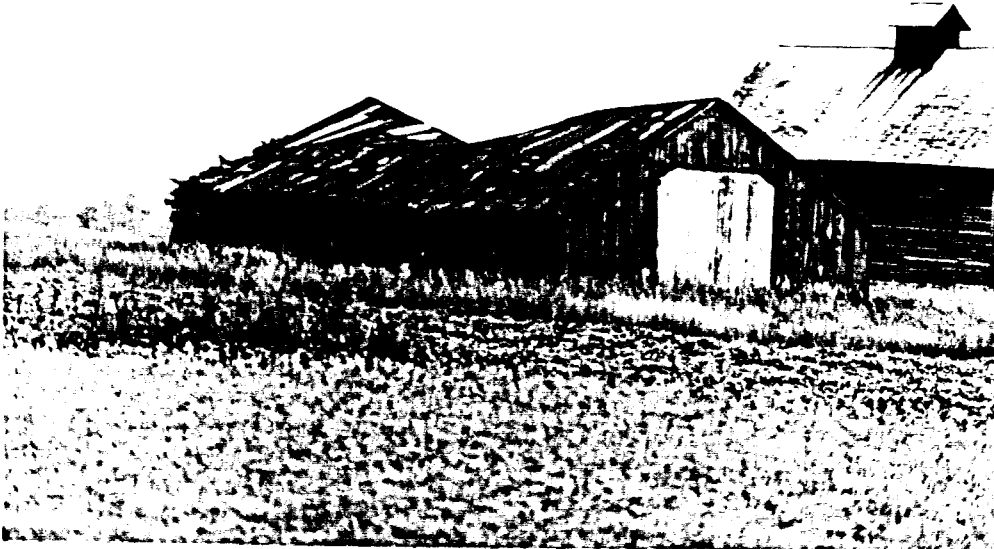
<p>N</p> <p>SITE PLAN</p>	<p>Roll No./Neg. No.: E/16 Surveyed by: AM/JM Date: 8/3/95</p>

Date/Source: 1880-86/Census, Plat	Condition: Poor	Integrity: High
---	-------------------------------	-------------------------------

Materials Foundation: N/A Walls: Vertical board Roof: Gable/ Metal	Architectural Style/Form: Shed Description/Features: Gable shed roof is collapsed. Sliding doors are located on the gable end.
No. Stories: 1 Major Alterations:	Historic Notes:
Historic Data Sources: Plats, Agricultural Census data

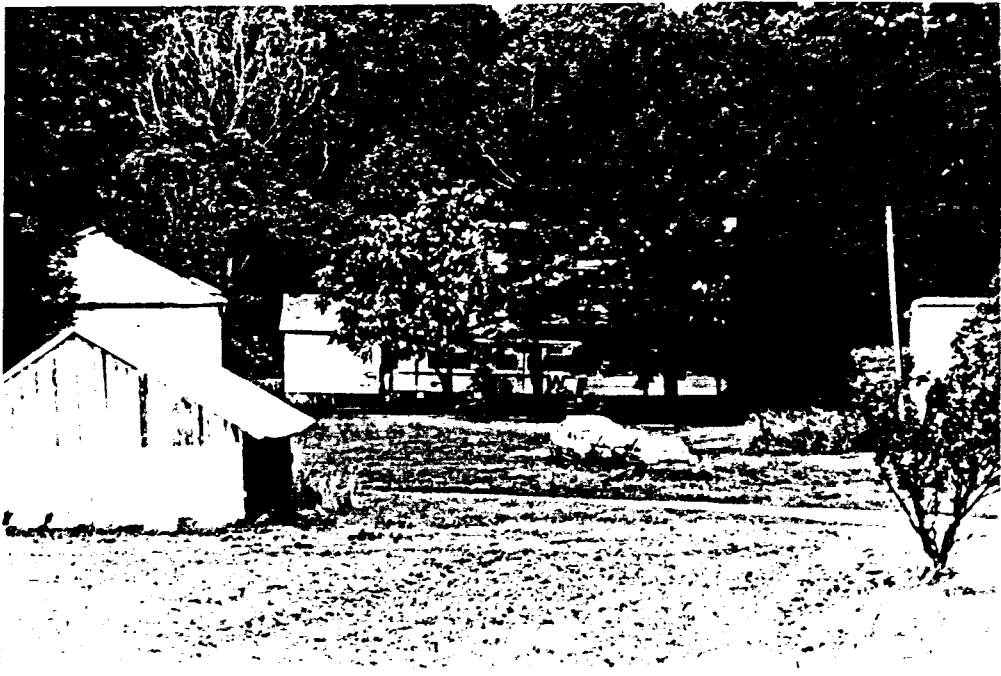
Roll No./Neg. No.: H/16	Surveyed by: JM
		Date: 9/6/95

Address/Location: 16601 S. 118th Avenue, Orland Township		Tax Parcel No. 27-19-300-006	Map Key No. 31
Name/Owner Current: Gallagher & Henry Historic: Lewis Tilsey	Structure: House Current Use/Historic Use: House/House Architect/Builder:	Landmark Evaluation Individual: N Farmstead: N Criteria: National Register: N Local: N Insufficient information to evaluate	
Date/Source: N/A	Condition: N/A	Integrity: N/A	
Materials Foundation: N/A Walls: Composition siding Roof: N/A	Architectural Style/Form: Not Available Description/Features: Frame house obscured; only one story gable addition is visible. Windows appear to be 2/2. Site is inaccessible and includes: house, granary, 2 barns, wind mill, pump house, shed, modern prefabricated shed, and several circular metal grain bins. Historic Notes:		
No. Stories: 2 Major Alterations:			
Historic Data Sources: Plats

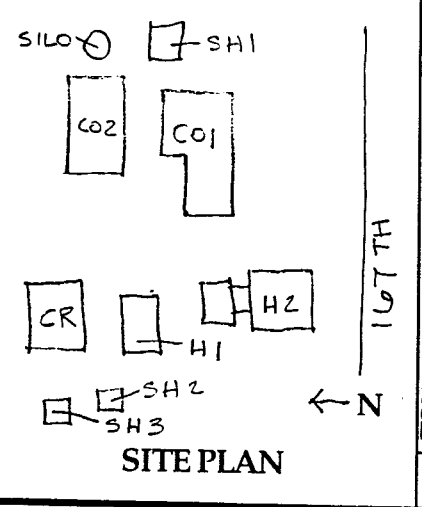
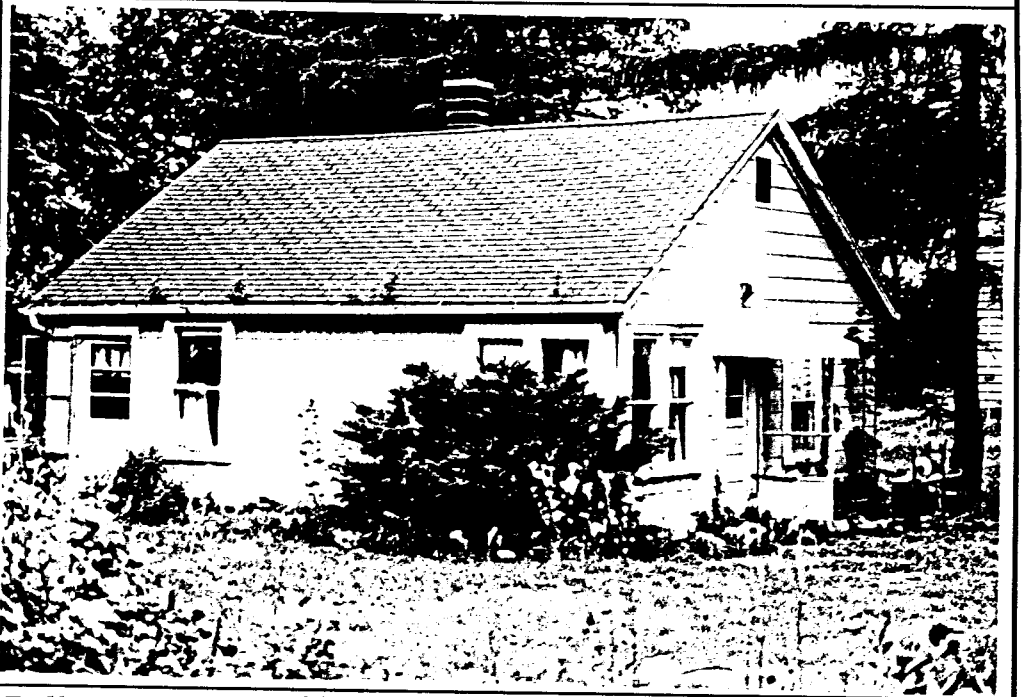
Roll No./Neg. No.: G/17 **Surveyed by:** JM/LS **Date:** 8/4/95

Date/Source: c.1900/Style, materials	Condition: Fair	Integrity: Medium
--	---------------------------	-----------------------------

Materials Foundation: N/A Walls: Composition siding Roof: Gable/ Asphalt shingle	Architectural Style/Form: Gable Front Description/Features: One story frame Gable Front house has paneled doors with 3 lights and 1/1 windows. Chimney is of concrete block.
No. Stories: 1 Major Alterations: Siding	Historic Notes:
