ORLAND RURAL HISTORY SURVEY

PREPARED FOR
THE VILLAGE OF ORLAND PARK

BY ANNE MCGUIRE & ASSOCIATES

DECEMBER, 1995

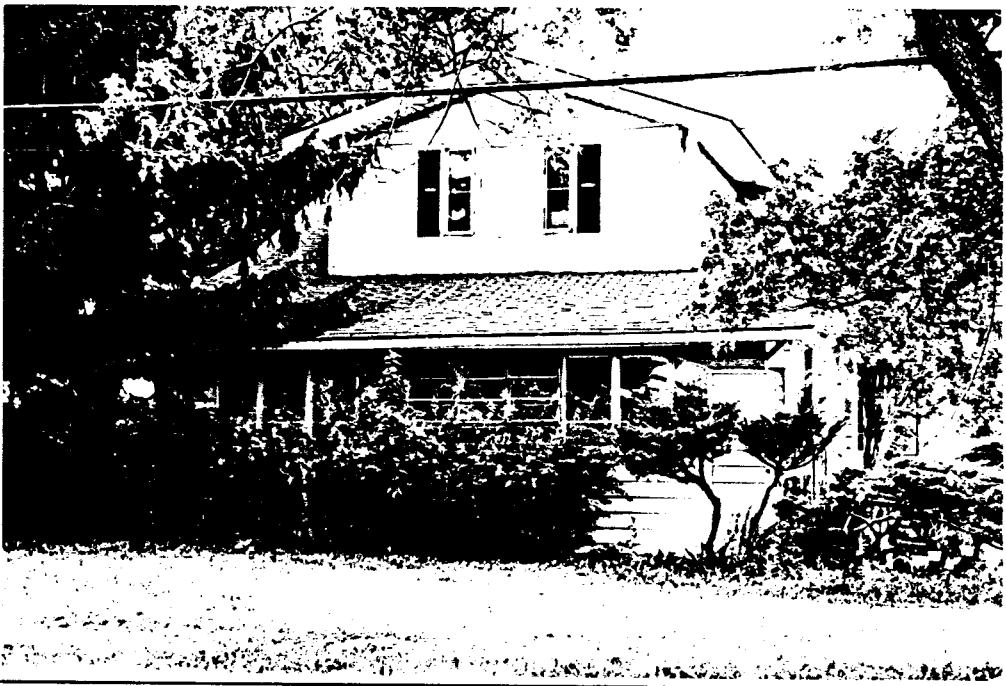
SITE PLAN	N		
Roll No./Neg. No.: G/16		Surveyed by: JM/LS	Date: 8/4/95

Address/Location: 11500 W. 167th Street, Orland Township		Tax Parcel No. 27-19-400-001	Map Key No. 32
Name/Owner Current: Gallagher & Henry Historic: Sayers	Structure: House (H2) Current Use/Historic Use: House/House Architect/Builder:	Landmark Evaluation Individual: N Farmstead: N Criteria: National Register: N Local: N	
Date/Source: c. 1925/Style	Condition: Fair	Integrity: Low	
Materials Foundation: Concrete block Walls: Aluminum siding Roof: Gable with dormer/ Asphalt shingle	Architectural Style/Form: Bungalow Description/Features: One and one-half story frame bungalow has been altered by the enclosure of the full width front porch, siding and some newer windows. Basic form is side gable with a wide, shallow front gable dormer above the porch.		
No. Stories: 1 + attic Major Alterations: Siding, porch enclosed	Historic Notes:		
Historic Data Sources: McAlester: <u>A Field Guide to American Houses</u>

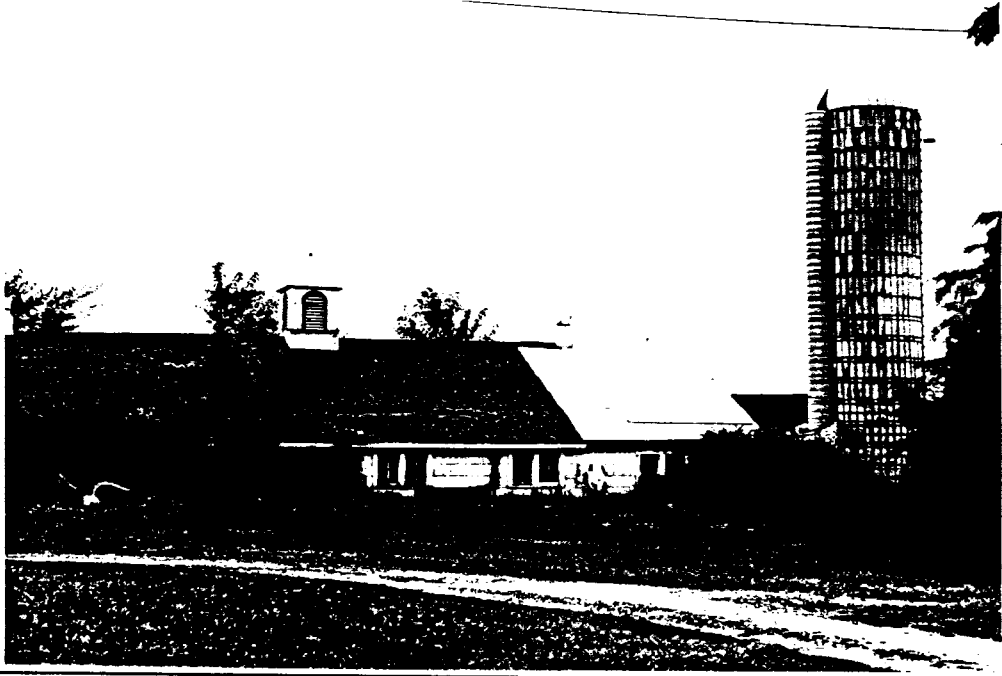
N			
SITE PLAN	Roll No./Neg. No.: G/15 Surveyed by: JM/LS Date: 8/4/95

Address/Location: 11500 W. 167th Street, Orland Township		Tax Parcel No. 27-19-400-001	Map Key No. 32
Name/Owner Current: Gallagher & Henry Historic: Sayers	Structure: Coop (CO1) Current Use/Historic Use: -/Coop Architect/Builder:	Landmark Evaluation Individual: N Farmstead: N Criteria: National Register: N Local: N	
Date/Source: 1880-86/Census, Plat	Condition: Fair	Integrity: High	
Materials Foundation: N/A Walls: Composition board Roof: Gable/ Asphalt shingle	Architectural Style/Form: Coop Description/Features: Long gable roofed coop has paired 4 light windows at each of six bays. On the roof ridge is a wood cupola and a later metal ventilator. While most of the coop roof is clad with asphalt shingle, some parts are clad in asphalt roll roofing. The gable roof at the East end of the North side is extended.		
No. Stories: 1 Major Alterations:	Historic Notes:		
Historic Data Sources: Plats, Agricultural Census data

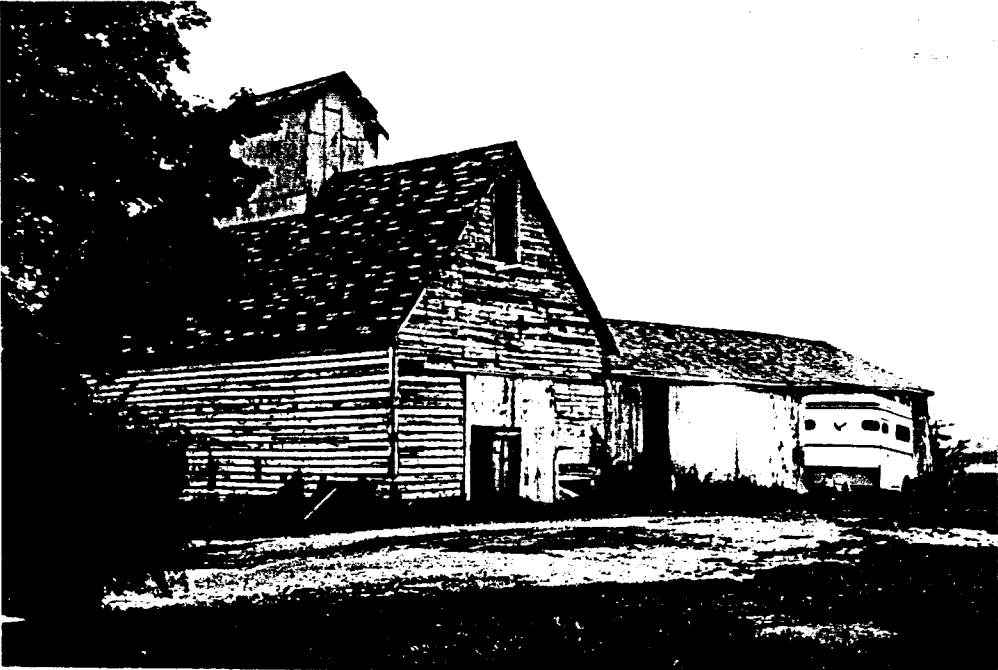
N			
SITE PLAN	Roll No./Neg. No.: G/18 Surveyed by: JM/LS Date: 8/4/95

Address/Location: 11500 W. 167th Street, Orland Township		Tax Parcel No. 27-19-400-001	Map Key No. 32
Name/Owner Current: Gallagher & Henry Historic: Sayers	Structure: Crib Current Use/Historic Use: -/Crib Architect/Builder:	Landmark Evaluation Individual: N Farmstead: N Criteria: National Register: N Local: N	
Date/Source: 1880-86/Census, Plat	Condition: Poor	Integrity: High	
Materials Foundation: N/A Walls: Horizontal boards Roof: Gable/ Asphalt shingle	Architectural Style/Form: Crib Description/Features: Gable roofed crib has spaced horizontal board siding on one side for storage of corn. Sliding doors are located at the gable end, one has a smaller service door cut into the sliding door. On the roof is an elevator. A one story gable roof shed addition extends from the North side of the crib.		
No. Stories: 1 + loft Major Alterations:	Historic Notes:		
Historic Data Sources: Plats, Agricultural Census data

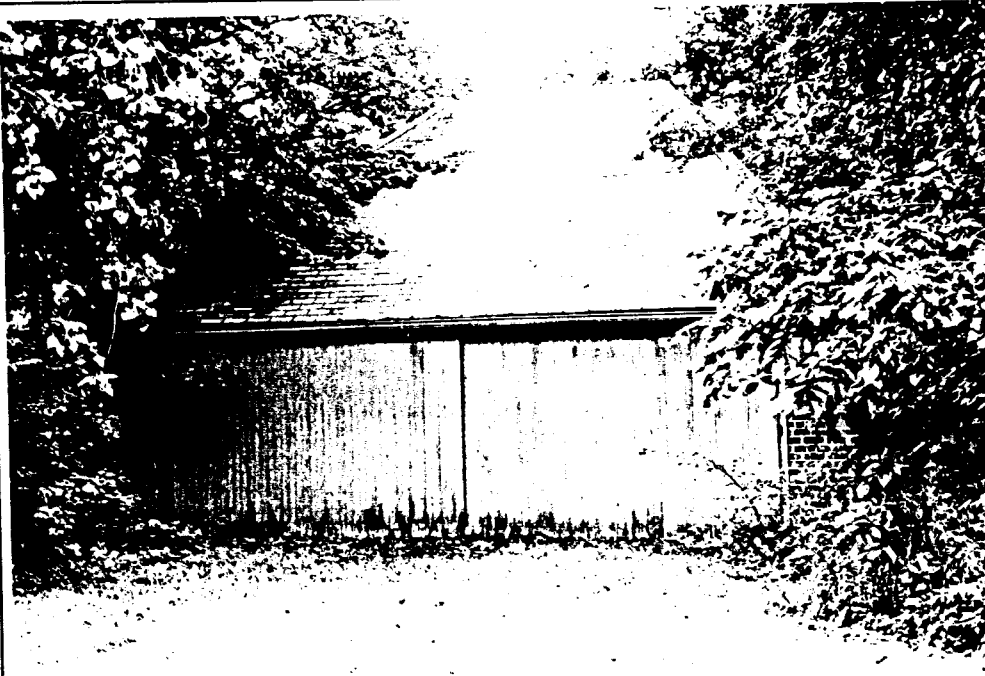
SITE PLAN			
N	Roll No./Neg. No.: G/23 Surveyed by: JM/LS Date: 8/4/95

Address/Location: E. side of Wolf Road, S. of 159th Street, Orland Township		Tax Parcel No. 27-20-100-005	Map Key No. 34
Name/Owner Current: Gallagher & Henry Historic: Jno. Sayers	Structure: Garage Current Use/Historic Use: Vacant/Garage Architect/Builder:	Landmark Evaluation Individual: N Farmstead: Y Criteria: 1, 3, 6 National Register: N Local: Y Development concept approved	
Date/Source: c.1925/Style, materials	Condition: Fair	Integrity: High	
Materials Foundation: N/A Walls: Brick Roof: Hip/ Asphalt shingle	Architectural Style/Form: Garage Description/Features: Two bay garage has vertical board overhead doors.		
No. Stories: 1 Major Alterations:	Historic Notes:		
Historic Data Sources:

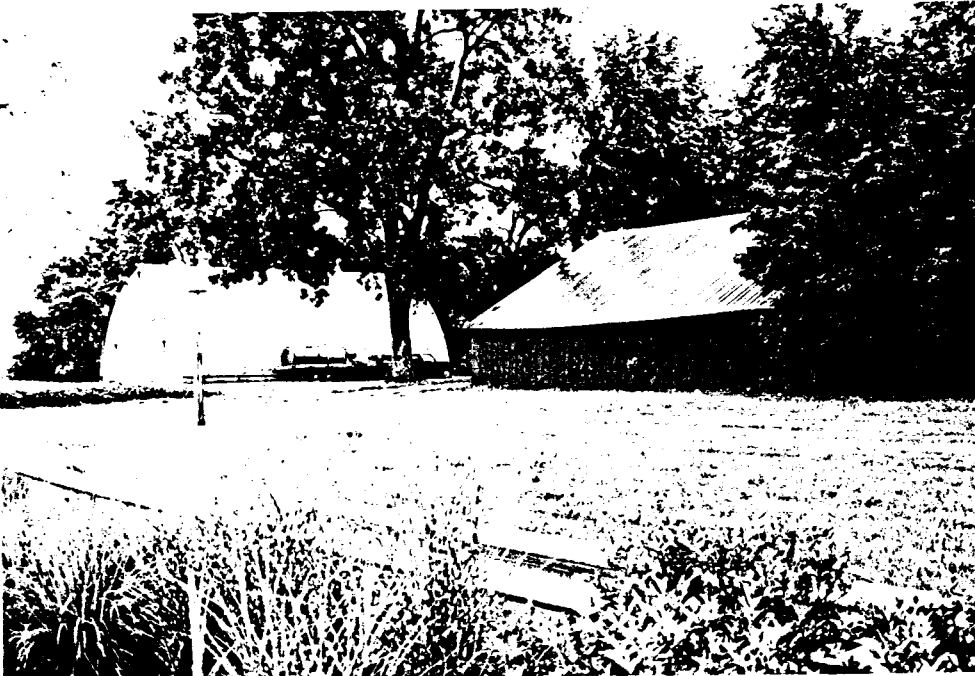
Address/Location: E. side of Wolf Road, S. of 159th Street, Orland Township		Tax Parcel No. 27-20-100-005	Map Key No. 34
Name/Owner Current: Gallagher & Henry Historic: Jno. Sayers	Structure: Bam (B1) Current Use/Historic Use: Bam/Bam Architect/Builder:	Landmark Evaluation Individual: N Farmstead: Y Criteria: 1, 3, 6 National Register: N Local: Y Development concept approved	
Date/Source: c.1920/ Noble	Condition: Good	Integrity: High	
Materials Foundation: Concrete Walls: Asphalt siding Roof: Gothic arch/ Asphalt shingle	Architectural Style/Form: Gothic Bam Description/Features: Gothic bam with arched roof extending to ground level foundation. Sliding vertical board doors at end walls. Small 4 light windows adjacent to doors.		
No. Stories: 1 + loft Major Alterations:	Historic Notes:		
Historic Data Sources: Noble: <u>Barns of the Midwest</u>

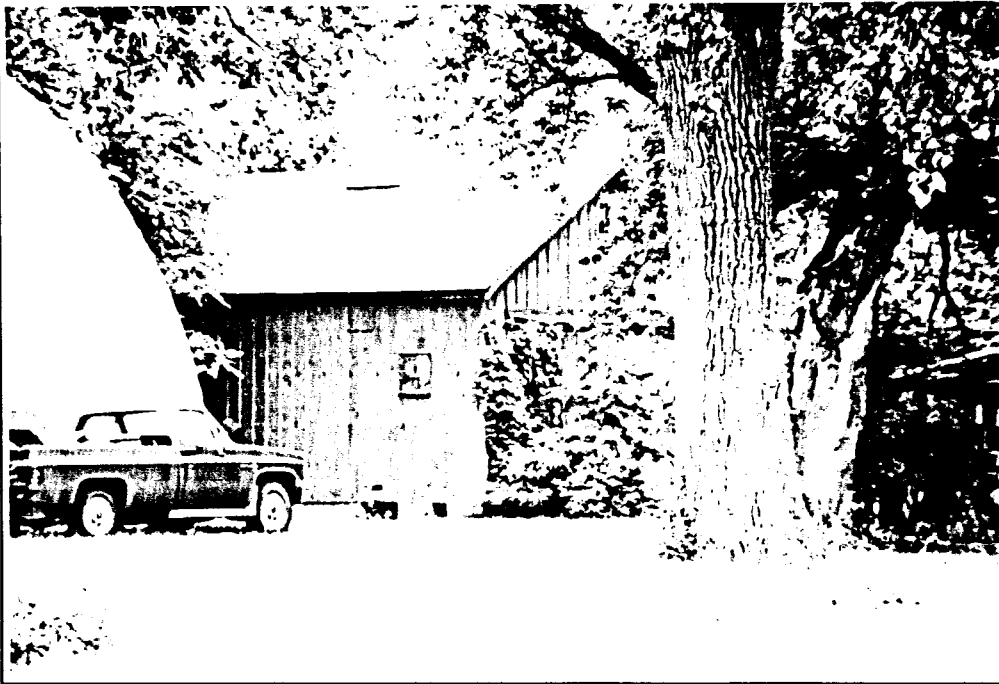
N			
SITE PLAN			
Roll No./Neg. No.: G/20		Surveyed by: JM/LS	Date: 8/4/95

Address/Location: E. side of Wolf Road, S. of 159th Street, Orland Township		Tax Parcel No. 27-20-100-005	Map Key No. 34
Name/Owner Current: Gallagher & Henry Historic: Jno. Sayers	Structure: Bam (B2) Current Use/Historic Use: Bam/Bam Architect/Builder:	Landmark Evaluation Individual: N Farmstead: Y Criteria: 1,3,6 National Register: N Local: Y Development concept approved	
Date/Source: c.1890/ Plats, Noble	Condition: Good	Integrity: High	
Materials Foundation: Concrete Walls: Vertical board & batten Roof: Gable/ Asphalt shingle	Architectural Style/Form: Gable Barn Description/Features: Gable barn has vertical board sliding doors at end wall. There is a small 4 light window in loft.		
No. Stories: 1 + loft Major Alterations:	Historic Notes:		
Historic Data Sources: Noble: <u>Barns of the Midwest</u> Plats

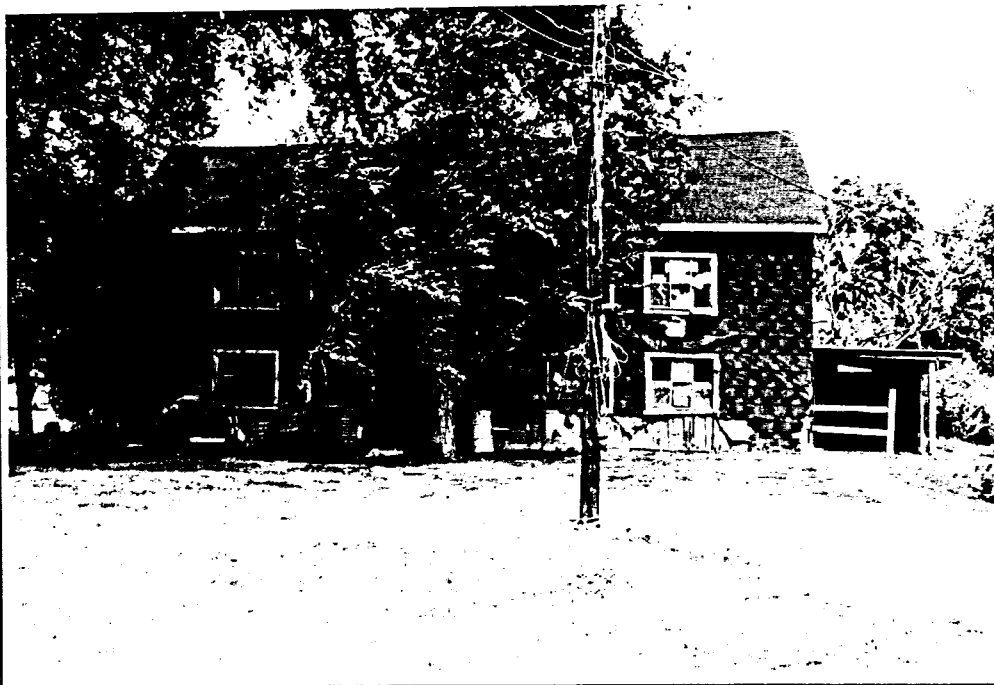
<p align="center">N</p> <p align="center">SITE PLAN</p>		Roll No./Neg. No.: H/10 Surveyed by: JM Date: 9/6/95

Address/Location: 10750 W. 167th Street, Orland Township		Tax Parcel No. 27-20-402-018	Map Key No. 36
Name/Owner Current: Ralph Morrissey Historic:	Structure: Bam Current Use/Historic Use: -/Bam Architect/Builder:	Landmark Evaluation Individual: N Farmstead: N Criteria: National Register: N Local: N	
Date/Source: c.1880/Style	Condition: Fair	Integrity: Medium	
Materials Foundation: N/A Walls: Asphalt siding Roof: Gable/ Asphalt shingle	Architectural Style/Form: Gable Bam Description/Features: Gable bam has two levels of large 6 light windows on the long (S) side. The asphalt siding on the bam walls is over vertical board siding. An open shed roofed addition is located on the Northeast corner.		
No. Stories: 2 + loft Major Alterations: One story shed roofed addition	Historic Notes:		
Historic Data Sources:

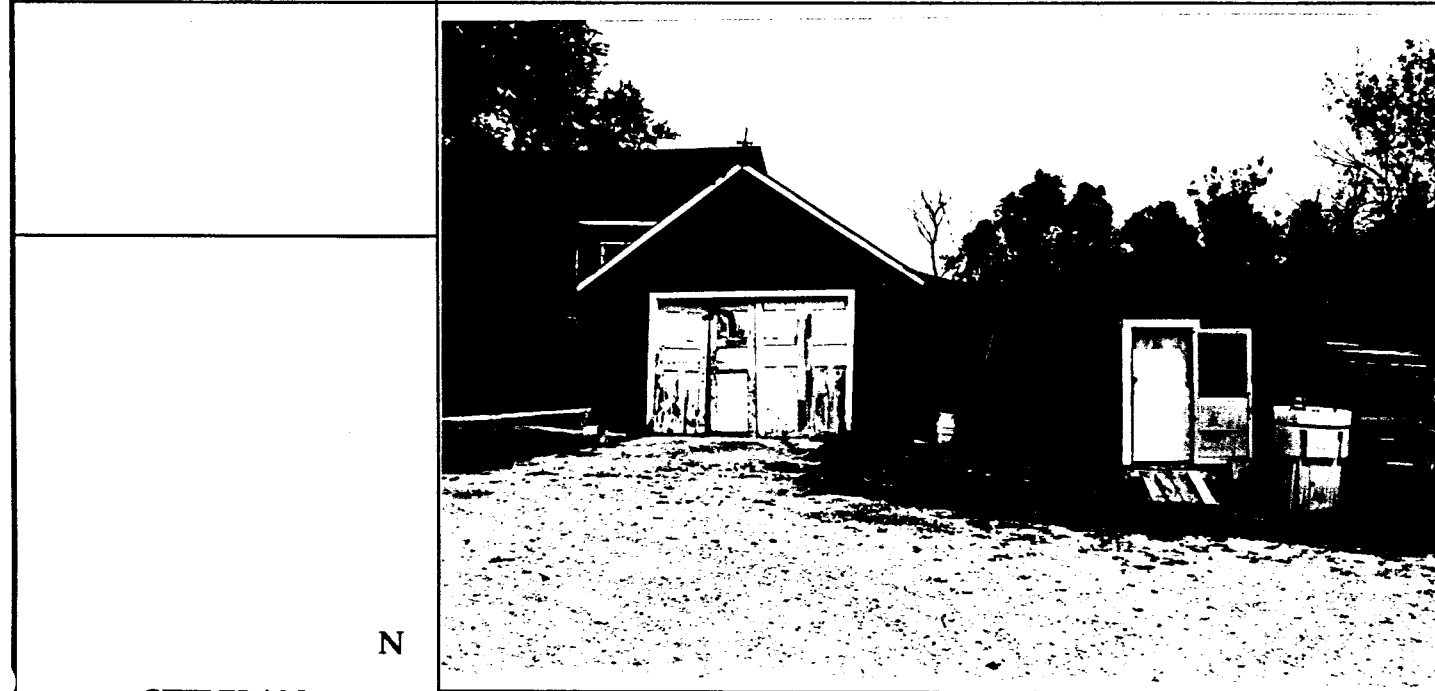
SITE PLAN	N	Roll No./Neg. No.: H/9	Surveyed by: JM	Date: 9/6/95
------------------	---	-------------------------------	------------------------	---------------------

Date/Source: c.1880/Style	Condition: Poor	Integrity: Low
-------------------------------------	---------------------------	--------------------------

Materials Foundation: N/A Walls: Asphalt siding Roof: Gable/ Asphalt shingle	Architectural Style/Form: Shed Description/Features: Gable shed has two pair of wood panel swing doors at the gable end (S). A gambrel roof shed addition with a door at the end (S) is connected to the gable roofed shed by an open shed at the roofs.
--	---

No. Stories: 1 Major Alterations: Sheds have added connecting link	Historic Notes:
--	------------------------

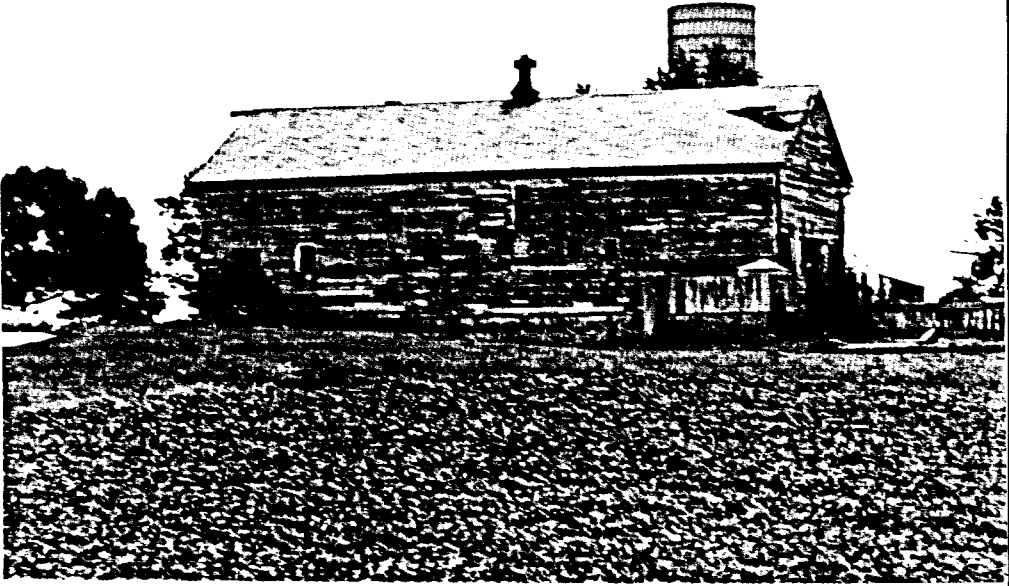
N	SITE PLAN		
	Roll No./Neg. No.: F/1	Surveyed by: JM/LS	Date: 8/4/95

Address/Location: 15901 S. 104th Avenue, Orland Township		Tax Parcel No. 27-21-100-001	Map Key No. 38
Name/Owner Current: Catholic Cemeteries Historic: W. Watson	Structure: Bam (B1) Current Use/Historic Use: Bam/Bam Architect/Builder:	Landmark Evaluation Individual: N Farmstead: Y Criteria: A, 1 National Register: Y Local: Y	
Date/Source: 1880-86/Census, Plat	Condition: Fair	Integrity: High	
Materials Foundation: N/A Walls: Horizontal board Roof: Gable/ Asphalt shingle	Architectural Style/Form: Gable Bam Description/Features: Gable bam has a metal ventilator at the ridge. Several small and varied window openings are located on the long sides. The doors are located at the gable end (S).		
No. Stories: 1 + loft Major Alterations:	Historic Notes:		
Historic Data Sources: Plats, Agricultural Census data

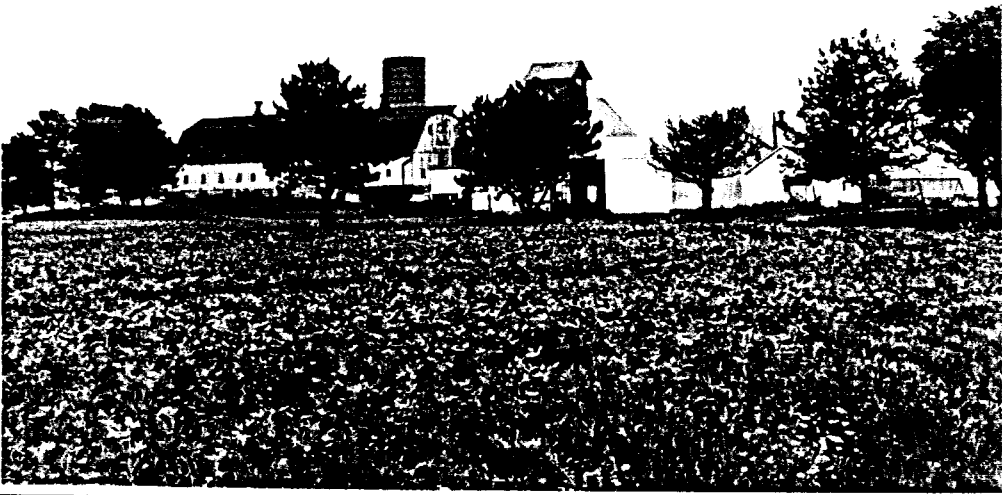
SITE PLAN	N	Roll No./Neg. No.: F/3 Surveyed by: JM/LS Date: 8/4/95

Address/Location: 15901 S. 104th Avenue, Orland Township		Tax Parcel No. 27-21-100-001	Map Key No. 38
Name/Owner Current: Catholic Cemeteries Historic: W. Watson	Structure: Bam (B2) Current Use/Historic Use: Bam/Bam Architect/Builder:	Landmark Evaluation Individual: N Farmstead: Y Criteria: A, 1 National Register: Y Local: Y	
Date/Source: c.1890/Noble	Condition: Fair	Integrity: High	
Materials Foundation: N/A Walls: Vertical board & batten Roof: Gambrel/ shingle	Architectural Style/Form: Gambrel Bam Description/Features: Gambrel bam which may be banked has a high foundation. The roof has metal ventilators at the ridge. Small regularly spaced windows and adjacent concrete silo, c. 1940, are typical of a dairy bam.		
No. Stories: 1 + loft Major Alterations:	Historic Notes:		
Historic Data Sources: Plats, Agricultural Census data

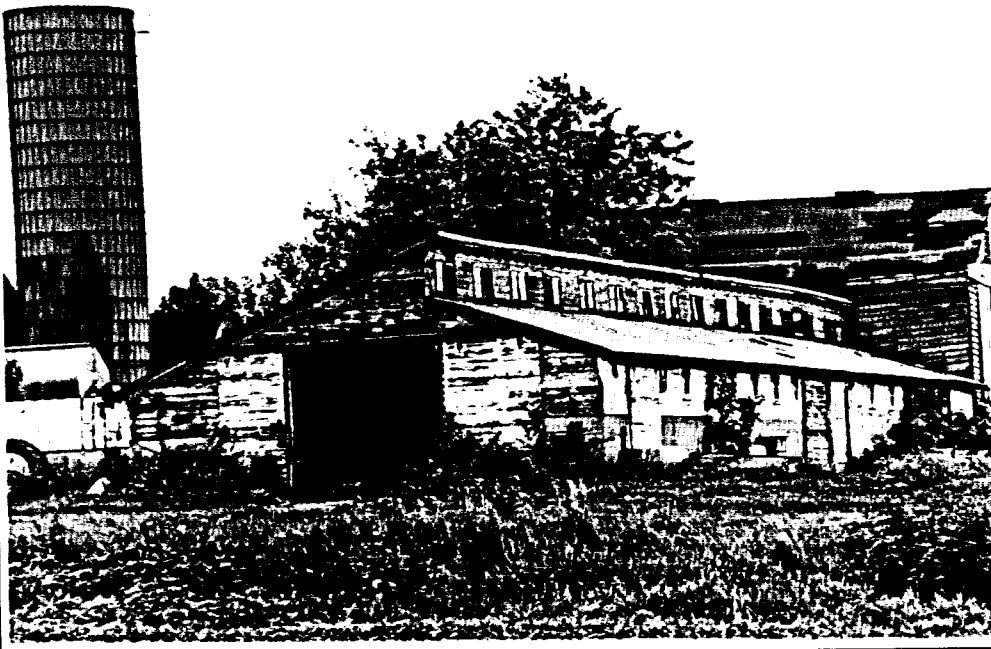
N	SITE PLAN		
Roll No./Neg. No.: F/0		Surveyed by: JM/LS	Date: 8/4/95

Address/Location: 15901 S. 104th Avenue, Orland Township		Tax Parcel No. 27-21-100-001	Map Key No. 38
Name/Owner Current: Catholic Cemeteries Historic: W. Watson	Structure: Coop and Crib Current Use/Historic Use: -/Coop and Crib Architect/Builder:	Landmark Evaluation Individual: N Farmstead: Y Criteria: A, 1 National Register: Y Local: Y	
Date/Source: c.1900/Coop, c.1880/Crib	Condition: Fair	Integrity: High	
Materials Foundation: Concrete Walls: Horizontal board Roof: Clerestory/ Asphalt shingle	Architectural Style/Form: Coop with attached Crib Description/Features: Large coop with clerestory roof had sliding doors at the short end (W). Made with a concrete foundation which extends up approximately 4 feet with horizontal board siding above. The coop has numerous small 4 light windows both at the top of each wall and at the clerestory. Attached to the coop is a gable roofed crib with spaced horizontal boards for corn storage. The crib is in poor condition with high integrity. Foundation of crib is unknown. Historic Notes:

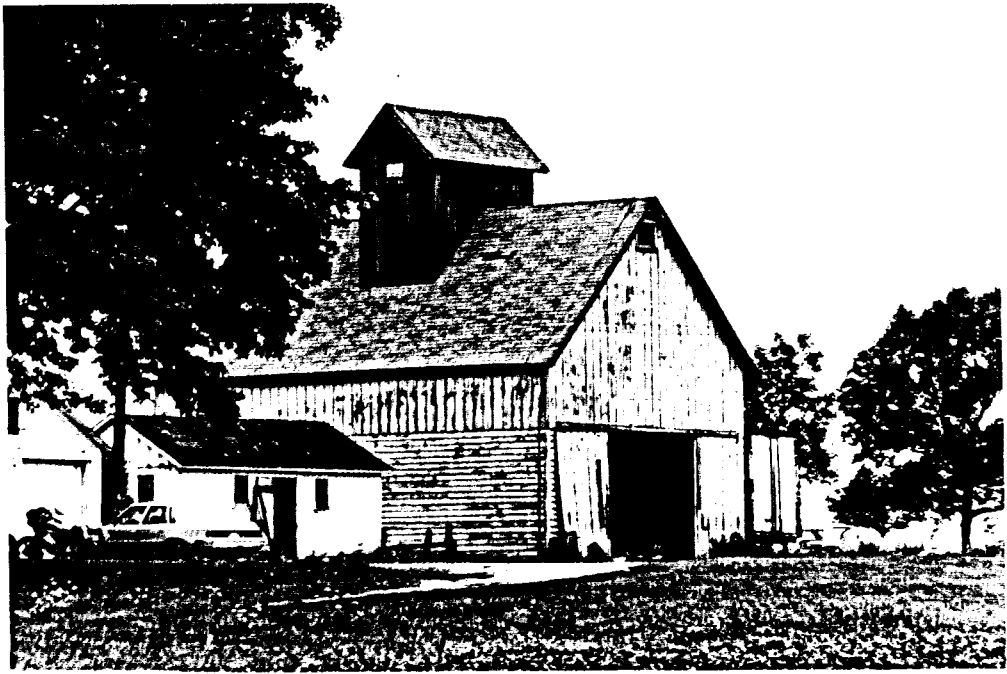
SITE PLAN	N		
Roll No./Neg. No.: E/24		Surveyed by: JM/LS	Date: 8/4/95

Address/Location: 15901 S. 104th Avenue, Orland Township		Tax Parcel No. 27-21-100-001	Map Key No. 38
Name/Owner Current: Catholic Cemeteries Historic: W. Watson	Structure: Granary Current Use/Historic Use: -/Granary Architect/Builder:	Landmark Evaluation Individual: N Farmstead: Y Criteria: A, 1 National Register: Y Local: Y	
Date/Source: 1880-86/Plats, Census	Condition: Fair	Integrity: High	
Materials Foundation: N/A Walls: Board & batten, horiz. bds. Roof: Gable/ Asphalt shingle	Architectural Style/Form: Granary Description/Features: Granary is of wood vertical board & batten siding except on the side (W) which has spaced horizontal boards for corn storage. The roof has a wooden elevator with gable roof. Gable end (S) sliding doors are also of board & batten. A small 6 light window is located high in the gable end.		
No. Stories: 1 Major Alterations:	Historic Notes:		
Historic Data Sources: Plats, Agricultural Census data

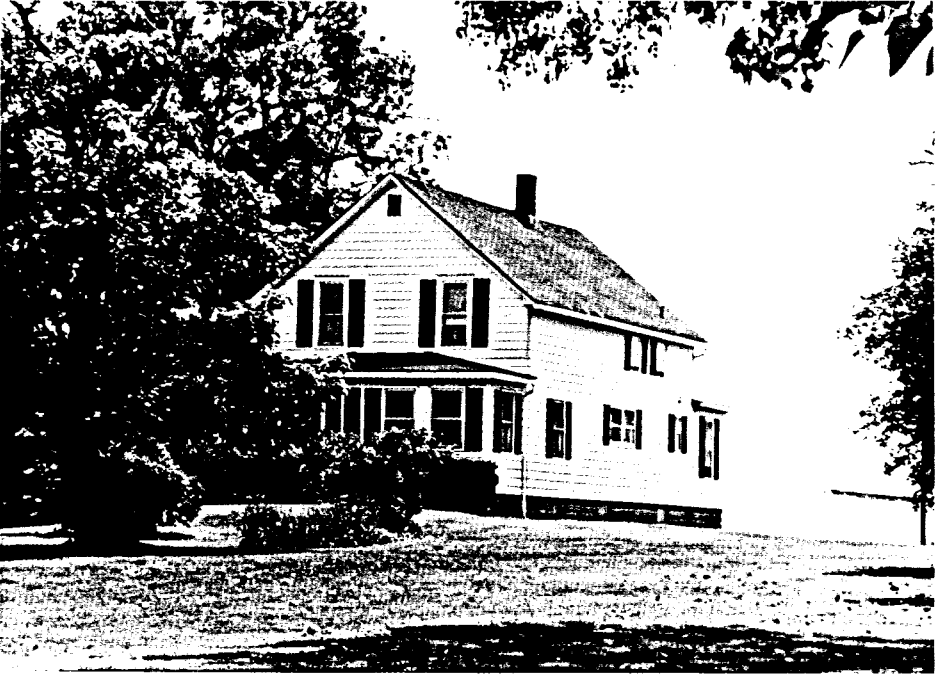
<p align="center">SITE PLAN</p>	Roll No./Neg. No.: B/1 Surveyed by: JM/AM Date: 8/3/95

Address/Location: 11601 W. 167th Street, Orland Township		Tax Parcel No. 27-30-1101-001	Map Key No. 43
Name/Owner Current: Gallagher & Henry Historic: Fred Hope Inman/ 1886 Plat	Structure: House Current Use/Historic Use: House/House Architect/Builder:	Landmark Evaluation Individual: N Farmstead: Y Criteria: 1,6 National Register: N Local: Y Development concept approved	
Date/Source: c.1900/Plat, Style	Condition: Good	Integrity: High	
Materials Foundation: Concrete block Walls: Synthetic siding Roof: Gable/ Asphalt shingle	Architectural Style/Form: Gable Front Description/Features: One and one-half story frame Gable Front house with enclosed front porch and one story rear (S) addition. On side (W) there is a 2 story, one bay projection with gable roof. Windows are 1/1. Also on site are: 3 barns, 1 is post-1945, another has milk house and silo, a shed, and 6 circular grain bins.		
No. Stories: 1-1/2 Major Alterations: Rear 1 sty enclosed addn., Porch enclosed, siding,	Historic Notes: Plats and Agricultural Census data indicate there has been a farm on this site since 1870. Ownership changed between 1870 (J. Simpson) and 1886 (F. Inman) and between 1886 and 1890 (H. A. Anderson). Existing historic buildings on the farmstead appear to date 1880-1930. Agricultural census of 1880 indicates corn, oats and apple orchard.

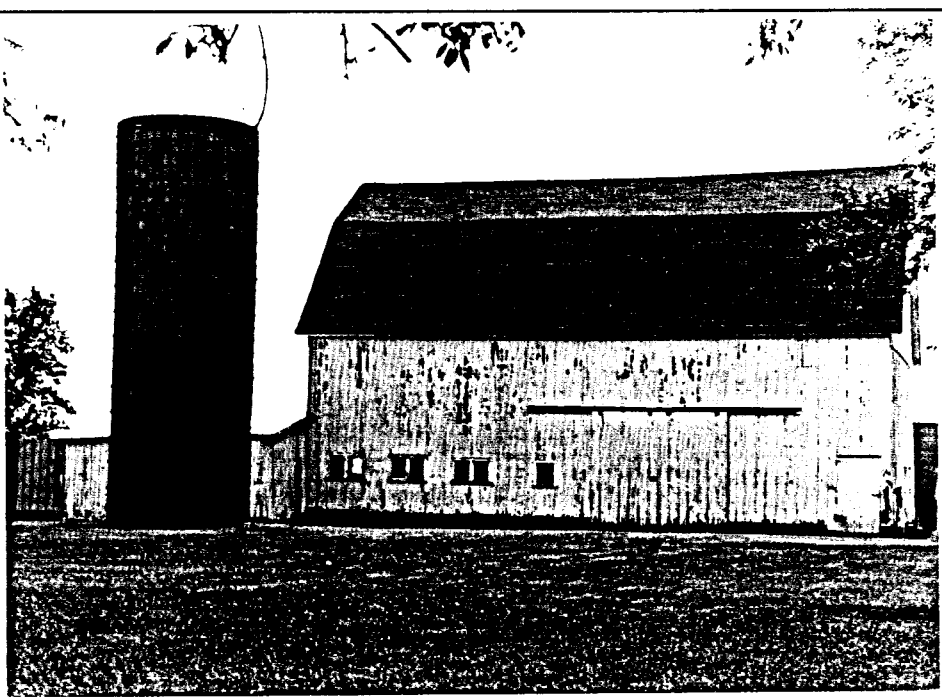
SITE PLAN	N		
Roll No./Neg. No.: B/3		Surveyed by: JM/AM	Date: 8/3/95

Address/Location: 11601 W. 167th Street, Orland Township		Tax Parcel No. 27-30-1101-001	Map Key No. 43
Name/Owner Current: Gallagher & Henry Historic: Fred Hope Inman/ 1886 Plat	Structure: Bam (B1) Current Use/Historic Use: Bam/Bam Architect/Builder:	Landmark Evaluation Individual: N Farmstead: Y Criteria: 1,3,6 National Register: N Local: Y Development concept approved	
Date/Source: c.1886/Plat. Noble	Condition: Good	Integrity: High	
Materials Foundation: N/A Walls: Vertical board Roof: Gambrel/ Asphalt shingle	Architectural Style/Form: Gambrel Bam Description/Features: Gambrel bam has paired sliding doors on the side (N) and several small 4 light windows. The siding is of painted wood board and batten. An historic 1 story attached milk house of vertical board and batten siding with metal clad gable roof is located at the NE corner of the bam. A concrete, metal stave silo, c. 1940, is next to the milk house.

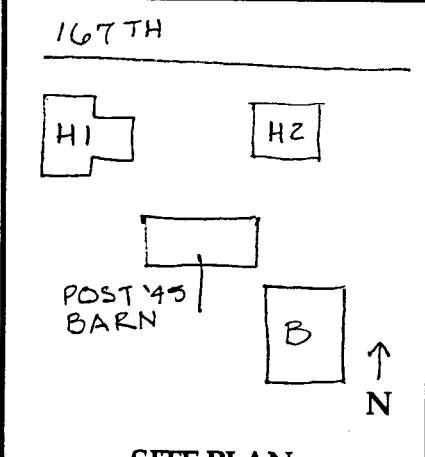
Roll No./Neg. No.: G/13 **Surveyed by:** JM/LS **Date:** 8/4/95

Date/Source: c.1880/Census,Plats	Condition: Poor	Integrity: Medium
--	---------------------------	-----------------------------

Materials Foundation: N/A Walls: Board & batten, clapbd. Roof: Gable with gable/ Asphalt shingle	Architectural Style/Form: Upright-and-Wing Description/Features: Severely deteriorated Upright-and-Wing. Vertical board and batten siding on upper and horizontal clapboard siding on lower walls. Also on site is a second house and 2 barns, one of which is post-1945.
No. Stories: 1 + attic Major Alterations: windows	Historic Notes: This one of two houses on the site. This obscured house could date to owner, Charles Graper, who is indicated on Agricultural Census of 1880 and Plat of 1886.
Historic Data Sources: Plats

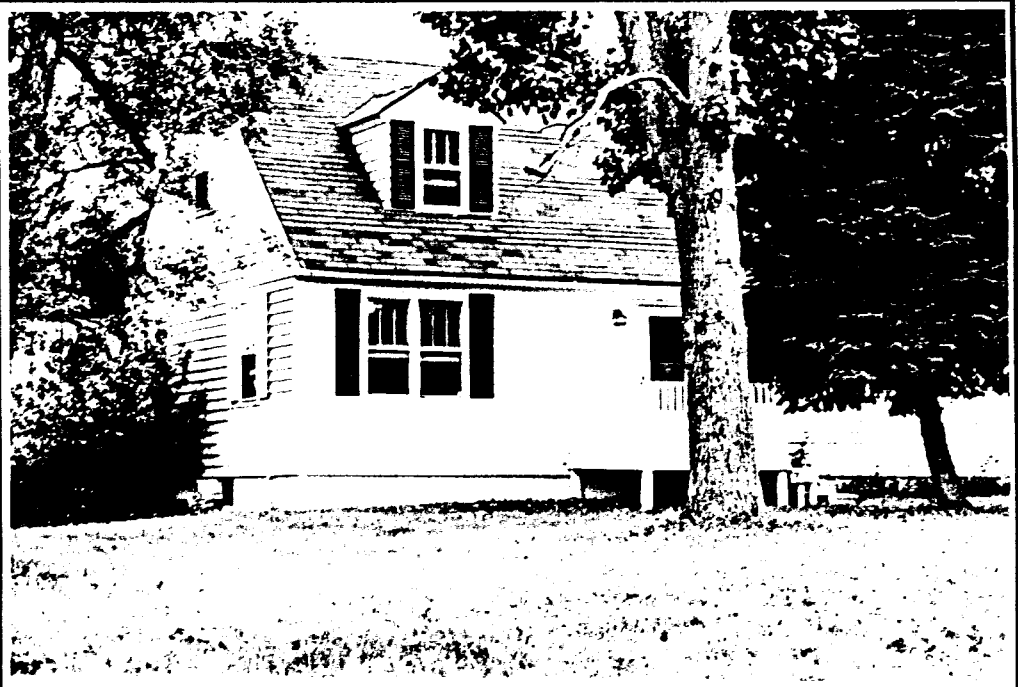
Date/Source: c.1880/Census,Plats	Condition: Good	Integrity: High
--	---------------------------	---------------------------

Materials Foundation: Concrete block Walls: Aluminum siding Roof: Gable/ Asphalt shingle	Architectural Style/Form: Colonial Revival Description/Features: Side gable, one story with attic, frame house in Colonial Revival style. Windows are 3/1, Craftsman style configuration. Two dormers are on the front facade (N).
No. Stories: 1 + attic Major Alterations: Entrance deck, siding, shutters	Historic Notes: This is one of two houses on this site. The older house (H1) dates to the Historic Name/Owner, Charles Graper. Refer to survey form for House (H1).
Historic Data Sources: Plats, McAlester: <u>Field</u> <u>Guide to American Houses</u>

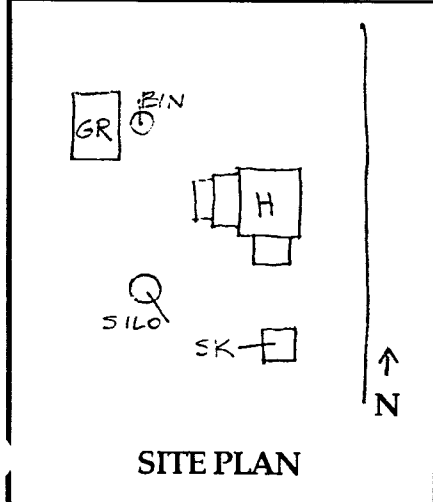
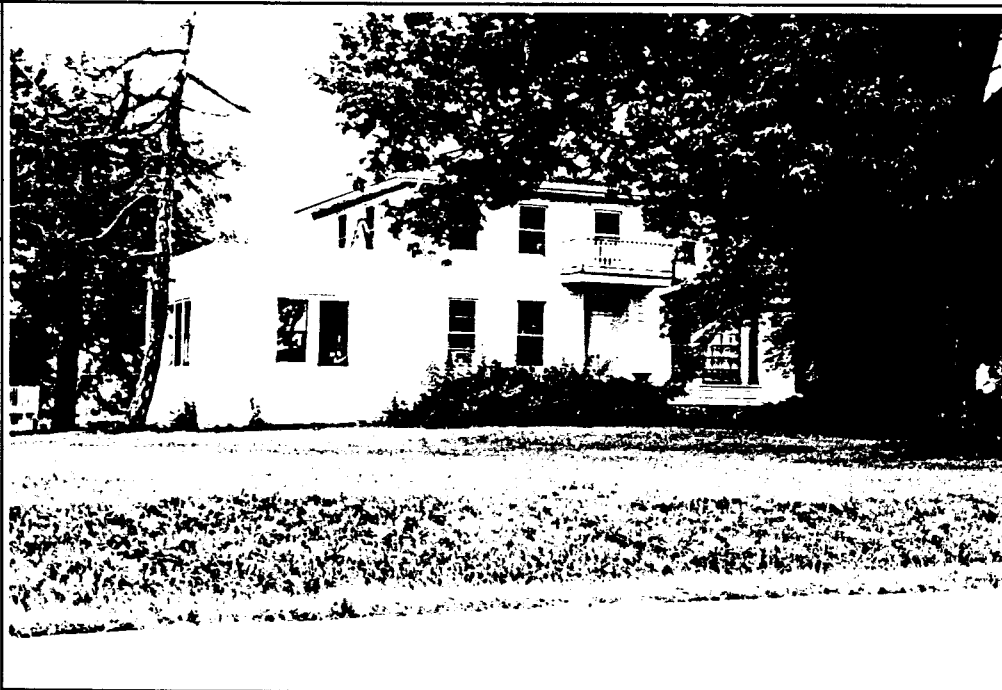
Roll No./Neg. No.: G/7 **Surveyed by:** JM/LS **Date:** 8/4/95

Date/Source: 1851-61/Plats	Condition: Good	Integrity: Medium
--	-------------------------------	---------------------------------

Materials
Foundation: Concrete block
Walls: Synthetic siding
Roof: Hip/
Asphalt shingle

No. Stories: 2
Major Alterations:
1 sty. add'n to South
siding, foundation

Architectural Style/Form: Four-over-Four
Description/Features:
Two story Four-over-Four has hipped roof, 6/6 double-hung windows and front entrance with transom light. The house has center entrance with bay window on the front (N) side. The wood balcony over the front entrance may be historic. A one story later addition is located on the side (S). Two additions are located on the rear (W). Also on site is a granary/crib, a summer kitchen, a silo (c.1950 "Harvestore"), and circular metal grain bins.
Historic Notes:
According to the 1860 Agricultural census, Allerton had 500 acres improved and 454 acres unimproved. This was by far the largest farm in the township at that time. Census records wheat, corn, oats, dairy cows, cattle, horses, and swine in 1860 and 1880. Plat of 1861 indicates property developed along what is now 183rd St. This house appears by form and style to date to the early period of the farmstead.

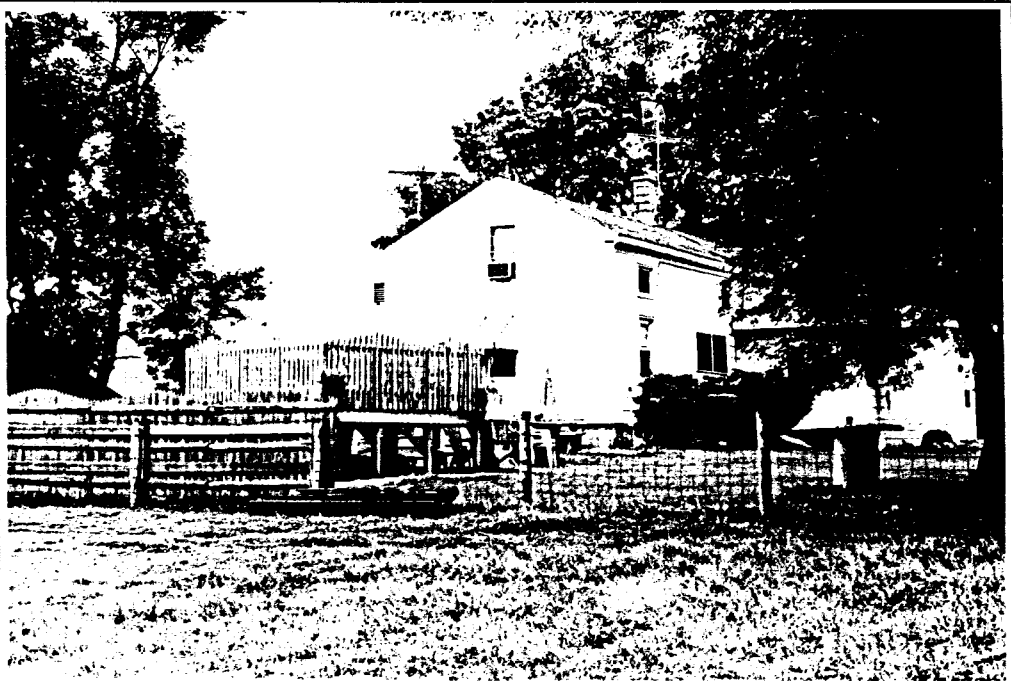
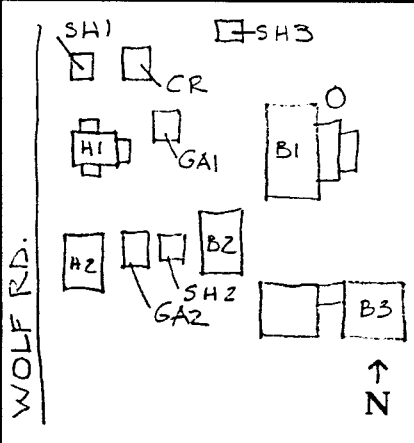
Roll No./Neg. No.: G/5 **Surveyed by:** JM/LS **Date:** 8/5/95

Address/Location: 17901 S. Wolf Road, Orland Township		Tax Parcel No. 27-32-300-001	Map Key No. 46
Name/Owner Current: Richard Erickson Historic: L. L. Chamberlin	Structure: House (H1) Current Use/Historic Use: House/House Architect/Builder:	Landmark Evaluation Individual: N Farmstead: Y Criteria: 1 National Register: N Local: Y	
Date/Source: 1851-61/Plats	Condition: Good	Integrity: Low, moved	
Materials Foundation: Concrete block Walls: Aluminum siding Roof: Gable/ Asphalt shingle	Architectural Style/Form: New England 1-1/2 Description/Features: Frame Side Gable house has Greek Revival style elements: small windows at the frieze band area and cornice returns. Windows are 1/1. A 1 story extended gable addition is on the rear (N), a 1 story gable addition is on the front (S), and another addition on the side (E). Site now has a large complex of buildings: 2 houses, 2 garages, 3 barns, some with shed additions, 1 with a silo, 3 sheds, 1 crib, 1 pen, several circular metal grain bins and additional pens. Historic Notes: According to owner, House (H1) was originally on the Allerton farm and was bought and moved across Wolf Road in 1925. Plat of 1861 and Census of 1850 indicates 80 acres farmed by Lewis Chamberlin. Owner indicates farm was once a buffalo plantation.

No. Stories: 1 + attic Major Alterations: Moved, additions, siding, windows	Historic Data Sources: Plats, Agricultural Census data, Owner

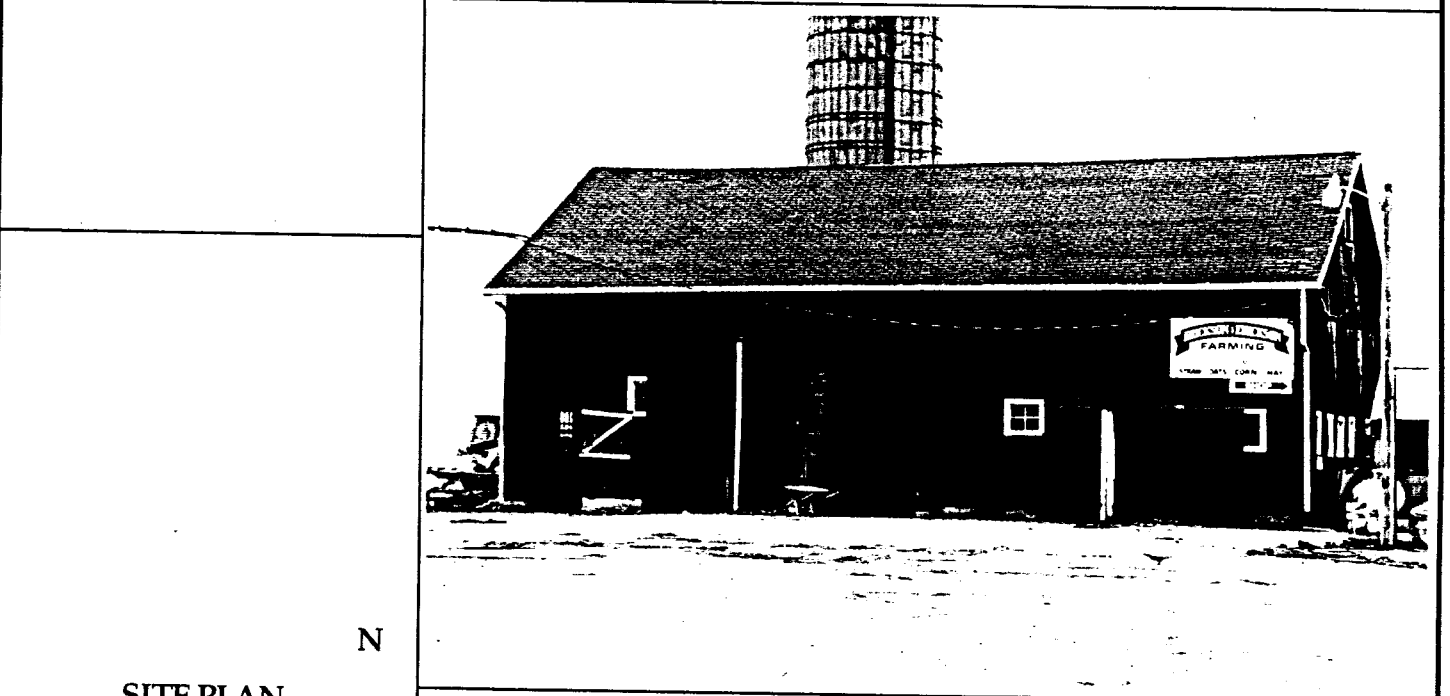
Roll No./Neg. No.: G/6 **Surveyed by:** JM/LS **Date:** 8/5/95

Date/Source: c.1890/Style, materials	Condition: Good	Integrity: High
--	---------------------------	---------------------------

Materials Foundation: Concrete Walls: Vertical board & batten Roof: Gable/ Asphalt shingle	Architectural Style/Form: Gable Bam Description/Features: Gable bam has sliding doors on the long (W) side and small 4 light windows. On the long (E) side there is a gable 1 story addition with metal roof. On the East side of this addition is a shed addition with vertical siding and asphalt shingles. Also on the East is a concrete & metal stave silo, c. 1940. On the end (S) of the barn is a 1 story shed roofed addition, perhaps a milk house, with concrete block foundation. Historic Notes:
No. Stories: 1 + loft Major Alterations:	
Historic Data Sources: Plats, Noble: <u>Barns of the Midwest</u>

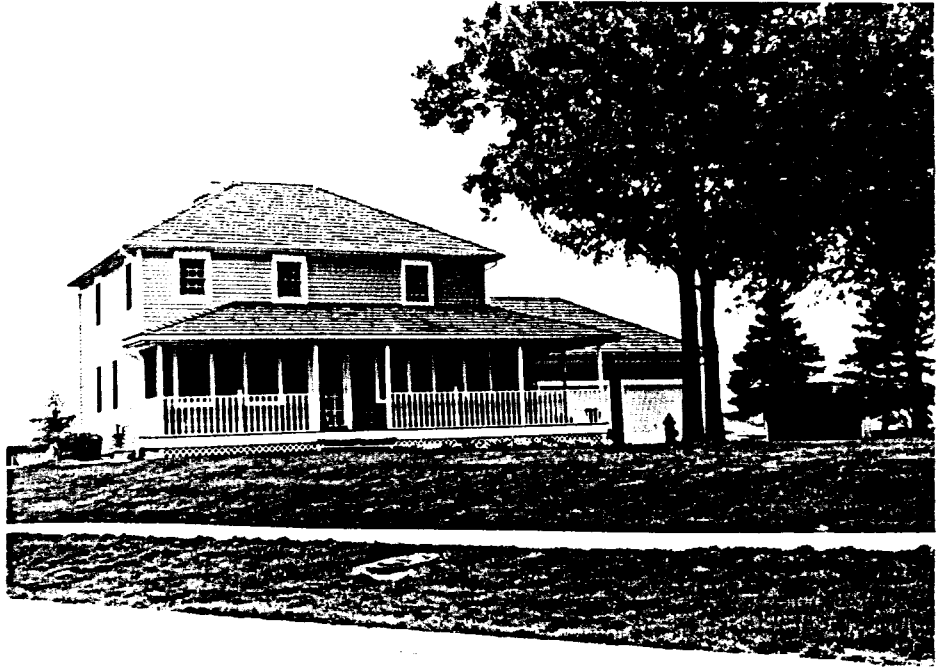
Address/Location: 10812 W.Andrea Dr., Orland Township		Tax Parcel No. 27-32-301-005	Map Key No. 47
Name/Owner Current: Wayne & Marilyn Jurgovan Historic: Francis Maue	Structure: House Current Use/Historic Use: House/House Architect/Builder:	Landmark Evaluation Individual: Y Farmstead: N Criteria: 1 National Register: N Local: Y Designated local landmark	
Date/Source: c.1860/Style, Maue history	Condition: Excellent	Integrity: Low	
Materials Foundation: Concrete Walls: Clapboard Roof: flat topped hip/ wood shakes	Architectural Style/Form: Four-over-Four Description/Features: Frame two story Four-over-Four house has a frame gable roofed two car garage addition on the side (E). A post-1945 one story porch spans the full front and wraps around the side (E) to the garage. Porch has square posts and new turned balusters. The roof modern shakes and the 6/6 windows are post-1945. House form and thick window frames are historic.

No. Stories: 2 Major Alterations: 2 car garage, windows porch, siding, roofing	Historic Notes: Maue is not listed on Agricultural Census records.		
Historic Data Sources: Plats, Old Orland Fndn: Brief History of Maue Farm

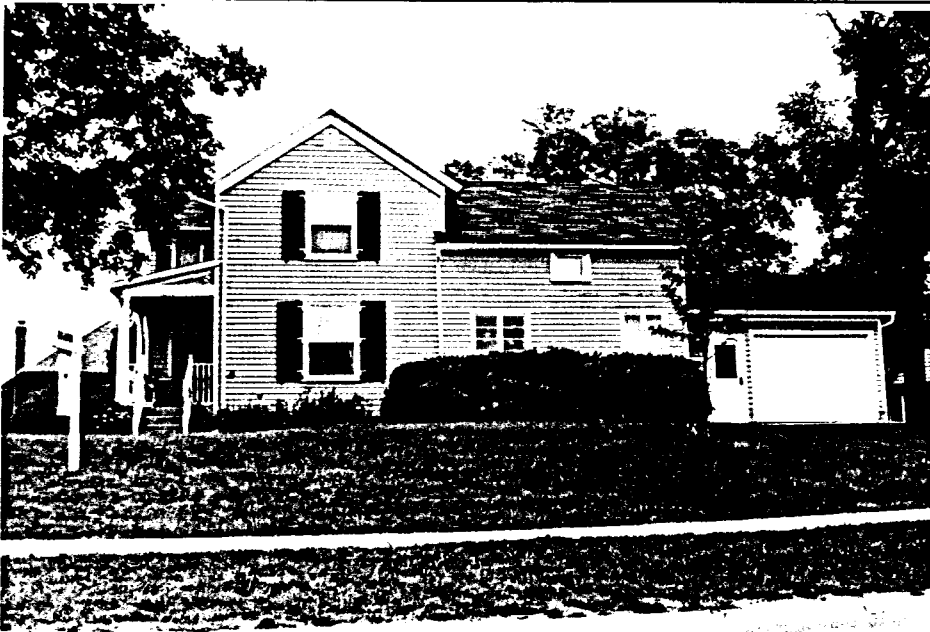
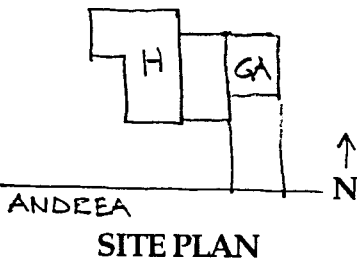
Roll No./Neg. No.: K/3 **Surveyed by:** AM/JM **Date:** 9/20/95

Date/Source: c.1886/Plat, style	Condition: Excellent	Integrity: Medium
---	--------------------------------	-----------------------------

Materials Foundation: Concrete Walls: Clapboard Roof: Gabled "L"/ Asphalt shingle	Architectural Style/Form: Gabled Ell Description/Features: Frame one and one-half story Gabled Ell has a post-1945 one story gable frame addition on the side (E). Attached to this addition is a post-1945 gable garage Addition. The historic "ell" house has a modern, picture window added to the front (S) side. The one story porch within the "ell" on the (W) side has round wood columns with balusters that are modern. Two entrance doors are off the porch: one to the North and one to the East. Restored c.1990. Historic Notes: Maue not listed on Agricultural Census records.
No. Stories: 1-1/2 Major Alterations: 1 story addition, garage addition, picture window	
Historic Data Sources: Plats, Old Orland Fndn: Brief History of Maue Farm

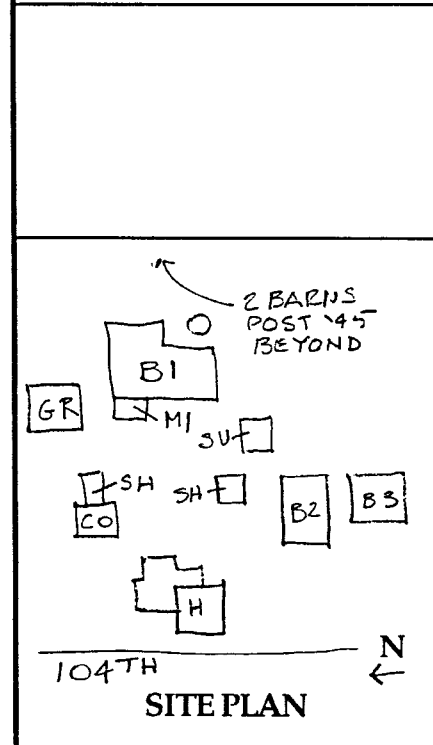
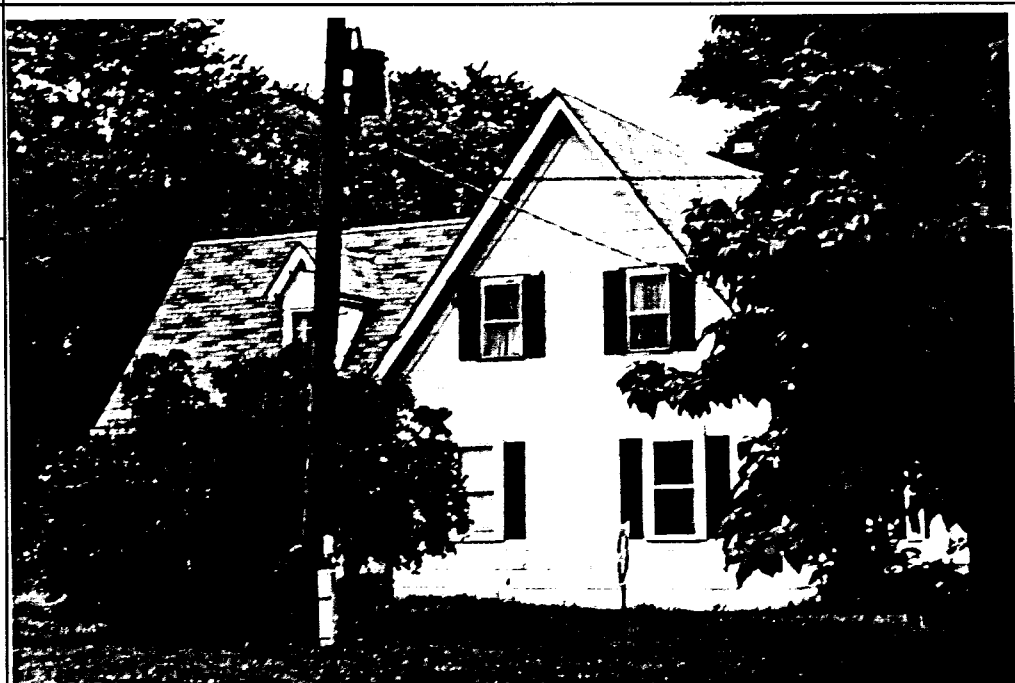
Roll No./Neg. No.: F/12 **Surveyed by:** JM/LS **Date:** 8/4/95

Date/Source: 1861/Plat, pre-1854/Owner	Condition: Fair	Integrity: High
--	---------------------------	---------------------------

Materials Foundation: Stone Walls: Composition siding Roof: Gable with gable wing/ Asphalt shingle	Architectural Style/Form: Side Gable with rear wing Description/Features: This one and one-half story frame Side Gable cottage has a one story rear (N) wing and two additions on the side (E). Gable roofs of house and wing are steeply pitched with dormer(s) on rear wing roof. Windows are 1/1, shutters have been added. Site includes: house, 5 barns, 2 of which are post-1945, a shed, a summer kitchen, a coop with shed addition, a granary, and circular metal grain bins. Historic Notes: Owner indicates property was owned by her grandfather, Knudson, since 1854; and a main part of the house (S) predates 1854 purchase with addition, c.1900. Census indicates farm used for dairy farming and grain. Chs. Knudson is owner recorded on 1861 Plat.
No. Stories: 1 + attic Major Alterations: Siding, shutters, windows replaced
