ORLAND RURAL HISTORY SURVEY

PREPARED FOR
THE VILLAGE OF ORLAND PARK

BY ANNE MCGUIRE & ASSOCIATES

DECEMBER, 1995

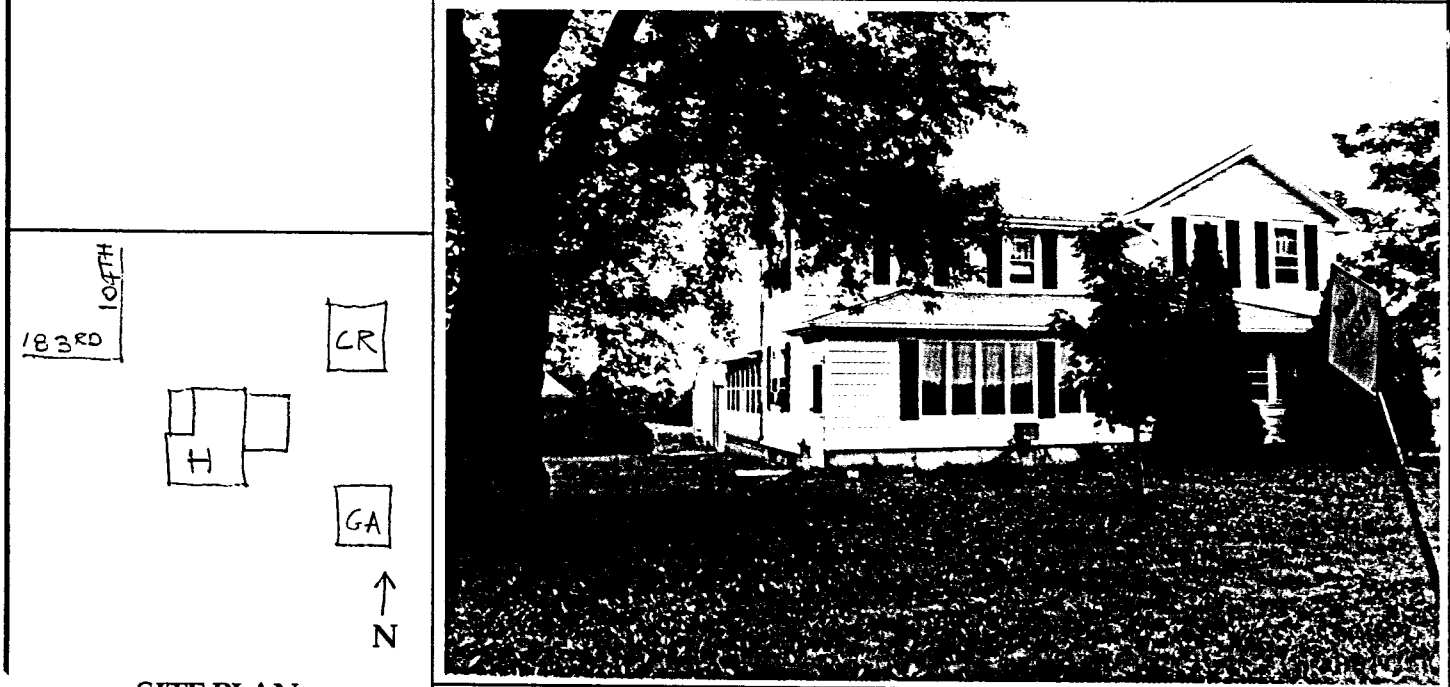
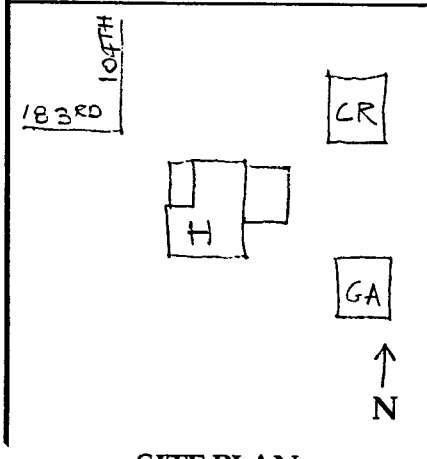
Roll No./Neg. No.: F/21 **Surveyed by:** JM/LS **Date:** 8/4/95

Date/Source: c.1920	Condition: Good	Integrity: Low
-------------------------------	---------------------------	--------------------------

Materials Foundation: Concrete block Walls: Aluminum siding Roof: Gable with Gable/ Asphalt shingle	Architectural Style/Form: Gabled Ell Description/Features: Altered frame Gabled Ell has a 1 story front (W) enclosed porch which extends the across the full front facade. A rear (E) gable wing extends from the Gabled Ell and has a side (N) enclosed porch. The windows are Craftsman style 4/1. The site also includes: garage, crib and post-1945 barn.
---	---

No. Stories: 2 Major Alterations: Front & rear porch enclosures	Historic Notes:
---	------------------------

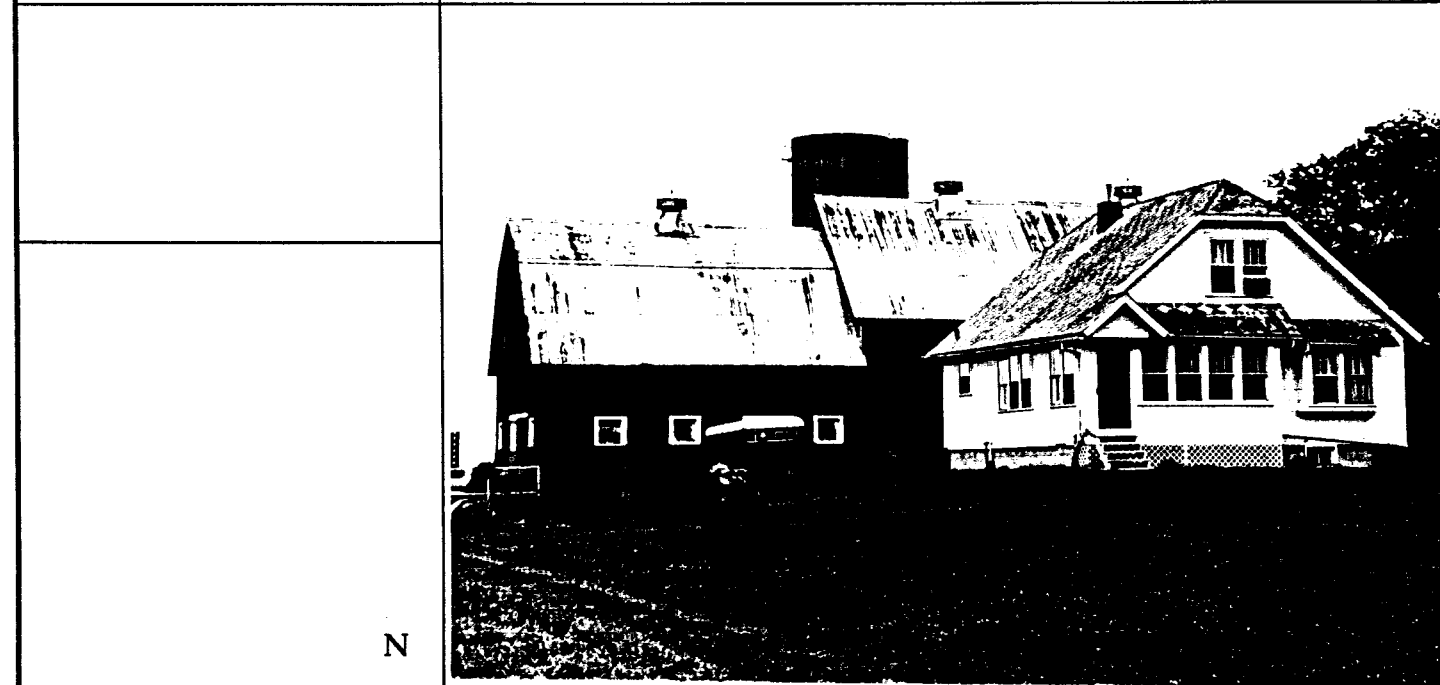
Date/Source: c.1880,c.1900 add'n/Noble	Condition: Good	Integrity: High
--	---------------------------	---------------------------

Materials Foundation: Concrete block Walls: Sheet metal siding Roof: Gable with Gambrel/ Sheet metal	Architectural Style/Form: Gable Bam with Gambrel Bam Addition Description/Features: Gable bam has three metal roof ventilators. A gambrel bam,c. 1900, has been added at the gable end just below the roof line. Both bam and addition have small multiple light windows. The gambrel addition is entered at the end (W). There is a concrete & metal stave silo, c.1940, on the side (S) and gable roofed 1 story milk house clad in panels on the side at the SE corner of the Gable Bam. There is a roofed entrance to the Gable Bam on the North side. Historic Notes:
No. Stories: 1 + loft Major Alterations: Siding

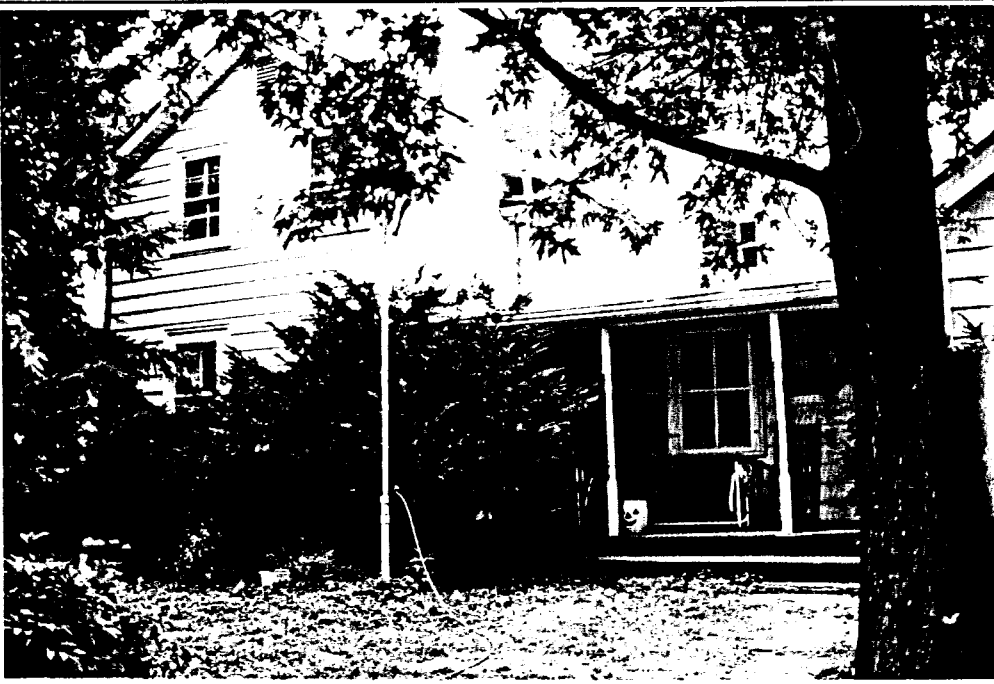
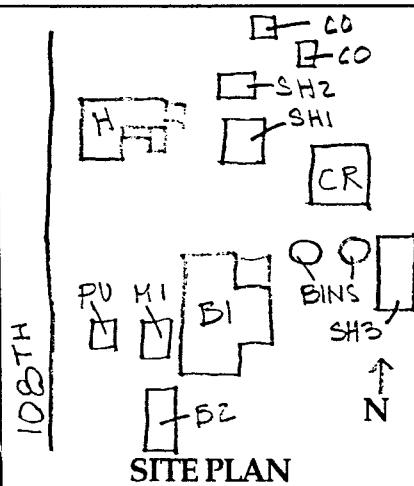
Date/Source: 1861/Plat	Condition: Good	Integrity: High
----------------------------------	---------------------------	---------------------------

Materials Foundation: Concrete Walls: Aluminum siding Roof: Gable with gable/ Asphalt shingle	Architectural Style/Form: Upright-and-Wing Description/Features: Frame Upright-and-Wing has 2 historic one story frame gable additions: 1 on the side (S), 1 on the rear (E). A porch is on the side (S). The house has a center front door on the West with a pedimented entry roof. On the front, side gable, there are full 2 story windows, while on the sides the 2nd floor windows extend up into the gable. These 2 full floor windows on the front, side gable indicate this may have been an I-House. The front (W) second floor windows are 6/6; other are 1/1. Historic Notes: The Agricultural Census data for 1860 and 1880 do not include Stillwagon. The site is indicated as improved on 1861 plat.
No. Stories: 1-1/2 Major Alterations: siding, historic addition, foundation	
Historic Data Sources: Plats	Site also includes: 2 barns, one of which is a stable, milk house, silo, pump house, crib, 2 shed, garage, and 2 circular metal grain bins.

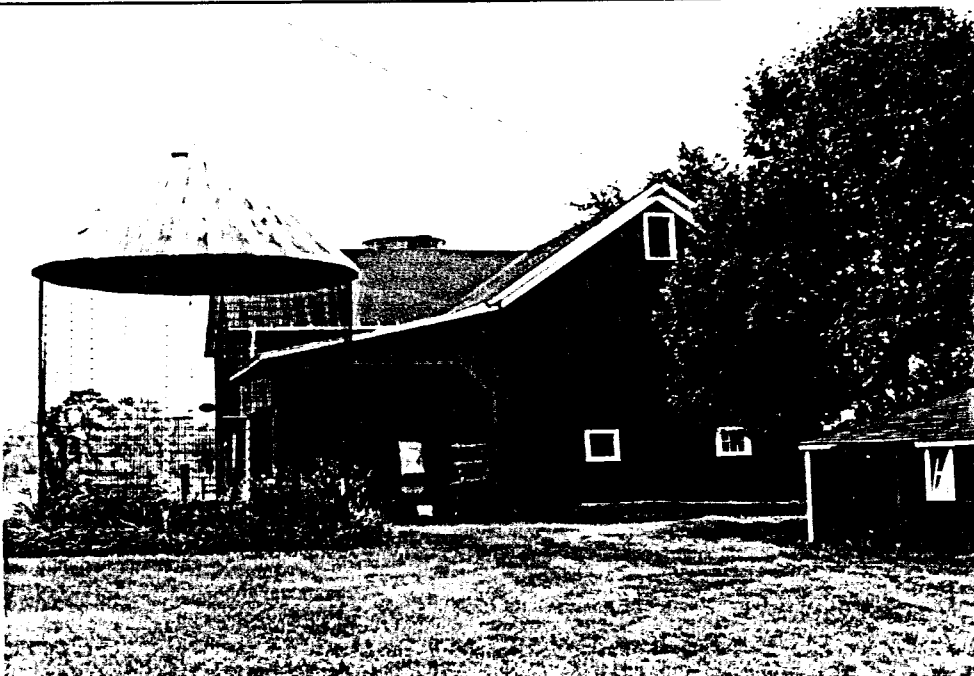
Address/Location: 17701 S. 108th Ave., Orland Township		Tax Parcel No. 27-32-200-002	Map Key No. 52
Name/Owner Current: Harwood Stellwagon Historic: Stillwagon (sic)/Plat	Structure: Bam (B1) Current Use/Historic Use: Bam/Bam Architect/Builder:	Landmark Evaluation Individual: N Farmstead: Y Criteria: A, 1 National Register: Y Local: Y	
Date/Source: c.1890/Style, Census	Condition: Good	Integrity: High	
Materials Foundation: Concrete Walls: Board & batten Roof: Gable with gable/ Asphalt shingle	Architectural Style/Form: Gable Bam with gable and shed extension Description/Features: Frame gable bam has a same height gable forming a "T" to the East, sliding doors on the long side (W), a glazed tile silo, c. 1925, on the South, and a separate milk house on the West adjacent to the doors. A shed extension fills the corner on the East. Windows are 6 light. Refer to survey form for milk house for photographic view of West side of bam. Historic Notes: Agricultural census data of 1880 and earlier does not include Stillwagon.

No. Stories: 1+loft Major Alterations: Extension			
Historic Data Sources: Plats

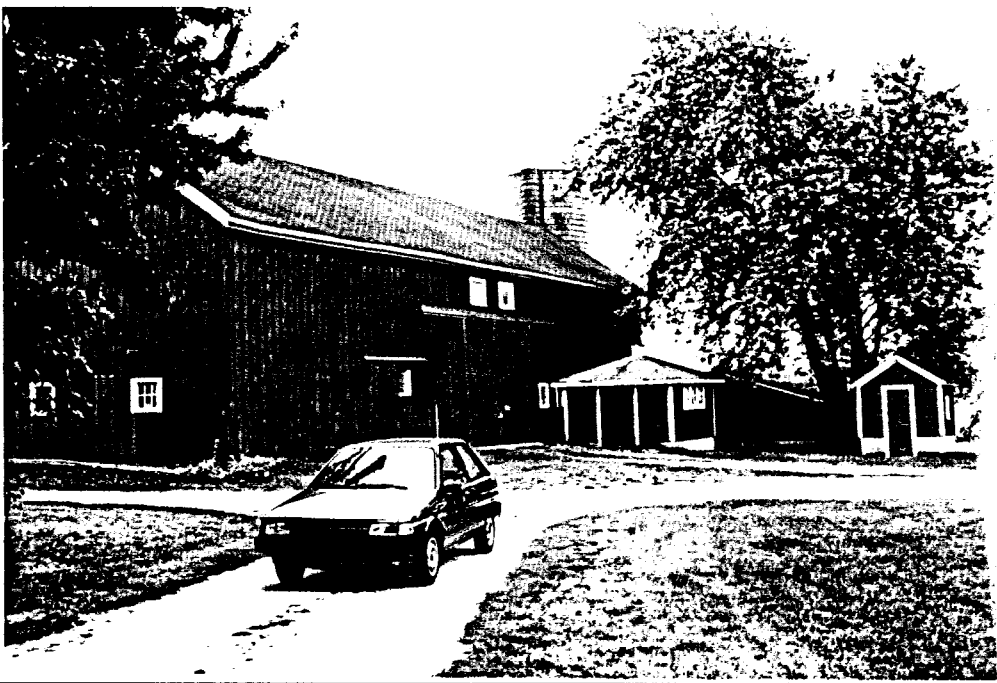
Address/Location: 17701 S. 108th Ave., Orland Township		Tax Parcel No. 27-32-200-002	Map Key No. 52
Name/Owner Current: Harwood Stellwagon Historic: Stillwagon (sic)/Plat	Structure: Milk House Current Use/Historic Use: Milk House/Milk House Architect/Builder:	Landmark Evaluation Individual: N Farmstead: Y Criteria: A, 1 National Register: Y Local: Y	
Date/Source: c.1920/Style, materials	Condition: Good	Integrity: High	
Materials Foundation: Concrete block Walls: Wood drop siding Roof: Pyramidal/ Asphalt shingle	Architectural Style/Form: Milk House Description/Features: Frame milk house is sited adjacent to the West side of Barn (B1) at the barn doors. The building has a pair of doors on the side (N) and a row of three 4-light windows on the side (W).		
No. Stories: 1 Major Alterations:	Historic Notes: Agricultural census data of 1880 and earlier does not include Stillwagon.		
Historic Data Sources:

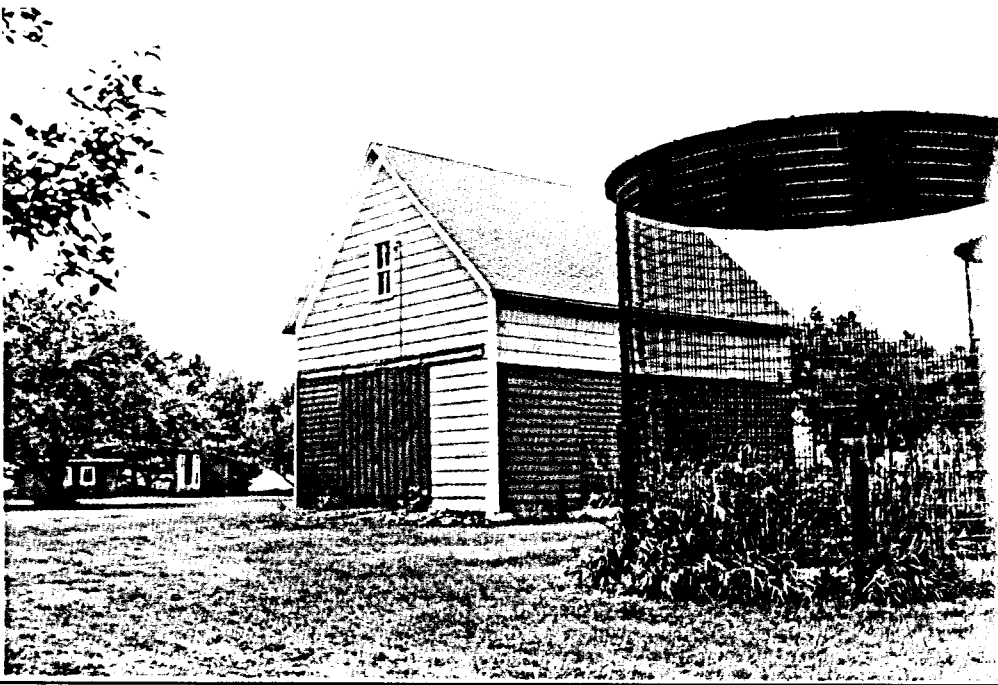
Address/Location: 17701 S. 108th Ave., Orland Township		Tax Parcel No. 27-32-200-002	Map Key No. 52
Name/Owner Current: Harwood Stellwagon Historic: Stillwagon (<i>sic</i>)/Plat	Structure: Crib Current Use/Historic Use: Crib/Crib Architect/Builder:	Landmark Evaluation Individual: N Farmstead: Y Criteria: A, 1 National Register: Y Local: Y	
Date/Source: c.1890/Style, Plats	Condition: Good	Integrity: High	
Materials Foundation: N/A Walls: Horiz. bds, comp. siding Roof: Gable/ Asphalt shingle	Architectural Style/Form: Crib Description/Features: Crib has spaced horizontal board for com storage visible on portions of both sides (N&S). A 1/1 window is located in the loft gable end (W). West end also has a pair of vertical board sliding doors.		
No. Stories: 1 + loft Major Alterations:	Historic Notes: Agricultural census data of 1880 and earlier does not include Stillwagon.		
Historic Data Sources:

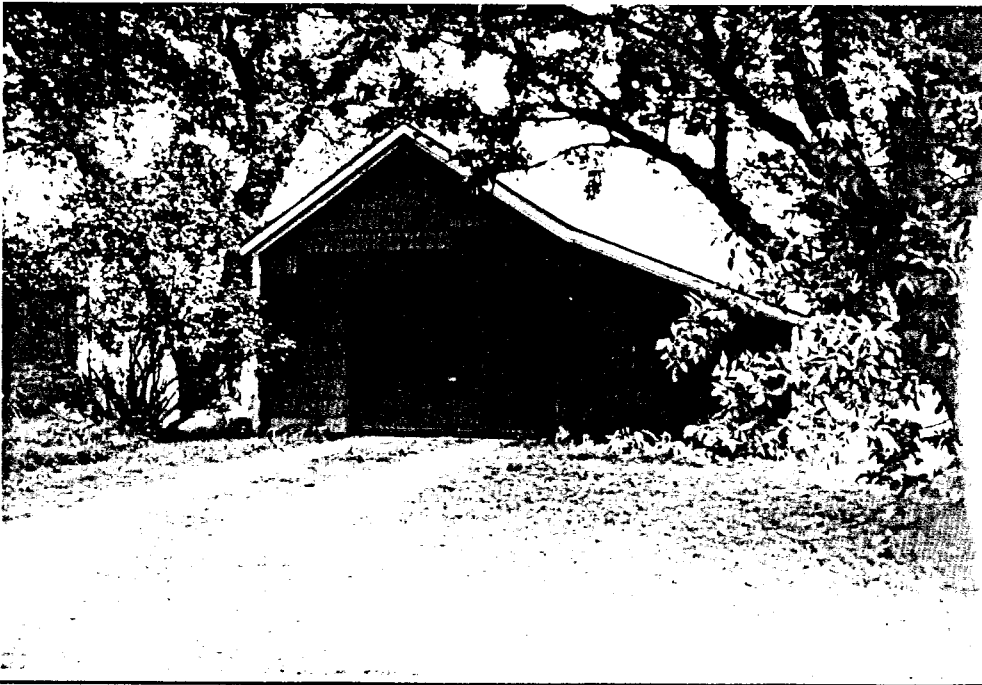
Address/Location: 17701 S. 108th Ave., Orland Township		Tax Parcel No. 27-32-200-002	Map Key No. 52
Name/Owner Current: Harwood Stellwagon Historic: Stillwagon (sic)/Plat	Structure: Shed (SH1) Current Use/Historic Use: Shed/Garage Architect/Builder:	Landmark Evaluation Individual: N Farmstead: Y Criteria: A, 1 National Register: Y Local: Y	
Date/Source: c.1910/Style	Condition: Good	Integrity: High	
Materials Foundation: N/A Walls: Composition, vert. bds. Roof: Gable w/ extension/ Asphalt shingle	Architectural Style/Form: Shed Description/Features: Frame shed has been modified into a garage with an overhead door on the gable end (W). The form is a gable with an extension to the South side. The building has composition siding on the West and vertical board siding on the rear (E). On the rear (E) of the extension are a pair of doors and a 4-light window.		
No. Stories: 1 Major Alterations:	Historic Notes: Agricultural census data of 1880 and earlier does not include Stillwagon.

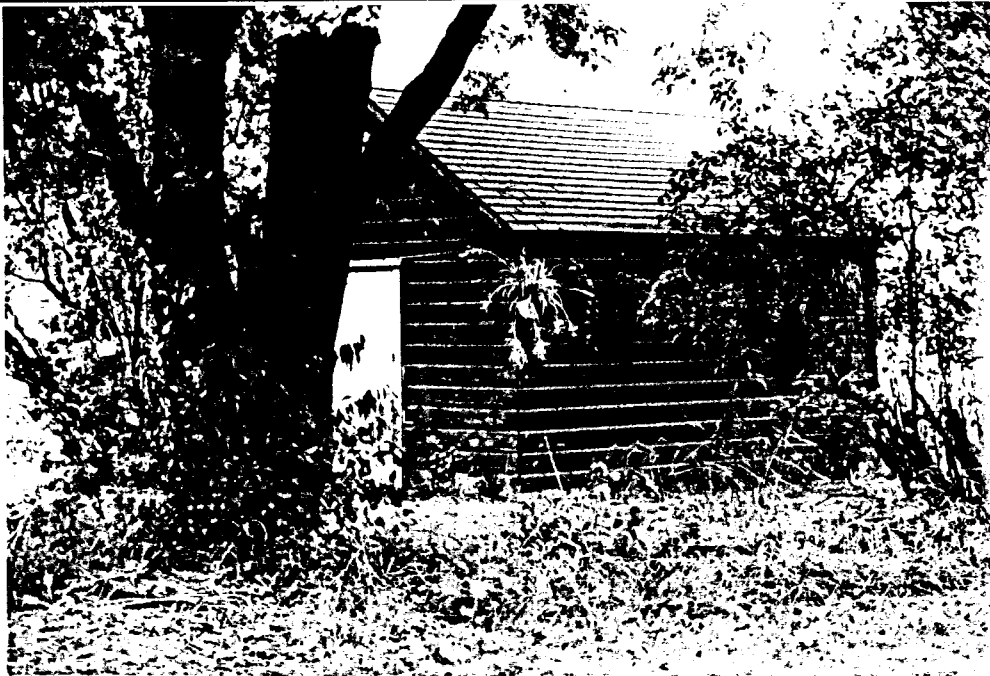
Address/Location: 17701 S. 108th Ave., Orland Township		Tax Parcel No. 27-32-200-002	Map Key No. 52
Name/Owner Current: Harwood Stellwagon Historic: Stillwagon (<i>sic</i>)/Plat	Structure: Shed (SH2) Current Use/Historic Use: -/Shed Architect/Builder:	Landmark Evaluation Individual: N Farmstead: Y Criteria: A, 1 National Register: Y Local: Y	
Date/Source: c.1910/Style	Condition: Good	Integrity: High	
Materials Foundation: N/A Walls: Wood drop siding Roof: Gable/ Asphalt shingle	Architectural Style/Form: Shed Description/Features: Frame shed has one door on the gable end facing West. There are no windows on the West or South. The building may have been used as a wash house or summer kitchen although no chimney is visible. Rafter tails are exposed.		
No. Stories: 1 Major Alterations:	Historic Notes: Agricultural census data of 1880 and earlier does not include Stillwagon.		
Historic Data Sources:

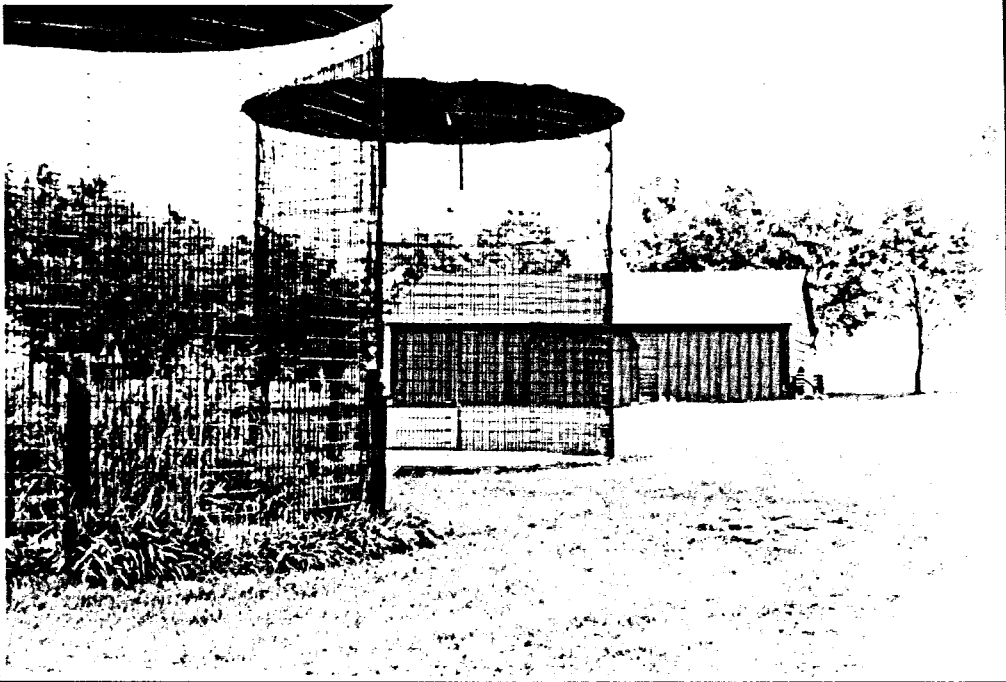
Address/Location: 17701 S. 108th Ave., Orland Township		Tax Parcel No. 27-32-200-002	Map Key No. 52
Name/Owner Current: Harwood Stellwagon Historic: Stillwagon (<i>sic</i>)/Plat	Structure: Shed (SH3) Current Use/Historic Use: Shed/Shed Architect/Builder:	Landmark Evaluation Individual: N Farmstead: Y Criteria: A, 1 National Register: Y Local: Y	
Date/Source: c.1930/Form	Condition: Good	Integrity: High	
Materials Foundation: N/A Walls: Horizontal boards Roof: Gable/ Asphalt shingle	Architectural Style/Form: Shed Description/Features: Frame three bay shed has door on the long side (W) which are of vertical boards.		
No. Stories: 1 Major Alterations:	Historic Notes: Agricultural census data of 1880 and earlier does not include Stillwagon.		
Historic Data Sources:

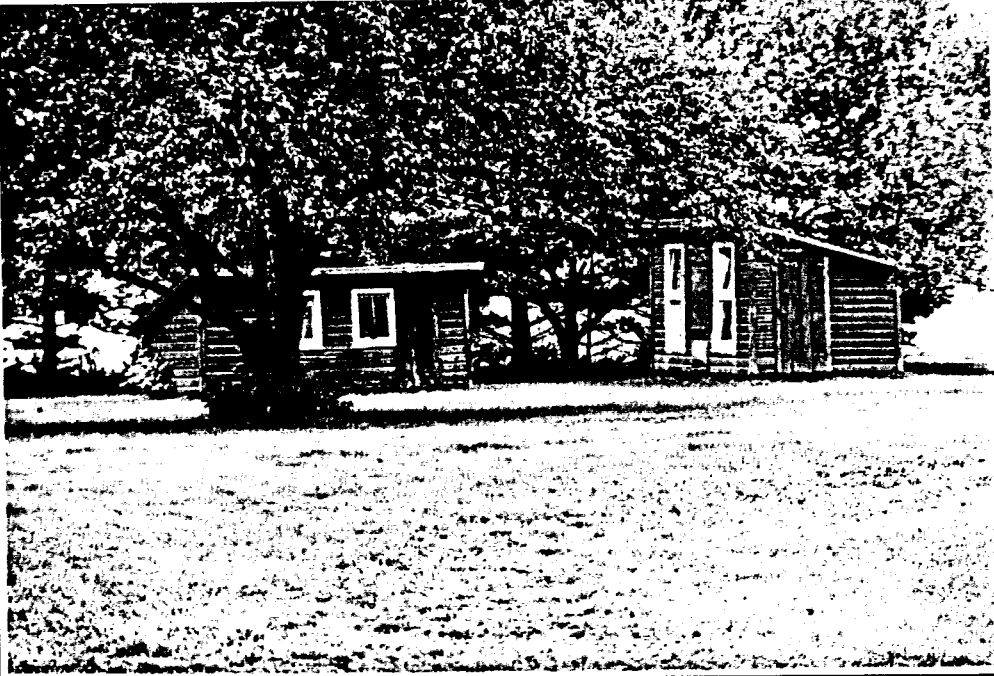
Address/Location: 17701 S. 108th Ave., Orland Township		Tax Parcel No. 27-32-200-002	Map Key No. 52
Name/Owner Current: Harwood Stellwagon Historic: Stillwagon (sic)/Plat	Structure: Coops (CO1, CO2) Current Use/Historic Use: Coop/Coop Architect/Builder:	Landmark Evaluation Individual: N Farmstead: Y Criteria: A, 1 National Register: Y Local: Y	
Date/Source: c.1900/Materials	Condition: Fair	Integrity: High	
Materials Foundation: N/A Walls: Wood drop siding Roof: Shed/ N/A	Architectural Style/Form: Coops Description/Features: Coop (CO1) with shed roof has tall side facing South with two 4-light windows and a vertical board door on the South side. Coop (CO2) is almost the same except for two double hung windows on the taller elevation facing West and a vertical board door on the South side. Coop (CO1) is on the left and Coop (CO2) is on the right in the photograph.		
No. Stories: 1 Major Alterations:	Historic Notes: Agricultural census data of 1880 and earlier does not include Stillwagon.
